Annual Inspection

Longbeach Play Area

La Rue a Don, Grouville, JE3 9DY

Inspection Ref: 2500133

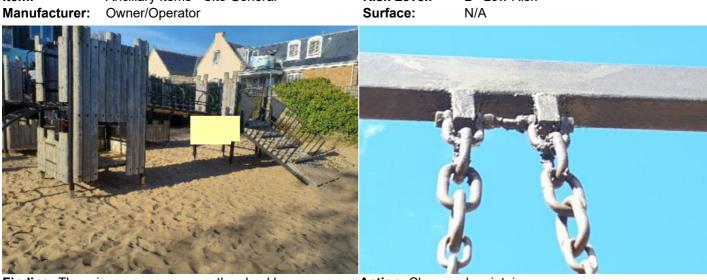
Finding: There is excess grease on the shackles

Action: Clean and maintain

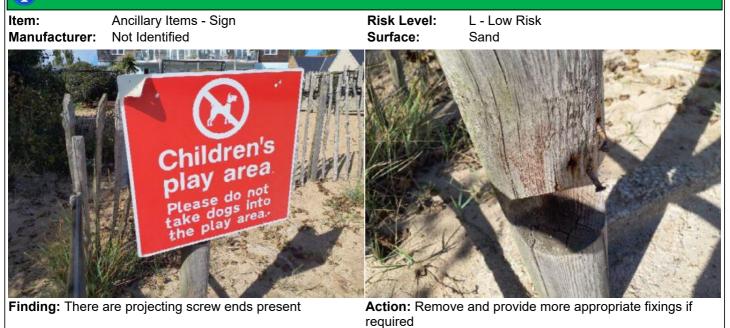
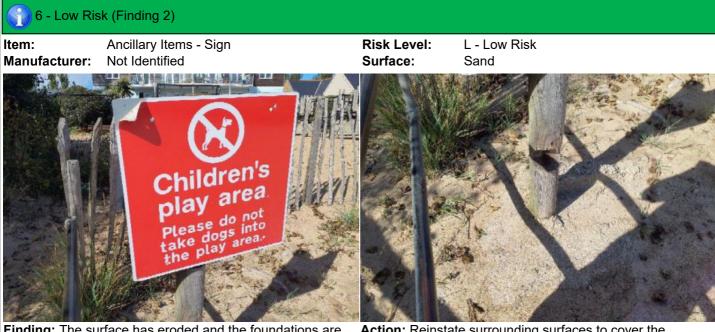
6 - Low Risk (Finding 1)

Finding: The surface has eroded and the foundations are exposed

Action: Reinstate surrounding surfaces to cover the foundations

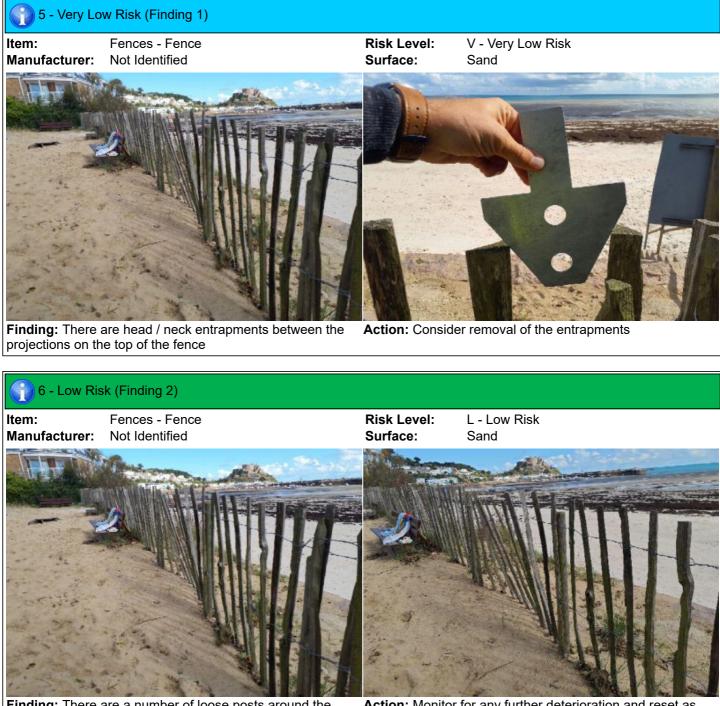
Finding: There are a number of loose posts around the fence

Action: Monitor for any further deterioration and reset as required

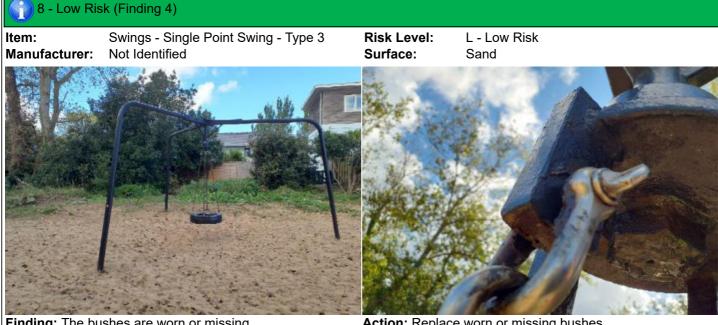
Finding: The bushes are worn or missing

Action: Replace worn or missing bushes

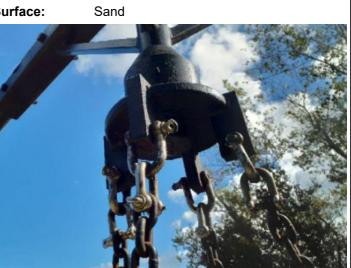
Finding: This item has an internal failsafe to catch the universal joint in the event of a catastrophic failure, however components as necessary as the failsafe is internal, the equipment is of some age and also due to its highly dynamic nature, we would recommend that the item is stripped down and a replacement provided as necessary.

Action: Strip down the universal joint and replace any worn

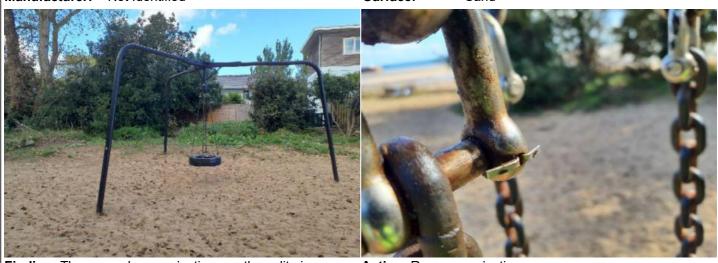
Finding: There are sharp projections on the split pins

Action: Remove projections

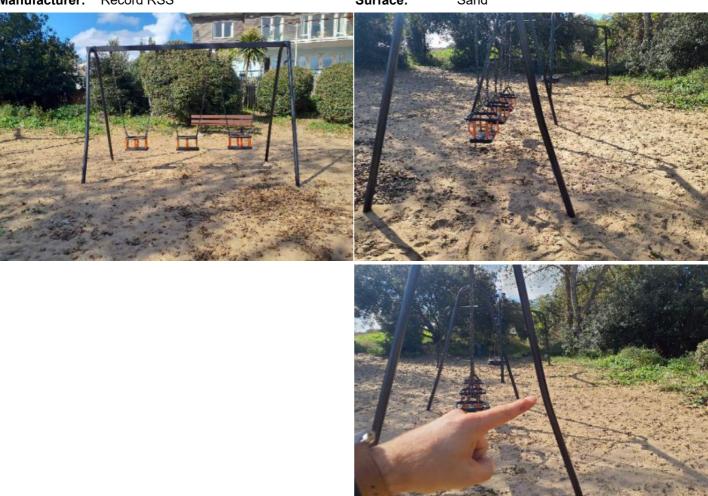
Finding: The frame is bent

Action: Monitor for any further deterioration and replace when worn

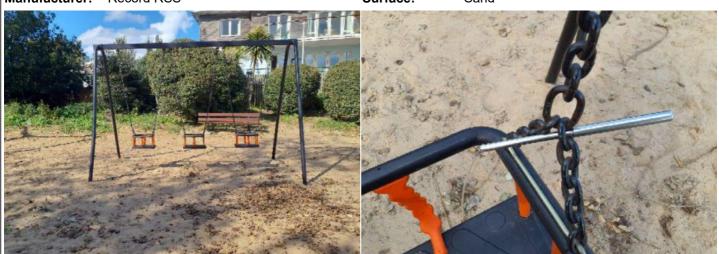
Finding: The chain openings are in excess of the 8.6mm as Action: Monitor - No remedial work recommended recommended by BS EN 1176

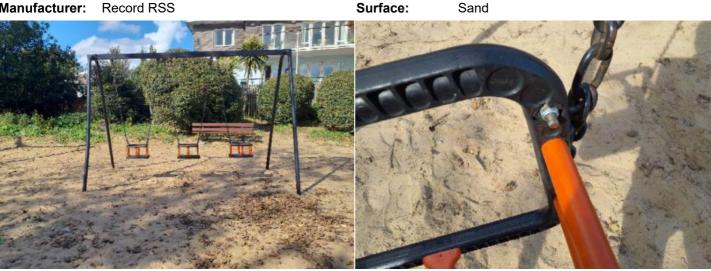
6 - Low Risk (Finding 3) Item: Swings - 1 Bay 3 Seat (Cradle) **Risk Level:** Manufacturer: Record RSS

Finding: There are caps missing from the underside of the Action: Replace missing caps under the seats seats

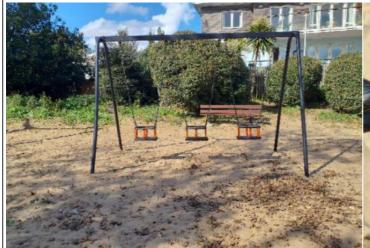
Finding: There is some notable evidence of chain wear

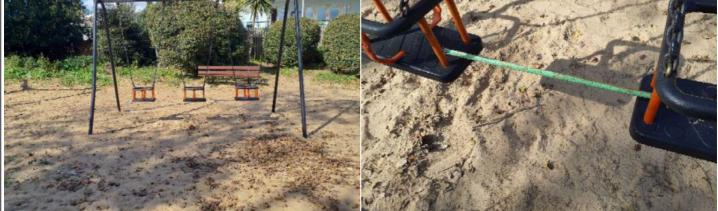
6 - Low Risk (Finding 5) Swings - 1 Bay 3 Seat (Cradle) Risk Level: L - Low Risk Manufacturer: Record RSS Surface: Sand

Finding: The seats are too close to each other as defined in Action: Monitor - No remedial work recommended BS EN 1176 Part 2; this is a low risk failure and no remedial action is required

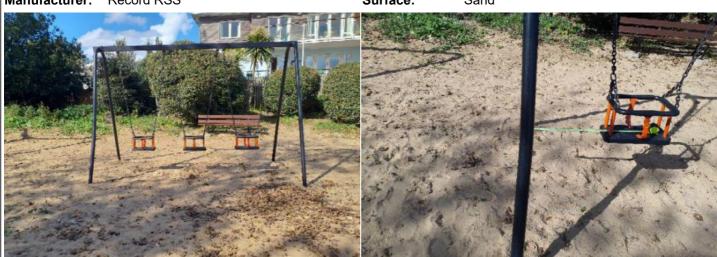
4 - Very Low Risk (Finding 6)

Finding: The seats are too close to the frame as defined in BS EN 1176 Part 2; this is a low risk failure and no remedial action is required

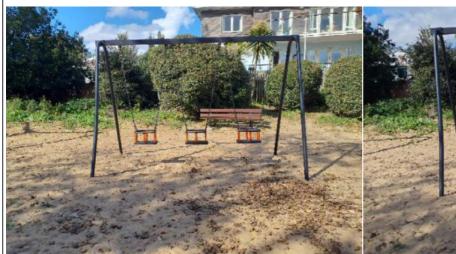
Finding: There are more than 2 seats in a single bay in contravention of BS EN 1176

Action: Monitor use and remove the middle swing if required

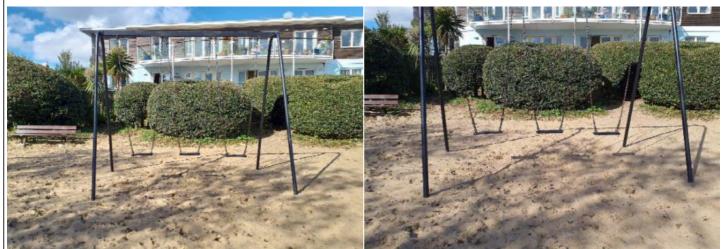
Finding: There are more than 2 seats in a single bay in contravention of BS EN 1176

Action: Monitor use and remove the middle swing if required

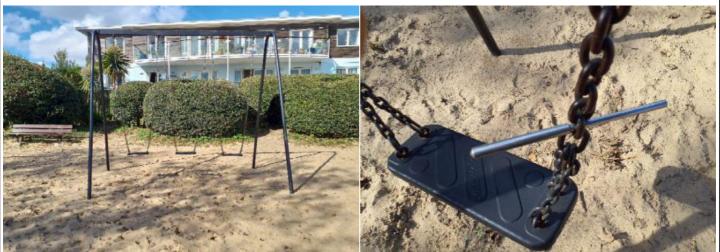
Finding: The chain openings are in excess of the 8.6mm as **Action:** Monitor - No remedial work recommended recommended by BS EN 1176

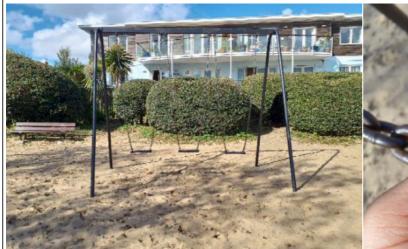
Finding: There is some notable evidence of chain wear

Action: Monitor for any further deterioration and replace when 40% worn

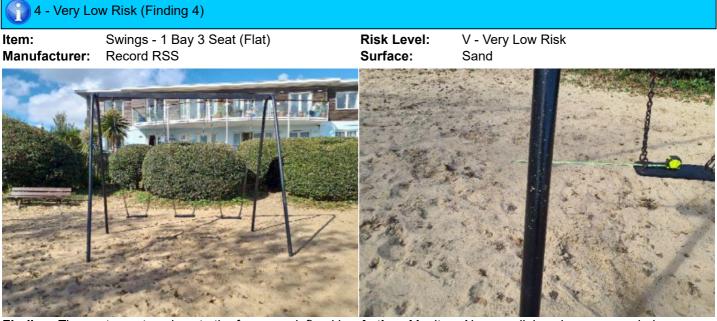
Finding: The seats are too close to the frame as defined in **Action:** Monitor - No remedial work recommended BS EN 1176 Part 2; this is a low risk failure and no remedial action is required

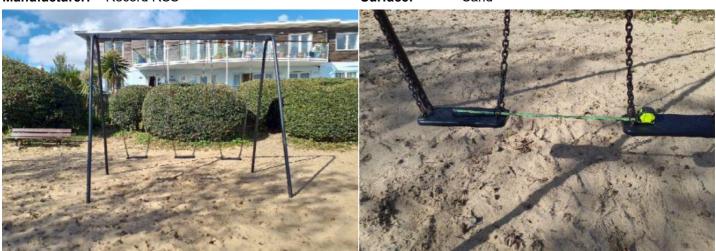
Finding: The seats are too close to each other as defined in **Action:** Consider removing the middle seat BS EN 1176 Part 2; this is a low risk failure and no remedial action is required

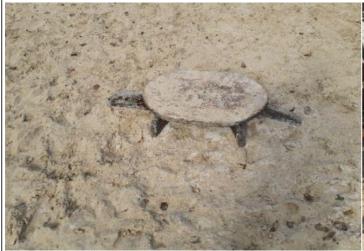
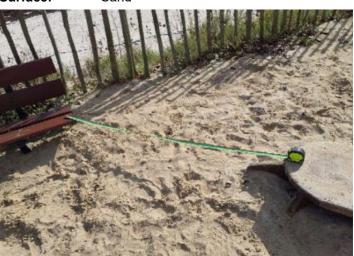
5 - Very Low Risk (Finding 1)

Finding: The bench forms a projecting obstacle / hard object within the falling space of the equipment, in contravention of the requirements of BS EN 1176 Part 1

Action: Monitor - No remedial work recommended

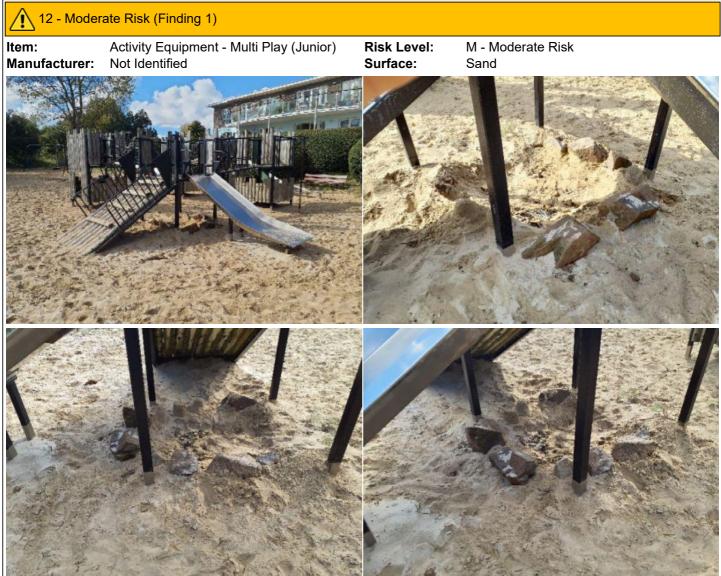
Finding: The large rocks / firepit forms a projecting obstacle **Action:** Remove all stones, rocks and other debris from the falling space of the equipment, in contravention of the requirements of BS EN 1176 Part 1

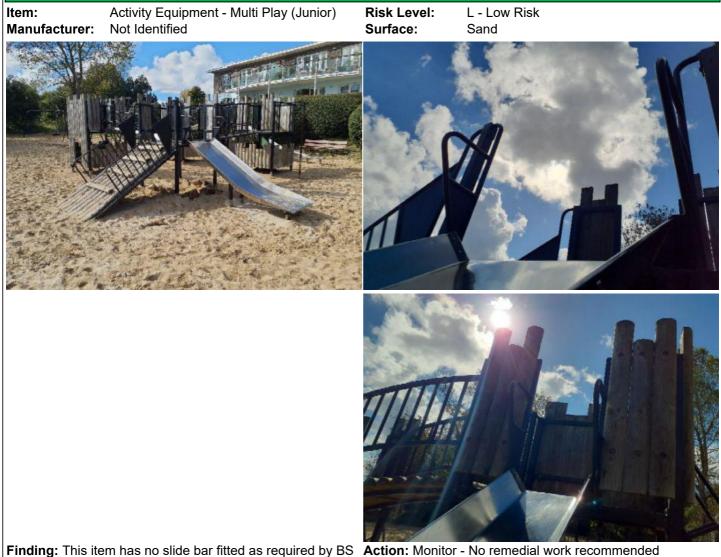
Finding: This item has no slide bar fitted as required by BS **Action:** Monitor - No remedial work recommended EN 1176 Part 3

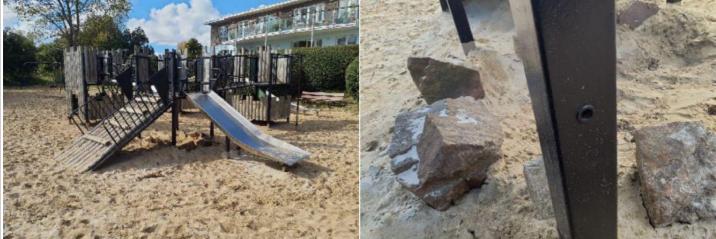
4 - Very Low Risk (Finding 4)

Finding: There is/are inserts missing

Action: Replace missing inserts

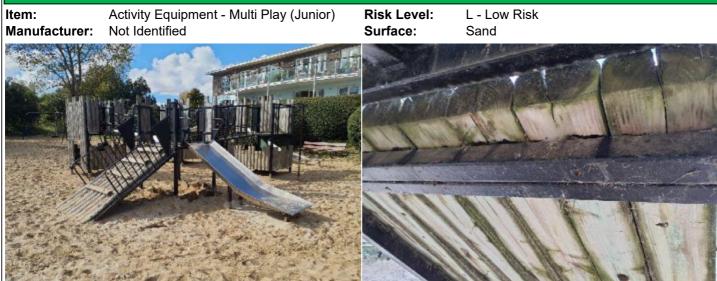
💮 8 - Low Risk (Finding 5)

Finding: There is or are fixings missing on the item

Action: Replace all missing fixings

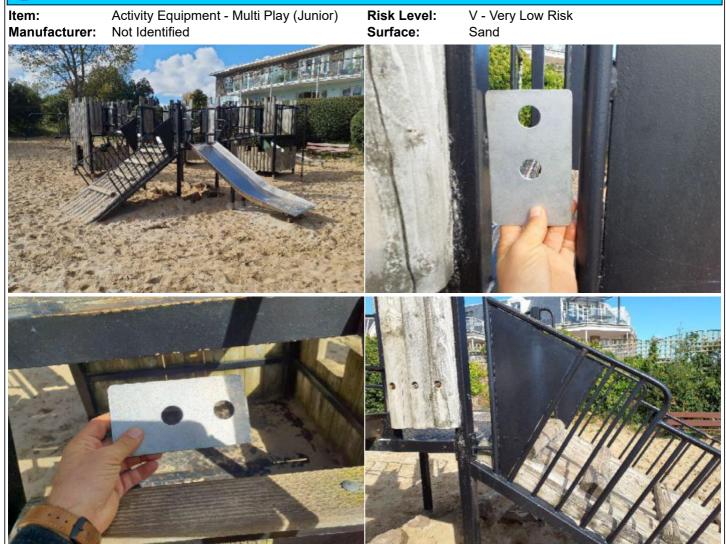
5 - Very Low Risk (Finding 6)

Finding: The item fails to meet the requirements of BS EN **Action:** Monitor - No remedial work recommended 1176 Part 1 4.2.7.2 head and neck entrapment in the barriers and/or steps

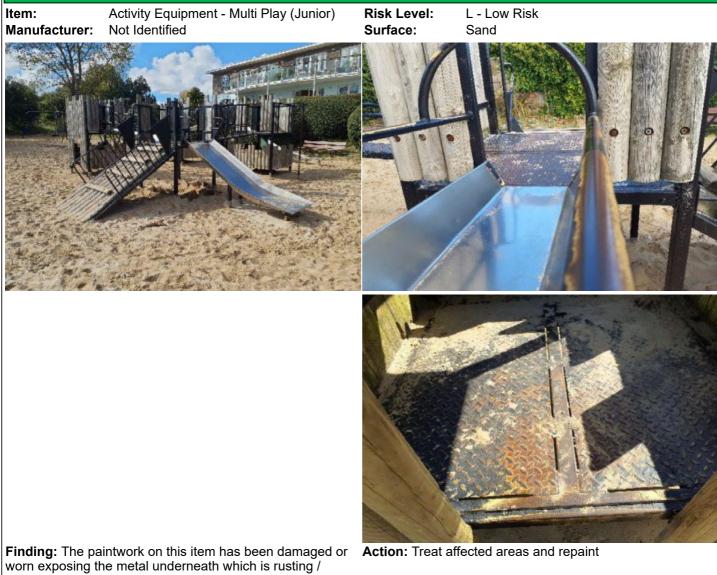
6 - Low Risk (Finding 7)

corroding

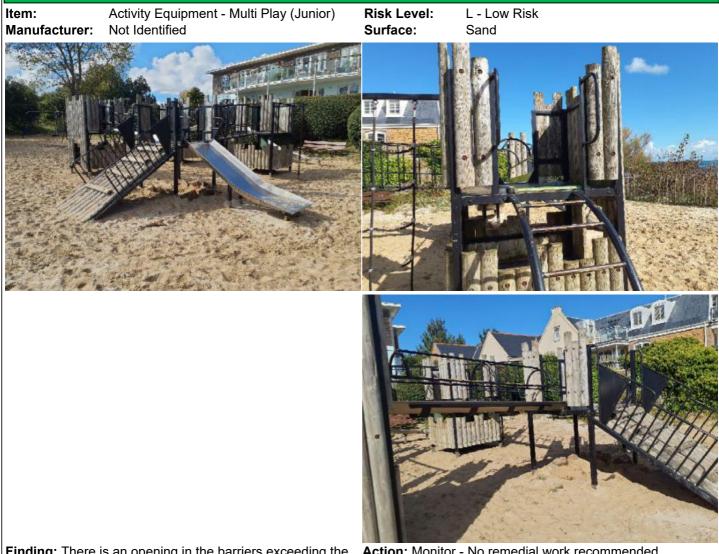
6 - Low Risk (Finding 9)

Finding: There is an opening in the barriers exceeding the width allowed (500mm) in BS EN 1176, and no guardrail has been provided; this is a low risk failure and no remedial action is required

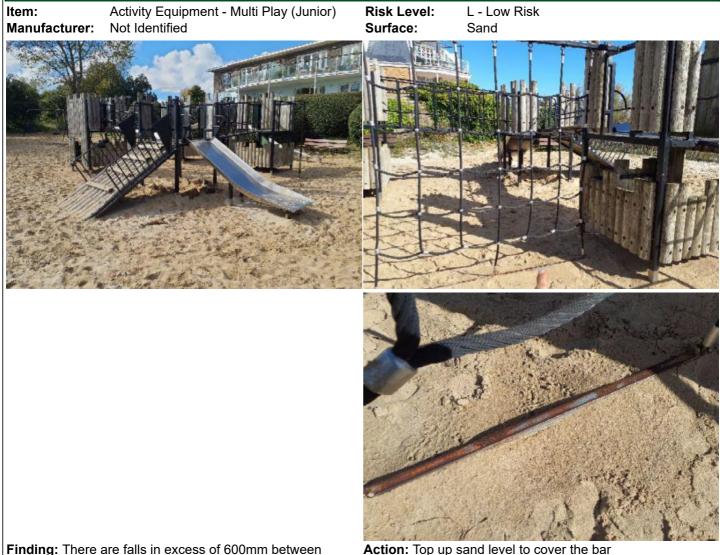
10 - Low Risk (Finding 10)

Finding: There are falls in excess of 600mm between adjacent components on the structure, in contravention of the recommendations set out in BS EN 1176 Part 1; 4.2.8.4

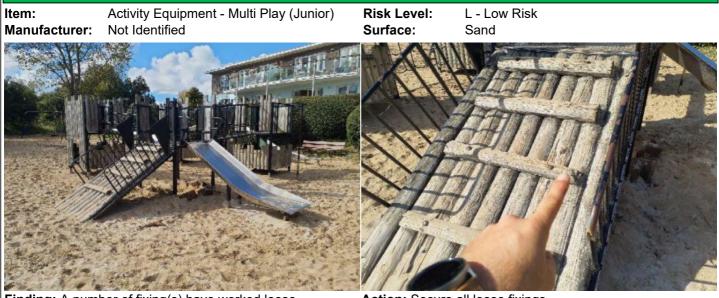
6 - Low Risk (Finding 12)

Finding: A number of fixing(s) have worked loose

Action: Secure all loose fixings

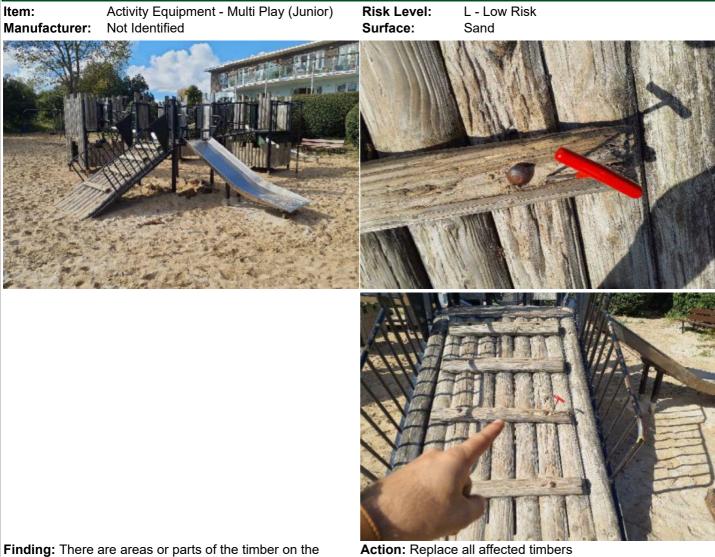
6 - Low Risk (Finding 13) 8

structure that have rotted

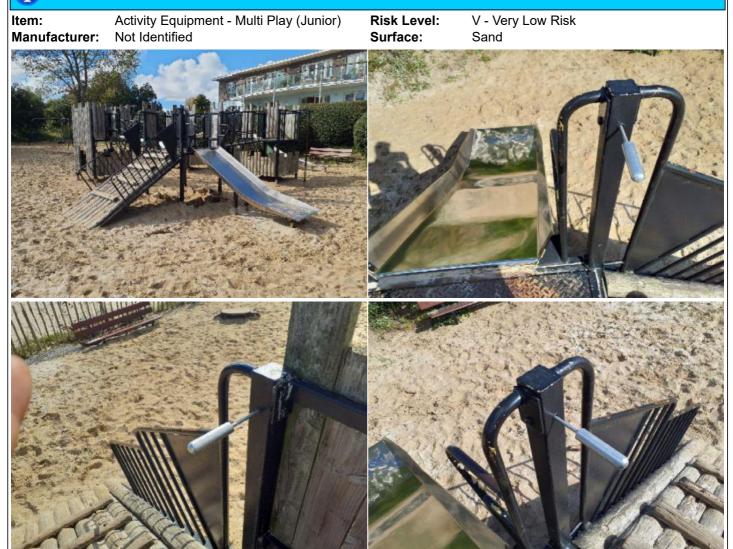
5 - Very Low Risk (Finding 14)

Finding: There is/are finger entrapment/s in the framework **Action:** Replace missing inserts to remove entrapments and the item fails to meet the requirements of BS EN 1176 Part 1 4.2.7.6 Entrapment of fingers

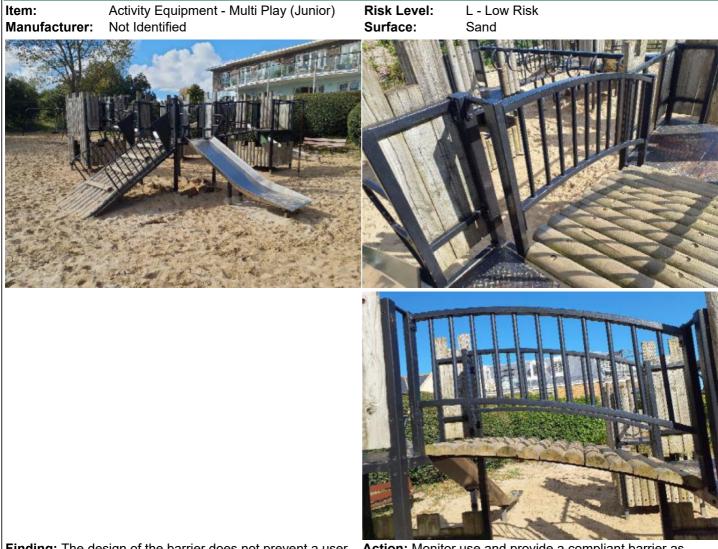
😭 8 - Low Risk (Finding 15)

Finding: The design of the barrier does not prevent a user from passing underneath in contravention of the requirements of BS EN 1176 Part 1

Action: Monitor use and provide a compliant barrier as required

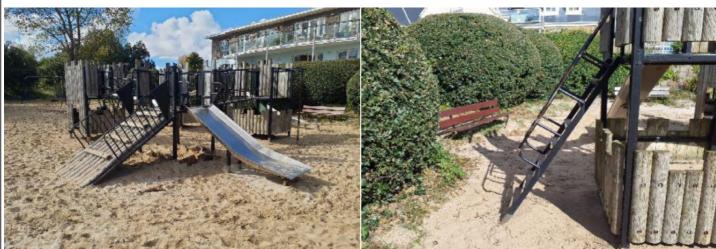
Finding: There is insufficient guarding on the steps leading **Action:** Monitor - No remedial work recommended up to the platform that exceeds 1m in height which contravenes the requirements on BS EN 1176 Part 1
