HAVRE DES PAS PEDESTRIAN CROSSINGS

Stage 1 & 2 Road Safety Audit (Rev A)

OUR REF. NO. 62100327-69-01A

DATE: FEBRUARY 2022

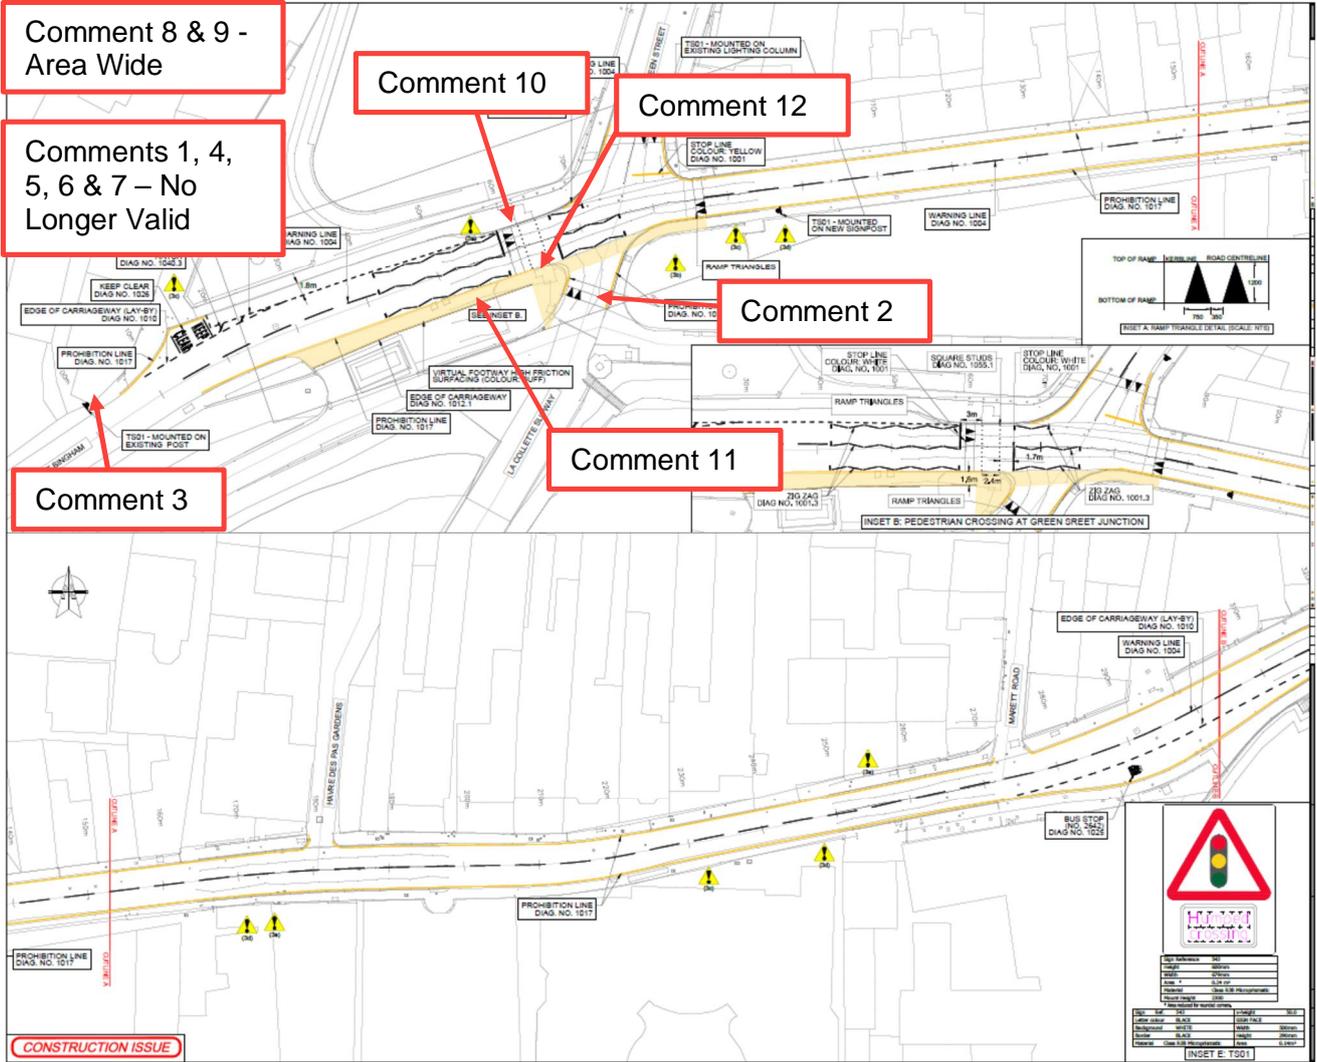
**Problem Location Plan
Stage 1 & 2 Road Safety Audit**

Comment 8 & 9 -
Area Wide

Comments 1, 4,
5, 6 & 7 - No
Longer Valid

Comment 3

Comment 10

Comment 12

Comment 2

Comment 11

Green Street Junction – the mapping used on the drawings for this junction is out of date. In particular, the kerbed build out on the southern side of the existing pelican crossing extends further to the west than shown. The extended buildout will assist with the tie in of levels for the ramp on the western side of the raised table. Other details at this location should be checked to ensure that the design is compatible with the new layout. **Mapping appears to have been updated in the revised drawings.**

Green Street Junction – no level details or sections have been provided for the raised table at this junction. The drawings show a ramp on the southern approach to the table, which starts a few metres in front of a cobbled section of slipway and close to the seafront promenade. A ramp at this location could cause an unnecessary hazard for pedestrians as well as be difficult to tie in to on its eastern side (where the adjacent levels are flush). The need for a ramp at this location is unclear as approach speeds will be very low. It is recommended that the levels on this southern side of the junction are checked to ensure that an appropriate solution is achieved. **Comment still valid in this revision of the RSA Report, although it is understood that level checks have been made.**

Western approach to the Green Street Junction – traffic signs TS01 & TS02 are shown in close proximity to each other. Although not considered to be a problem, it is recommended that checks are made to ensure that the larger sign (TS02) does not obstruct visibility to the 20mph sign (TS01) located behind it. **Comment still valid in this revision of the RSA Report, although it is understood that appropriate checks have been made.**

Area Wide – 20mph signs are to be installed at either end of Havre des Pas, which is within an existing 20mph limit. The audit team did not check to see whether the 20mph limit is also signed in each side road. The validity of the 20mph speed limit could be questioned if it is not signed on the side roads joining it. **The 20 mph signs previously proposed for Havre des Pas have been omitted in from the latest version of the drawings. Check that adequate repeater signs are provided along the length of Havre des Pas.**

In addition, the Highways (Road Humps) (Jersey) Regulations 2002 requires that all road humps are signed with traffic sign No. 557.1 in combination with traffic sign No. 557.2, 557.3 or 557.4. It is noted that where the speed humps are within a 20mph the Highway Authority, in consultation with the Minister, may decide that these signs are not required. **Comment still valid in this revision of the RSA Report.**

There are a few anomalies with the road markings shown on the current version of drawings 1964/1200/001 & 1964/1200/002.

Green St Junction & the Crossing near Roseville Junction - The central zig zag markings on the eastern side are the wrong way around. On the approaches to the crossing the zig zag markings should run in parallel, with the marks converging and diverging on the exit side.

Crossing near Roseville Junction - The zig zags are not in pairs (ie an odd number, not even). This means that the last mark does not tie into the kerb. Either extend or reduce by one mark.

Zebra crossing outside Ommaroo Hotel – Check the configuration of the striped markings to ensure that the first white stripe is away from the kerb face.

Green St Junction – the tactile paving at the signalised crossing doesn't appear to line up correctly.

Green St Junction – high friction surfacing has been proposed for the virtual footway on the southern side of the junction. Pedestrians that trip and fall on to the surface may sustain more severe injuries than if a less abrasive surfacing material is used.

Green St Junction – buff coloured high friction surfacing has been proposed for the virtual footway on the southern side of the junction. Buff coloured tactile paving has also been proposed at the crossing and therefore it is important to provide adequate contrast for visually impaired pedestrians.
