GOVERNMENT OF JERSEY

MONT LES VAUX RESURFACING WORKS

Feasibility Report

Report No: 1965/001

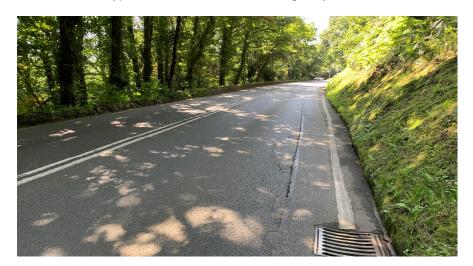
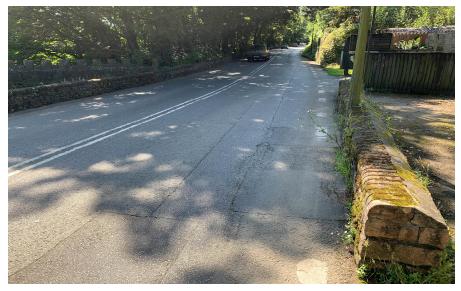
- 2.1 <u>Pavement Visual Conditions</u>
- 2.1.1 A visual inspection of the existing pavement was undertaken on the 14th of July 2021 by , Senior Engineer from WSP.
- 2.1.2 There are a number of visible defects across the scheme extents which are listed below:
- Cracking (Linear and crocodile)
- Severe rutting
- Utilities trenches
- Potholes
- 2.1.3 Figure 1 & 2 below are typical of the state of the carriageway surface.

Figure 1 & 2 – Typical state of the schemes existing carriageway

- 2.2.6 Table 3' results shows a large variation in core depths with a 109mm average thickness of bound material. Areas where core RAG ratings give a rating of red or amber directly correlate with areas of rutting, cracking and crazing noted during a pavement condition survey completed by (Senior Engineer, WSP) on July 14th, 2021.

- 3.1 Pavement
- 3.1.1 The cores taken along Mont Les Vaux show a vast variation in the thickness of bound pavement materials. This ranging from 200mm at most to 40mm at minimum. This taken from the analysis of the core grading thicknesses shown in Table 3 of this report,
- 3.1.2 Following analysis of cores within Table 3 two pavement options are recommended.

Option A- That areas of pavement be treated with a 150mm inlay for the scheme extents. 150mm Inlay consists of the following materials

Option B – That part of the road be treated with 150mm inlay and between Ch.220 to Ch.978 be treated with 50mm overlay, materials noted following.
