Report on the investigation of  
two accidents during berthing and unberthing  
of

***Logos II***

St Helier, Jersey

**Report No 1/2008  
January 2008**

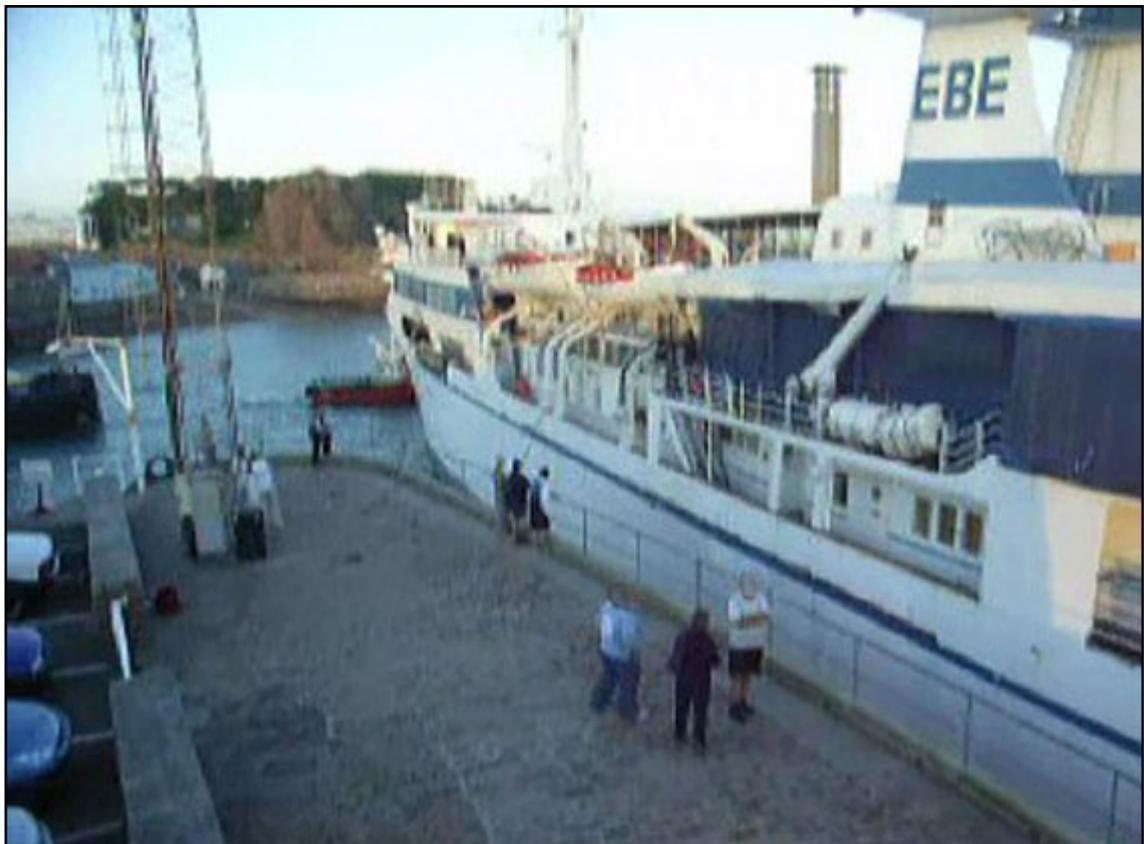
Figure 4

*Logos II* weighed anchor at 2008 and the master handed the con to the DHM. The vessel proceeded at full ahead manoeuvring speed of 7 knots and, after the passage through Small Road, she executed the turn towards the inner harbour without difficulty. During the transit through the inner pier heads, on which a large crowd had gathered to greet the ship and was cheering loudly, the DHM instructed *Titan* to: 'get on the bow as soon as possible and start pushing us down south'. The skipper of *Titan* immediately complied with this instruction (**Figure 4**), and soon after, the port quarter of *Logos II* began to swing towards Albert Pier head. The DHM was able to check the swing of the port quarter by the use of ahead power and port helm.

*Titan* pushing *Logos II* on entry through the pier heads (image captured from video)

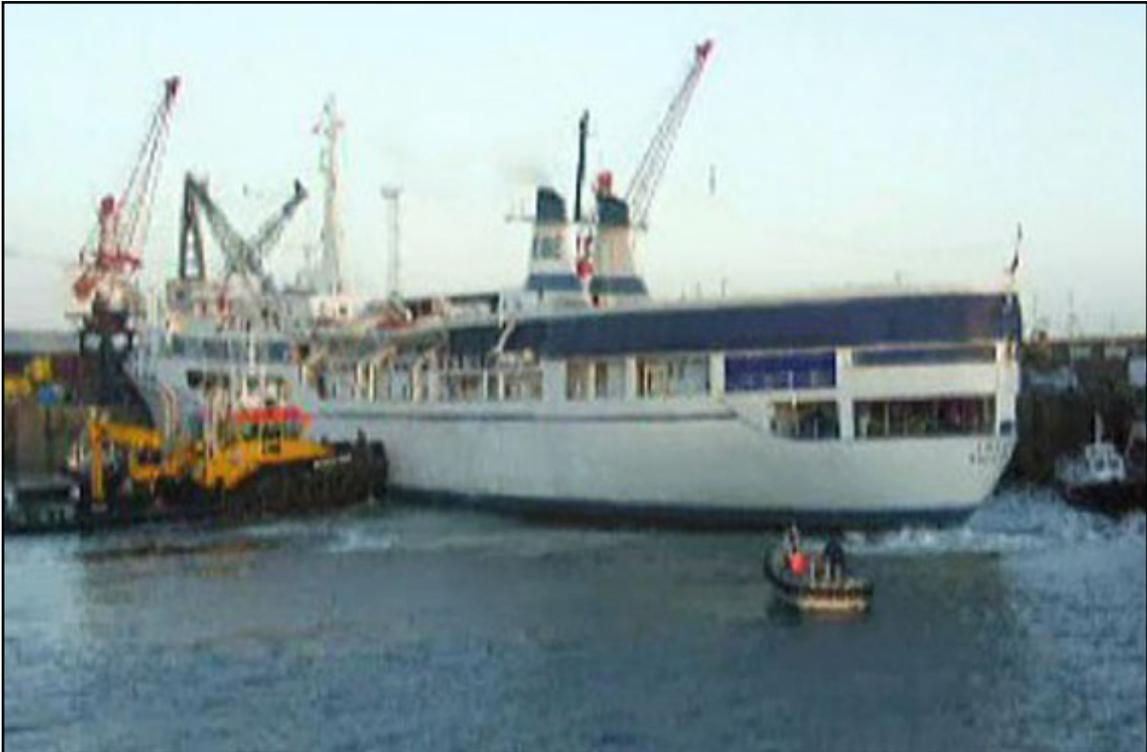
Figure 5

On clearing the pier heads, *Marineco Toomai* took up a position just aft of amidships (**Figure 5**) on the port side of *Logos II*. At 2043, the DHM instructed both tugs to push the vessel towards Victoria Pier. His instruction to *Marineco Toomai* was: 'can you push easy on the stern, we will to push her bodily down' [sic]. The DHM looked over the port side on several occasions as *Logos II* closed Victoria Pier, but was unable to accurately determine the position of *Marineco Toomai* due to obstructions in his line of site. He assumed she was in her assigned station; he did not check directly with the tug and was not informed otherwise. Soon after, *Halcyon*, a harbour work boat which had been requested by the DHM to standby to assist, positioned herself on the port quarter of *Logos II* and also started to push (**Figure 6**). This action was not requested or seen by the DHM.

Marineco Toomai pushing from amidships (image captured from video)

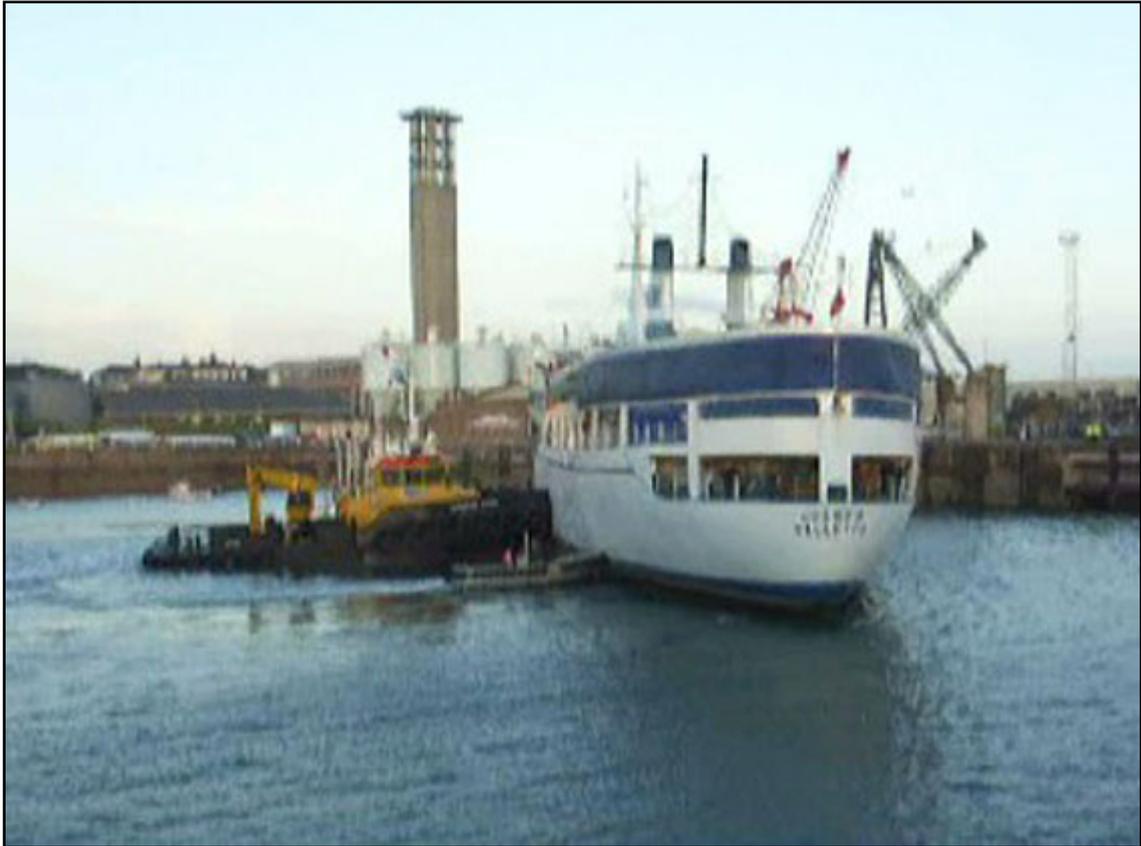
Figure 6

Marineco Toomai & Halcyon pushing on port quarter (image captured from video)

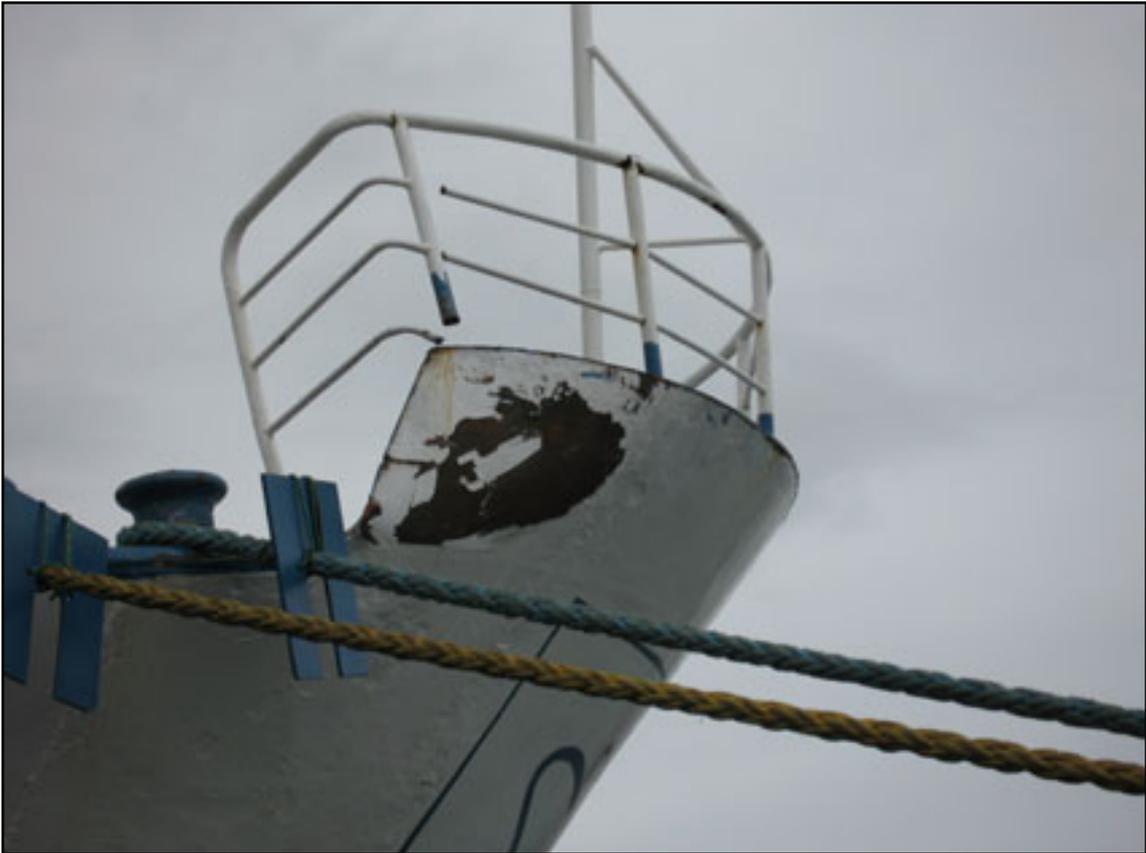
Time and date : 2047 (UTC+1) on 20 June 2007  
Location of incident : St Helier, Jersey  
Persons on board : 197  
Injuries/fatalities : None  
Damage : Vessel sustained indent on her starboard bow, bent pulpit railings and superficial damage to paintwork. Structural damage was caused to two small craft and minor damage to a shore crane.

As *Logos II* neared the berth, the vessel's bow started to close the pier much quicker than intended. This was commented upon by the master, and the DHM attempted to check this movement by ordering *Titan* to stop pushing and *Marineco Toomai* to push with full power. He also ordered the engines to full astern. These actions failed to check the vessel's movement, and at 2047 her bow made contact with the quay and a shore crane (**Figures 7 & 8**).

Damage to starboard bow of *Logos II*

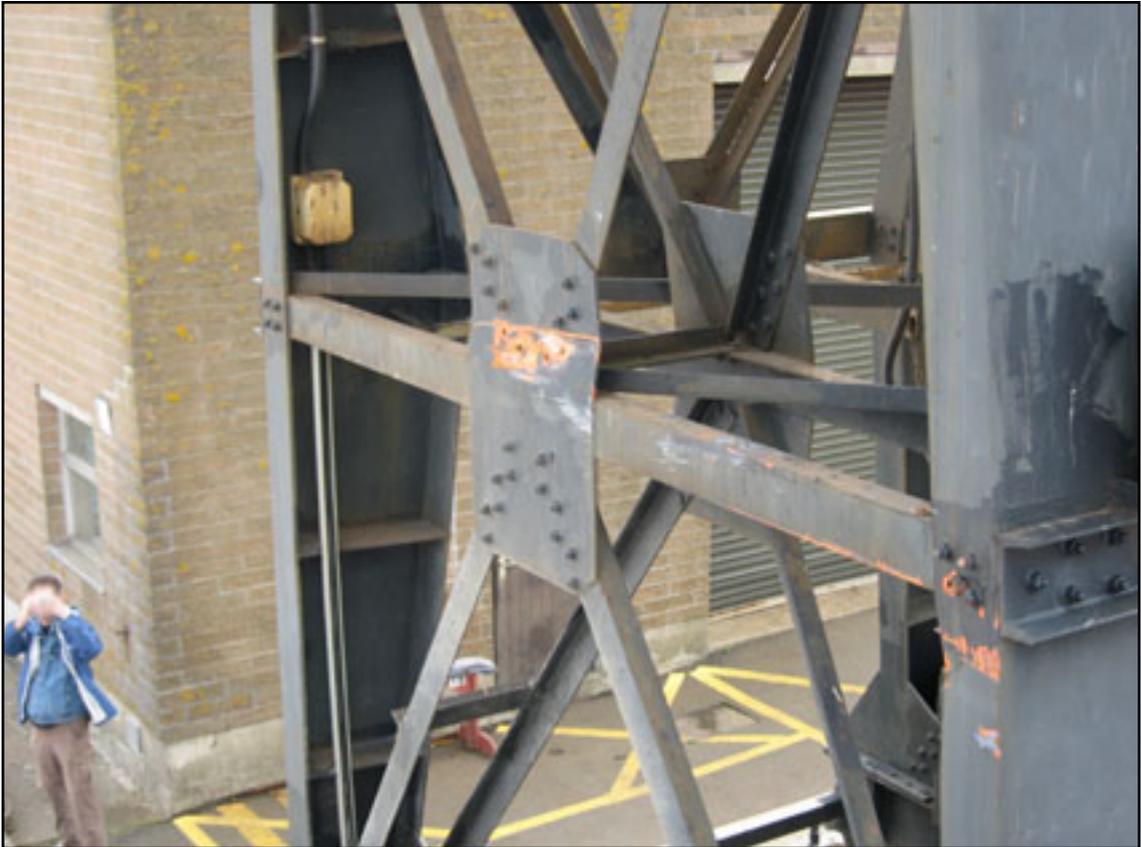
Damage to shore crane

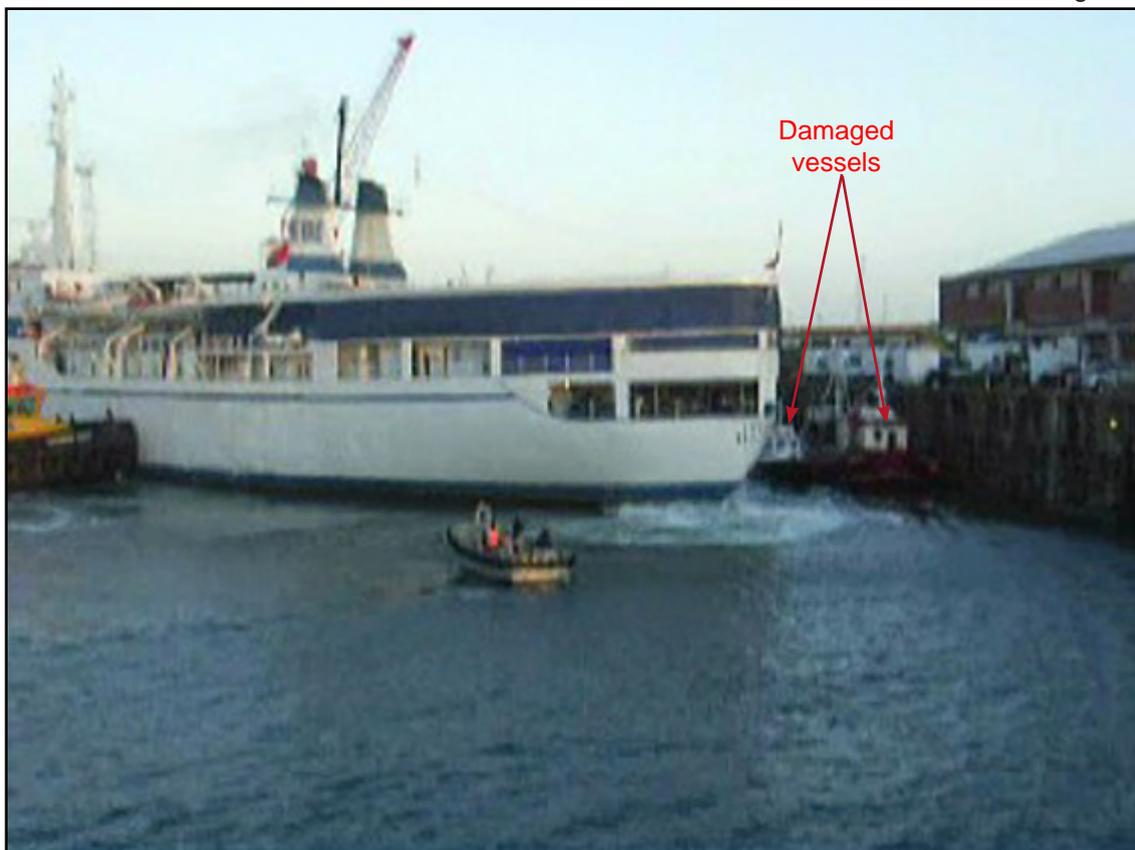
Figure 9

The DHM immediately ordered the engines to be stopped and then set to half ahead, and for the helm to be put to hard to starboard. The aft tug was also ordered to stop pushing, but the stern of *Logos II* made contact with two of the small boats (**Figure 9**).

Stern of *Logos II* prior to contact with boats moored at London Berth (image captured from video)

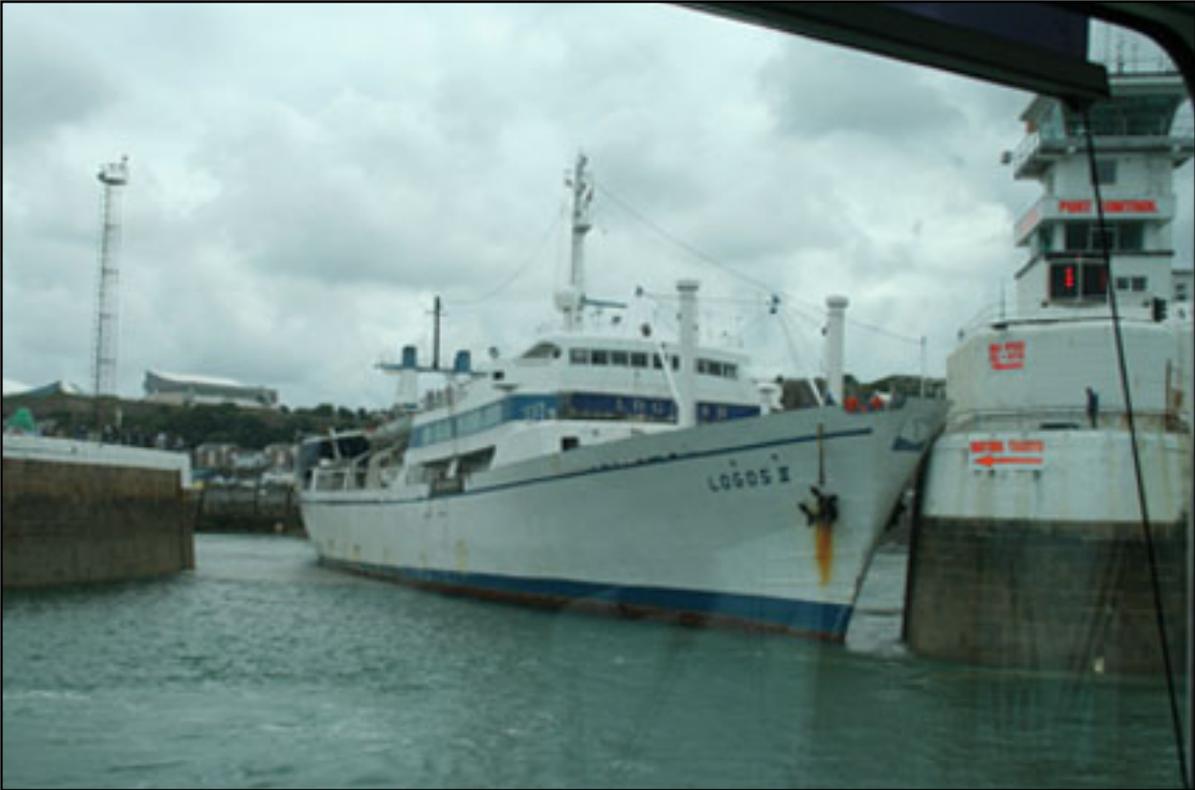
Figure 11

Without the assistance of the forward tug, *Logos II* came to rest with her port bow on the Victoria Pier head (**Figure 11**) at 1200. Damage to the vessel was superficial, but damage to the concrete and railings on the pier head was more extensive (**Figure 12**). A tow line was quickly re-secured to *Duke of Normandy*, and *Logos II* was pulled clear of the pier head. The tow was then released to allow the ship to increase speed, but when the AHM attempted to alter course to the south, *Logos II* again failed to respond to the helm, and the assistance of *Duke of Normandy* was required to push her bow towards her intended heading. The vessel then completed her departure from St Helier without further incident.

Logos II in contact with Victoria Pier head

As soon as the tow line parted, there was little action the pilot could take to avoid the ship's bow coming to rest on Victoria Pier head. In view of the influence of the north west wind, along with the poor handling characteristics of the vessel and the close proximity of the pier heads, attempts to manoeuvre *Logos II* clear might have resulted in more serious damage.

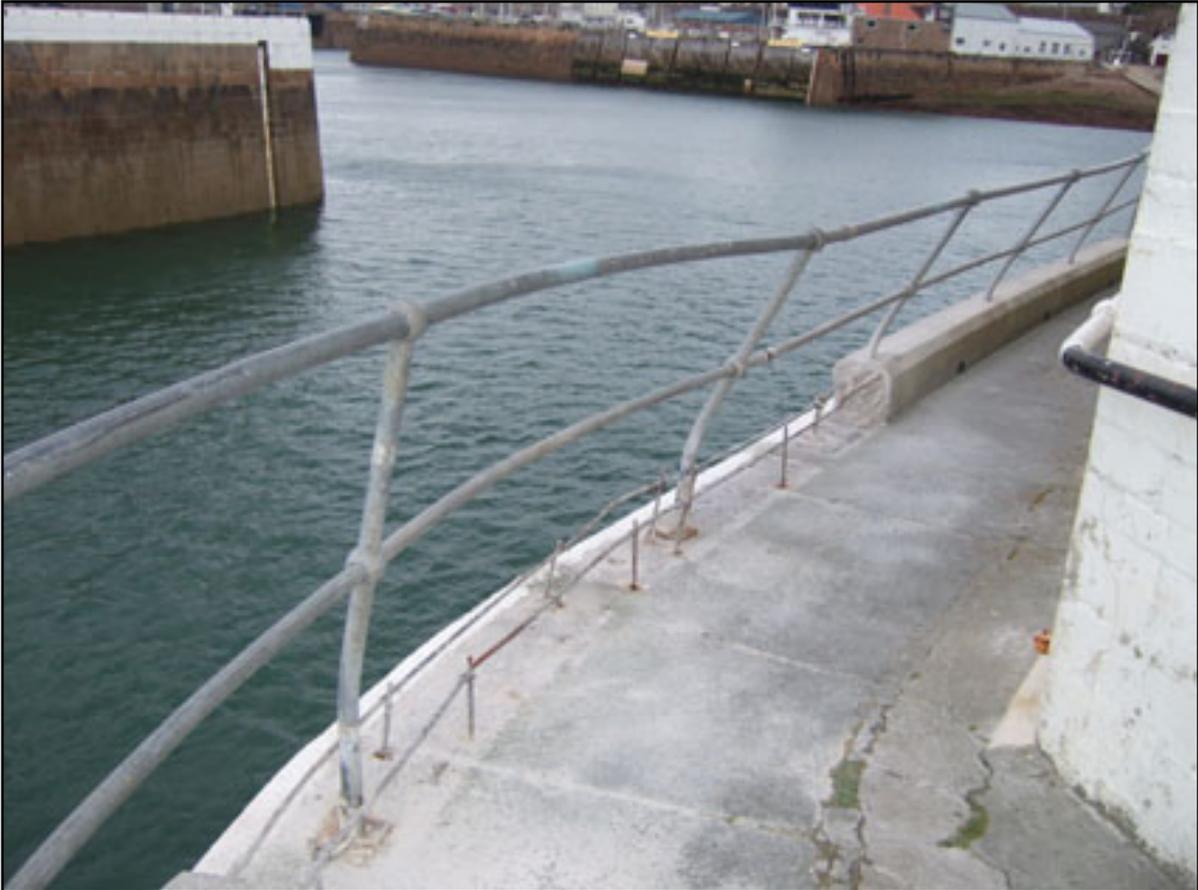
Figure 12

Time and date : 1200 (UTC+1) on 26 June 2007  
Location of incident : St Helier, Jersey  
Persons on board : 189  
Injuries/fatalities : None  
Damage : Structural damage was caused to concrete land ties and safety railings on Victoria Pier head.

Damage to Victoria Pier head
