PRELIMINARY RISK ASSESSMENT

REPORT NO. 14502

Plémont Bay Holiday Village,

Jersey

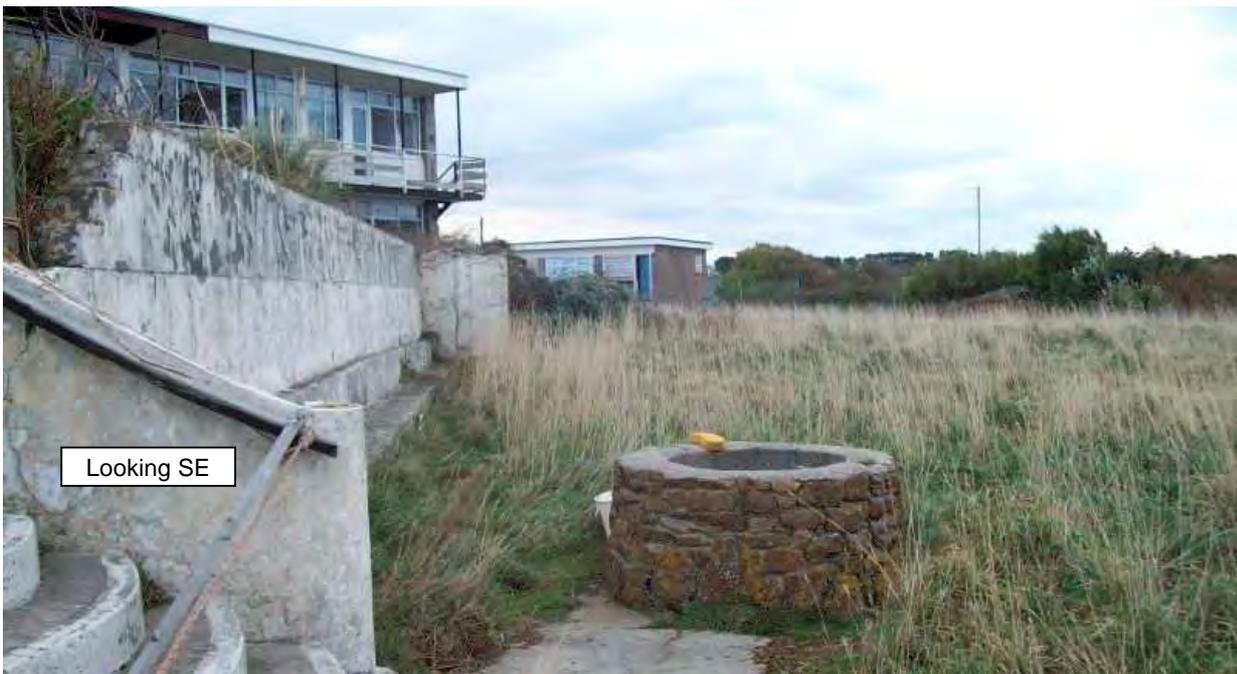
The above Photo is taken from the NW corner of the site, adjacent to a store building. A small well is located at the bottom of the steps.

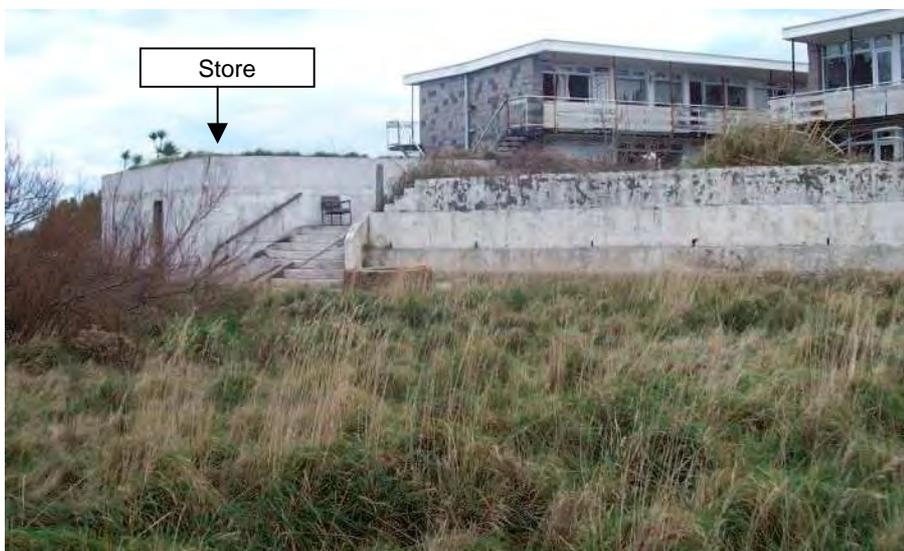
The roughly vegetated open area was the site of the old Plémont Hotel, which burnt down in the 1940's. There is no evidence of the hotel or of the fire. The ground generally slopes from north to south.

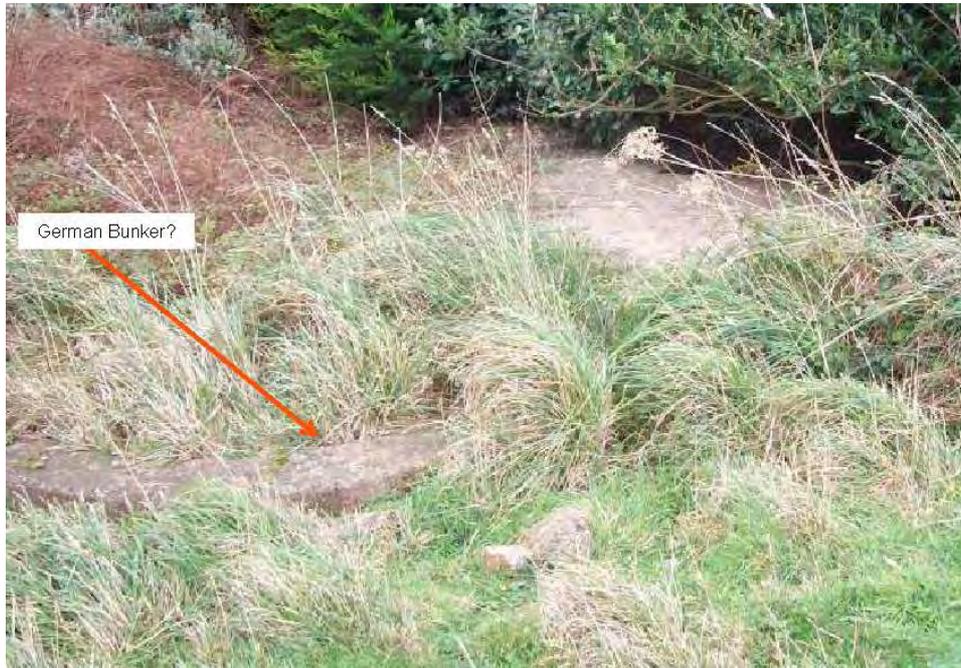
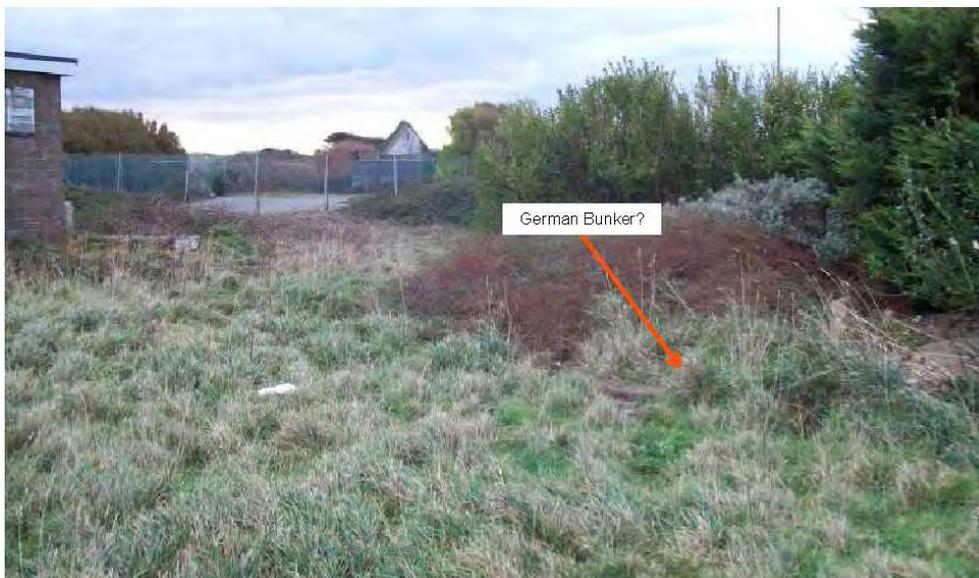
To the south of the Hotel site, there is a circular and square concrete structure. The structure is mostly covered by thick vegetated. This could be a German Bunker.

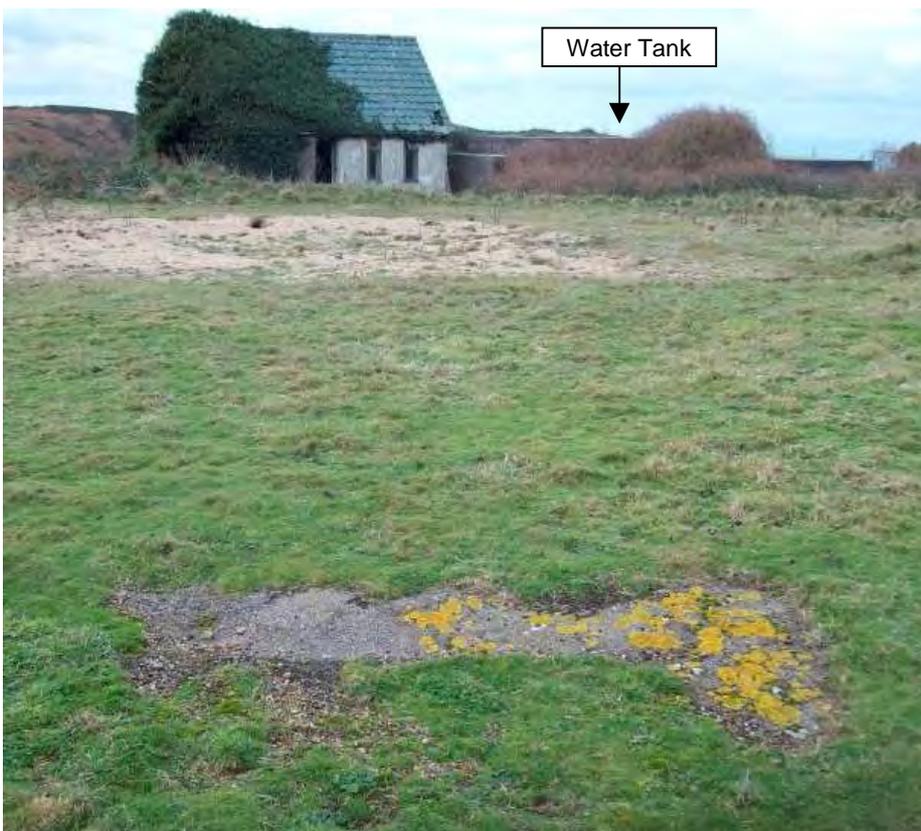
To the south of the tennis court there is the water treatment tank. This consists of a large rectangular concrete structure, which extends approximately 1.2m above ground.

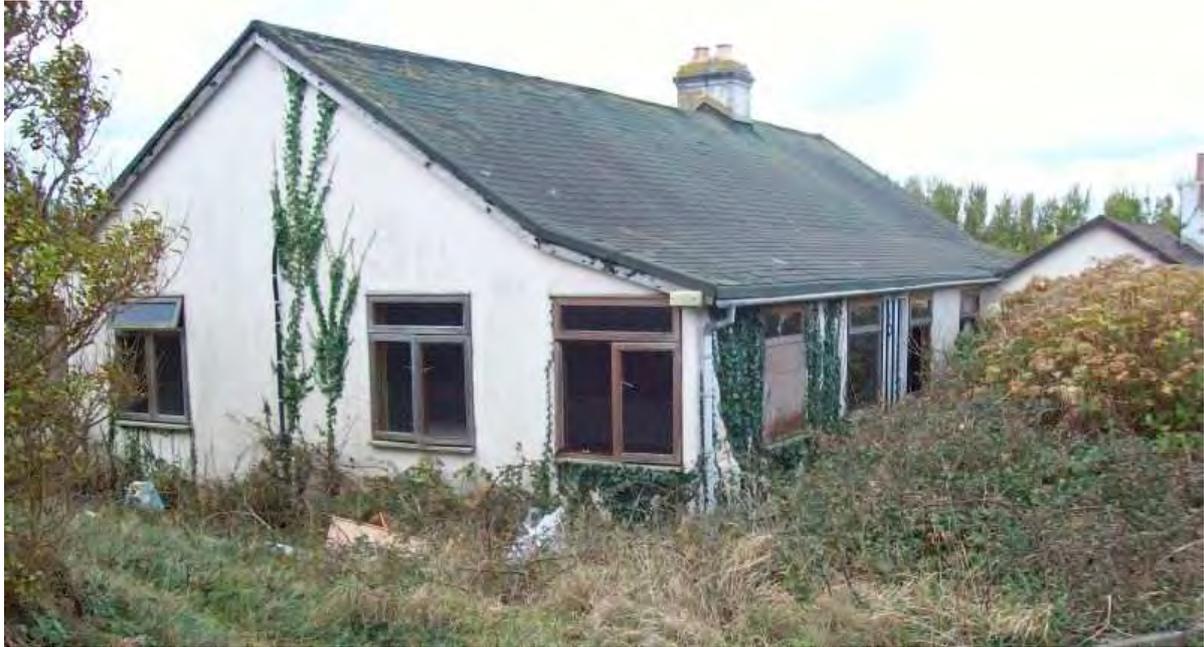
Adjacent to the water tank is a small building most likely used for storage. The building is in disrepair with the roof and walls showing damage.

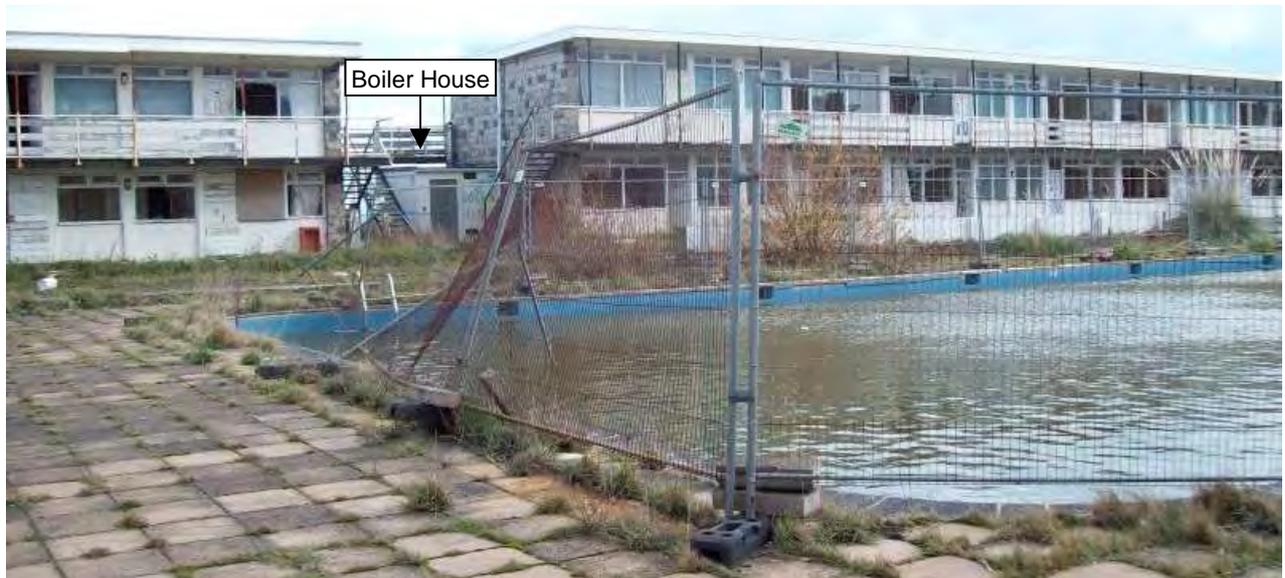
The main Holiday village is located at the north and central areas of the site. There are eight brick built two storey apartment blocks generally all orientated to face the swimming pool etc. The apartments are in disrepair with broken windows and generally open to the elements. It appears that a boiler house is shared between two blocks, with the building located at the end of one of these. Therefore, in total there are four small boiler houses attached to the apartment blocks which are now unused.

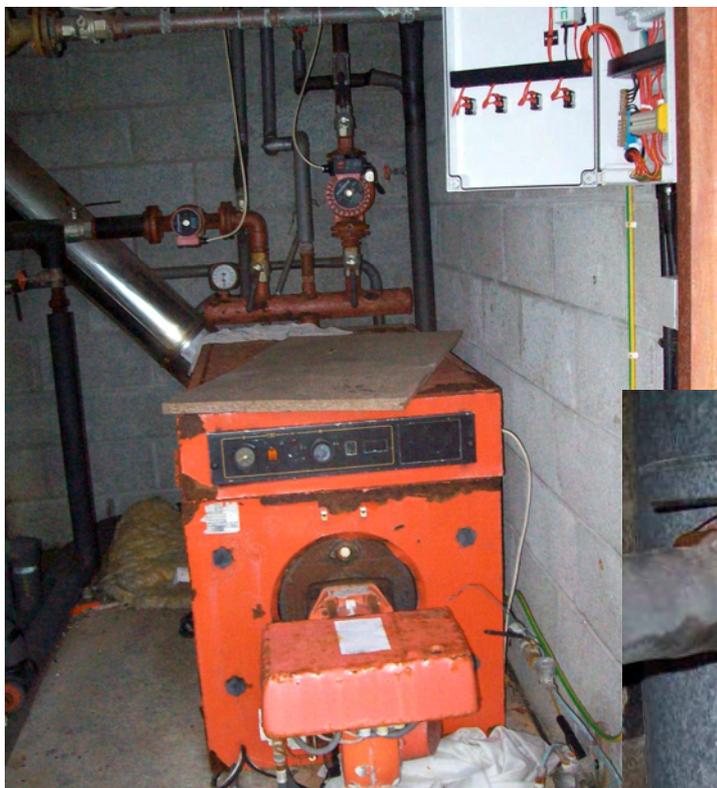
Only one of these small boiler houses was accessible during the walkover. This was located at the southern end of the most western apartment block (north of the shop).

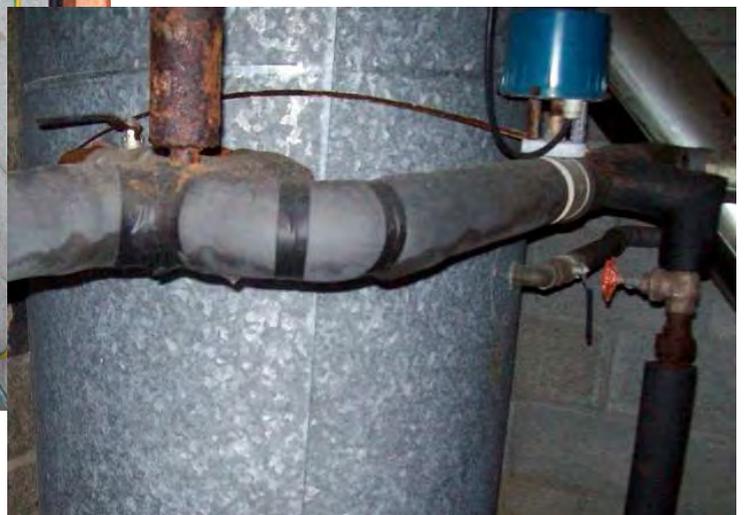
It appears that the central heating system was fuelled by oil. The site oil tank is located at the NW corner of the site. Therefore it is assumed that there is an underground oil distribution network to feed each boilers.

The major potential environmental issue on site is the oil distribution pipeline network. It is understood that the pipeline network is made of plastic. It is likely that small scale leakages will have occurred throughout the network. The oil can attack the glue at joints and therefore leaks can occur. It is understood that this system has approximately been in place since 1984. It is not known what had been in before but it is possible, the plastic pipes replaced corroded pipes from the previous system. These pipes may also have leaked in the past.

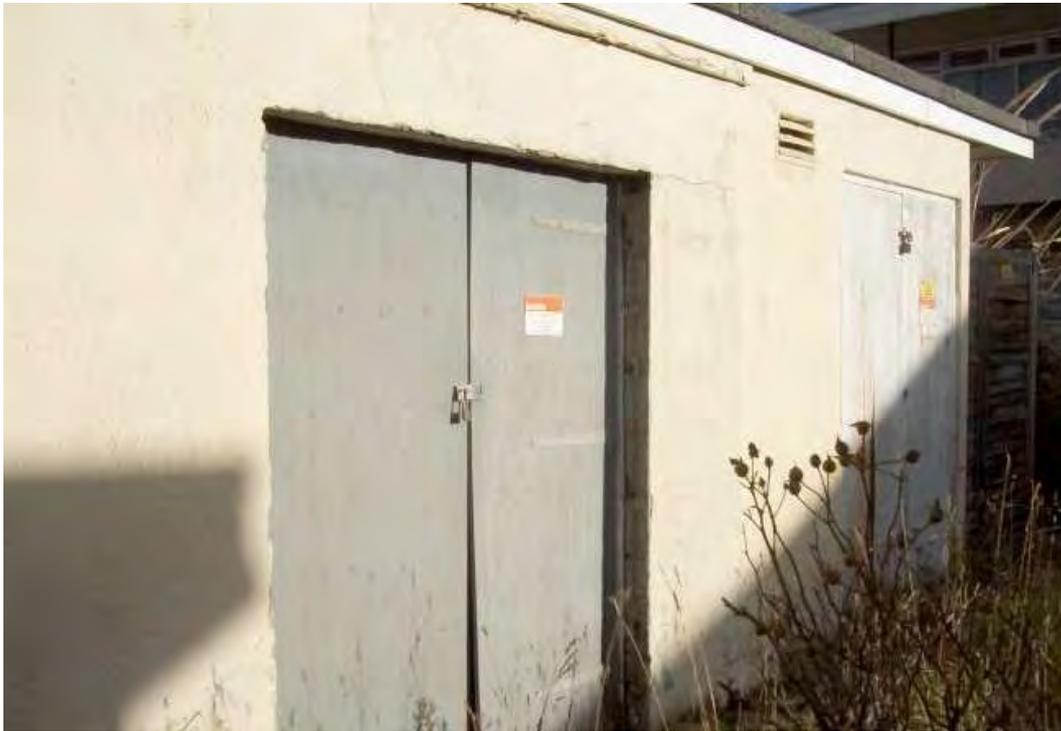
To the SE of the swimming pool and boiler house there is the site electrical substation, which is still in use. It is understood that this still feeds the manager's bungalow to the east of the site. On the otherside of the sub-station is the Laundrette.

The camp site contains a working electrical sub-station. There is the potential for the surrounding soil adjacent to the sub-station to contain Polychlorinated Biphenyl (PCB's).

- 2) Total Petroleum Hydrocarbons (TPH) Speciated and TPH screen. Carried out in the locations of the oil pipe network, Oil tank and any other areas showing impact from hydrocarbons.
- 3) Asbestos screen tests – carried out in soils possible impacted from asbestos in the existing buildings and pipes.
- 4) PCB testing – carried out on soils adjacent to sub-station and in areas where heavy oils were store or used.

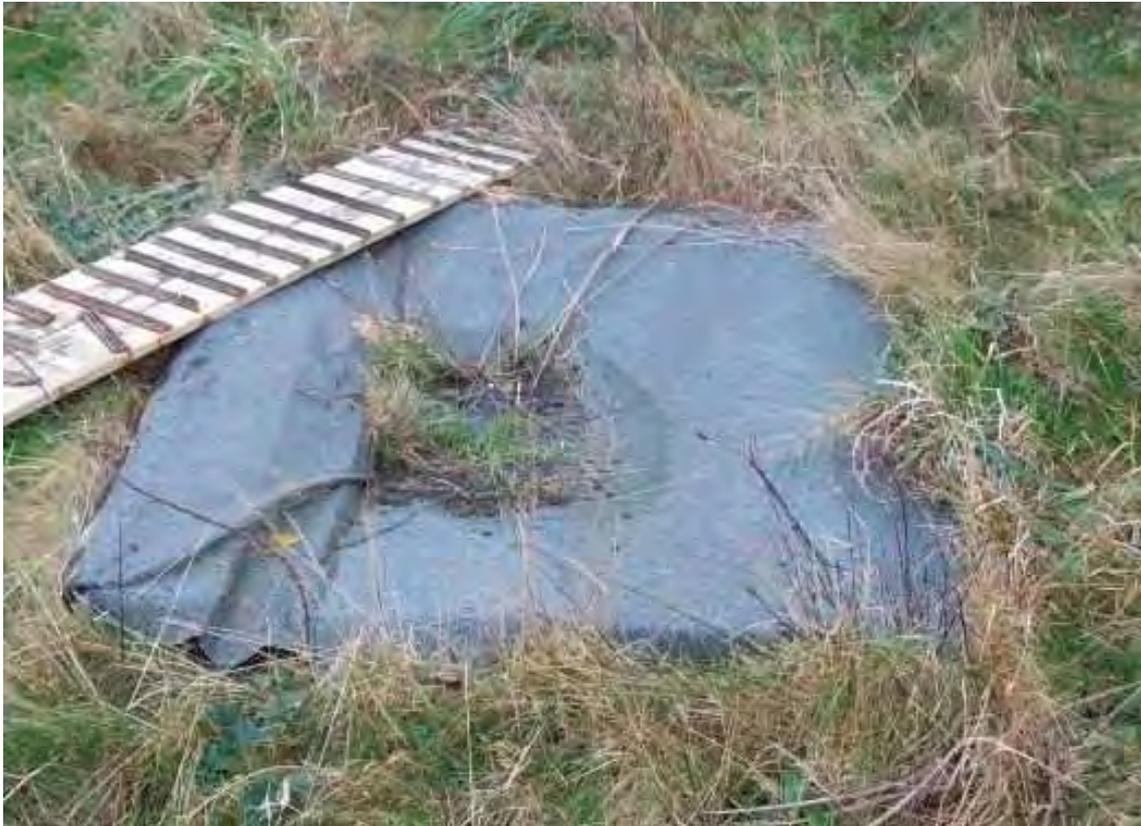
To the east of the sub-station there is wood(rotten) /felt covered service trench. The trench is breeze block lined. It was most likely covered by something more durable when the camp was still working. Permanent access to the pipework must have been needed within this area.

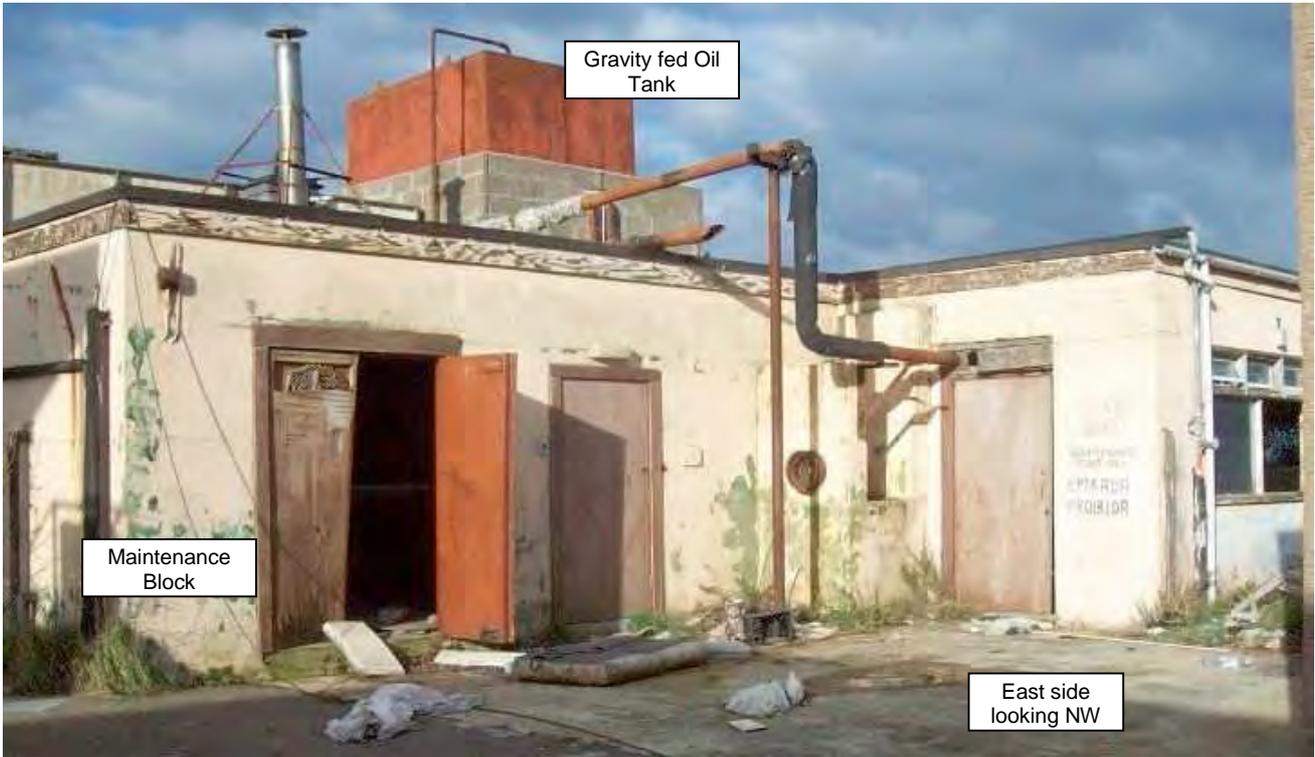
To the NE of the Amenity Block is the Maintenance block. The maintenance block contains a large oil tank on the top of the roof. The tank appears to be surrounded with a brick wall bund.

The oil tanks are thought to supply all the central heating to the apartments and heat the swimming pool.

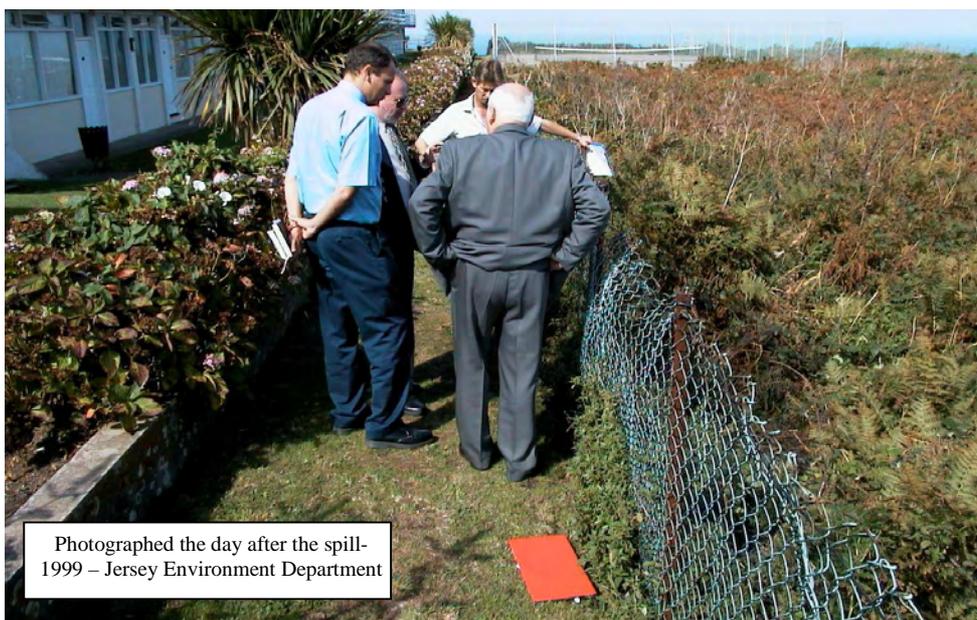
In August 1999, children were playing with a valve at a 'T' piece to the north of the Amenity Block and adjacent to the cliff edge. Although this was in a prohibited area, the fence was poorly maintained. The valve broke and up to 1800 gallons of heating oil was lost to the surrounding areas, some of which went down the cliff edge.

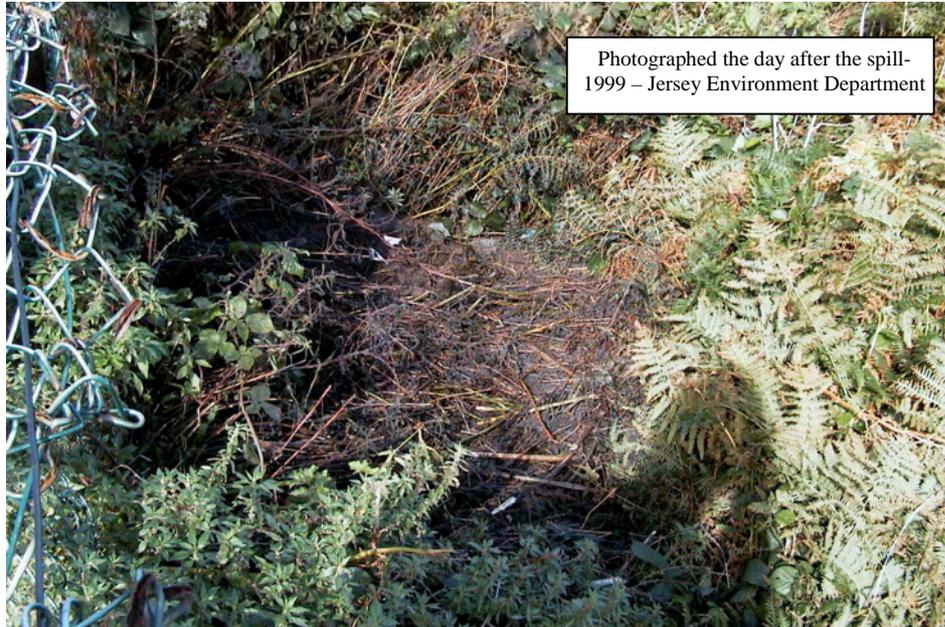
The Island's Environmental Department was contacted and environmental and ecological concerns were made. A pollution control report from the Environment Department carried out at the time is attached in the appendices. The report was a review of the findings and proposed remedial measures up to 26/10/99. The final entry (26th Oct) of the report says that the remedial works would involve excavation of soils and bio-remediation and would start that day. At the time of this report, we did not have information to confirm what works were completed.

During the site walkover there was no surface evidence of the spill and the area was heavily vegetated.
