HAVRE DES PAS PEDESTRIAN CROSSINGS

Stage 1 & 2 Road Safety Audit

OUR REF. NO. 62100327-69-01

DATE: NOVEMBER 2021

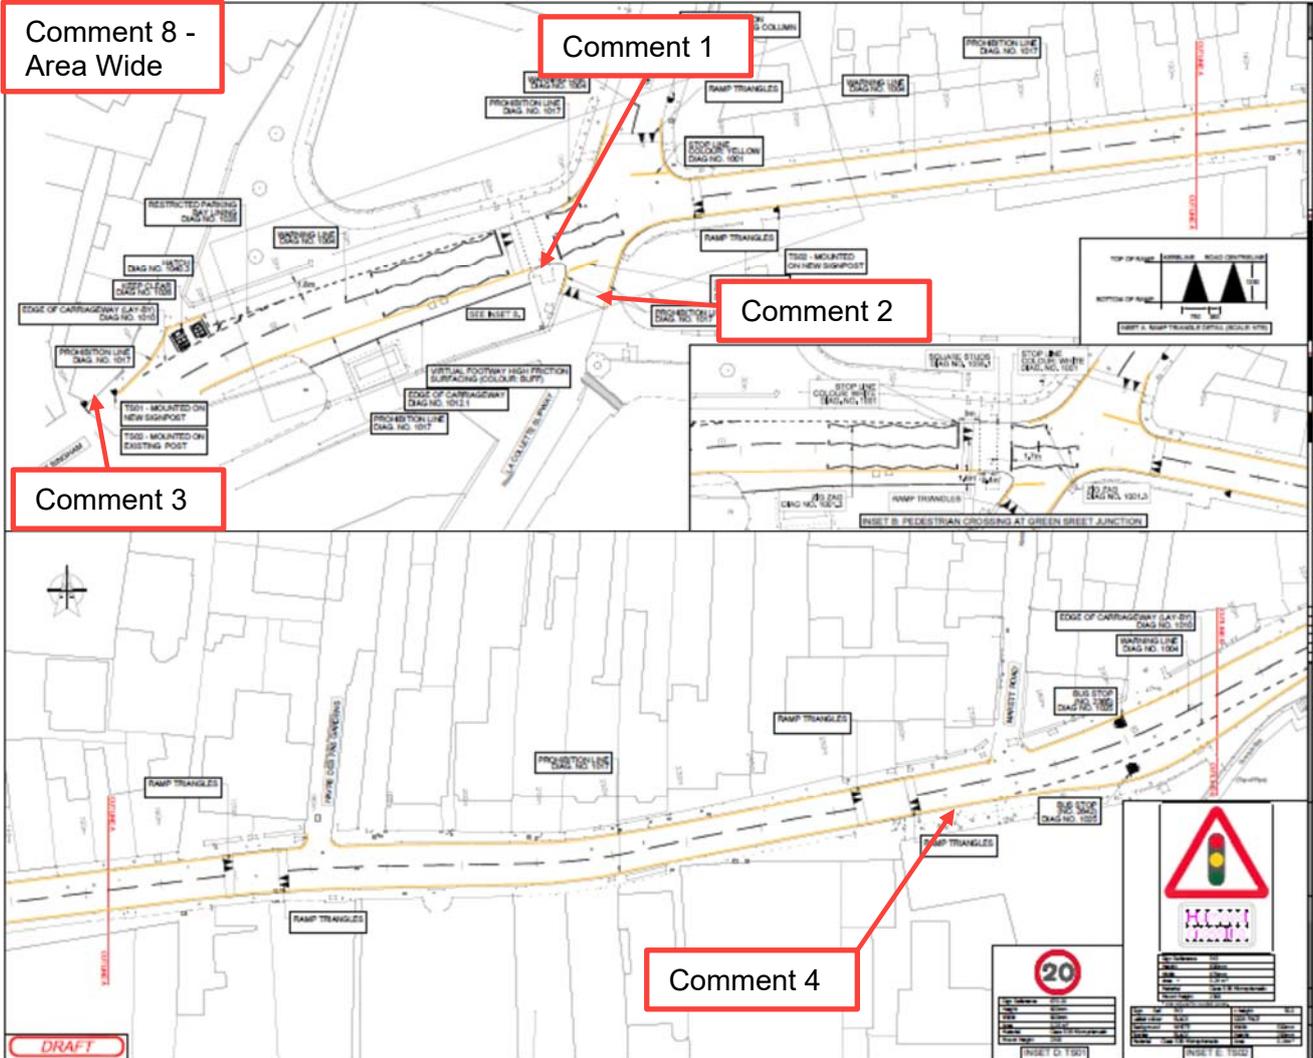
**Problem Location Plan
Stage 1 & 2 Road Safety Audit**

Green Street Junction – the mapping used on the drawings for this junction is out of date. In particular, the kerbed build out on the southern side of the existing pelican crossing extends further to the west than shown. The extended buildout will assist with the tie in of levels for the ramp on the western side of the raised table. Other details at this location should be checked to ensure that the design is compatible with the new layout.

Green Street Junction – no level details or sections have been provided for the raised table at this junction. The drawings show a ramp on the southern approach to the table, which starts a few metres in front of a cobbled section of slipway and close to the seafront promenade. A ramp at this location could cause an unnecessary hazard for pedestrians as well as be difficult to tie in to on its eastern side (where the adjacent levels are flush). The need for a ramp at this location is unclear as approach speeds will be very low. It is recommended that the levels on this southern side of the junction are checked to ensure that an appropriate solution is achieved.

Western approach to the Green Street Junction – traffic signs TS01 & TS02 are shown in close proximity to each other. Although not considered to be a problem, it is recommended that checks are made to ensure that the larger sign (TS02) does not obstruct visibility to the 20mph sign (TS01) located behind it.

Raised table adjacent to the Fort D’Auvergne Hotel – at the time of the site visit there was considerable construction work being undertaken at the hotel site. It is not known whether these developments will include any vehicular access that could conflict with the location of the proposed raised table.

Pedestrian Crossing at the Lido – the stop lines are shown positioned directly at the base of the ramps to the raised table. This may make the lines less noticeable to drivers as well as cause vehicles to roll back if they slightly overshoot the stop line. It is recommended that the lines are positioned at a suitable distance back from the ramps.

Raised Table opposite the Ommaroo Hotel – there is an existing dropped crossing with tactile paving a few metres to the west of the proposed raised crossing. There are no plans to remove this crossing, however, having two crossings in such close proximity is quite unusual.

Raised Pedestrian Crossing near the junction with St Clement’s Road – unlike the other crossings, this raised table is located on a section of road between streetlights. Although no obvious dark areas were observed during the night visit, it may be necessary to check lighting levels in this area to ensure that the raised table is clearly visible to approaching drivers.
