Investigation into grounding of
SOUTHERN BAY ROSE
on 25th June 2013

1.0 Summary

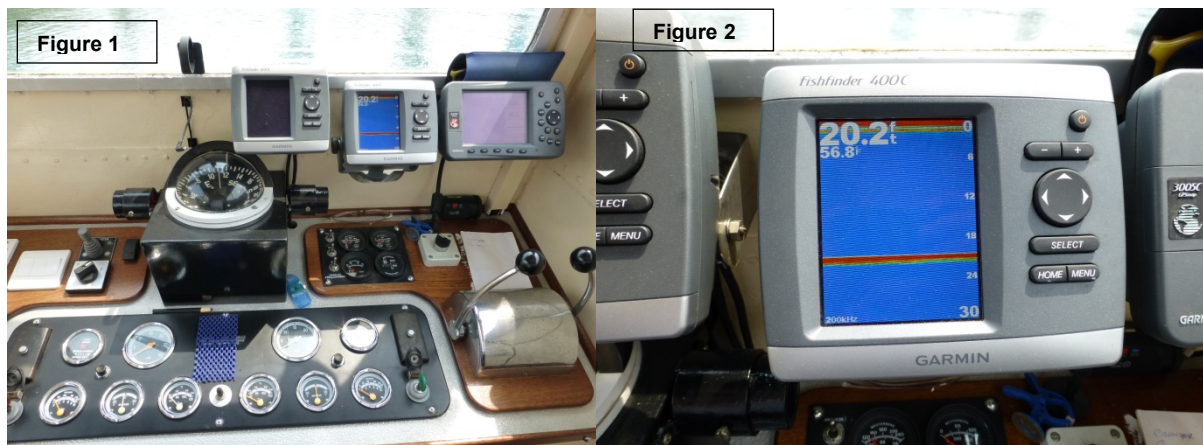
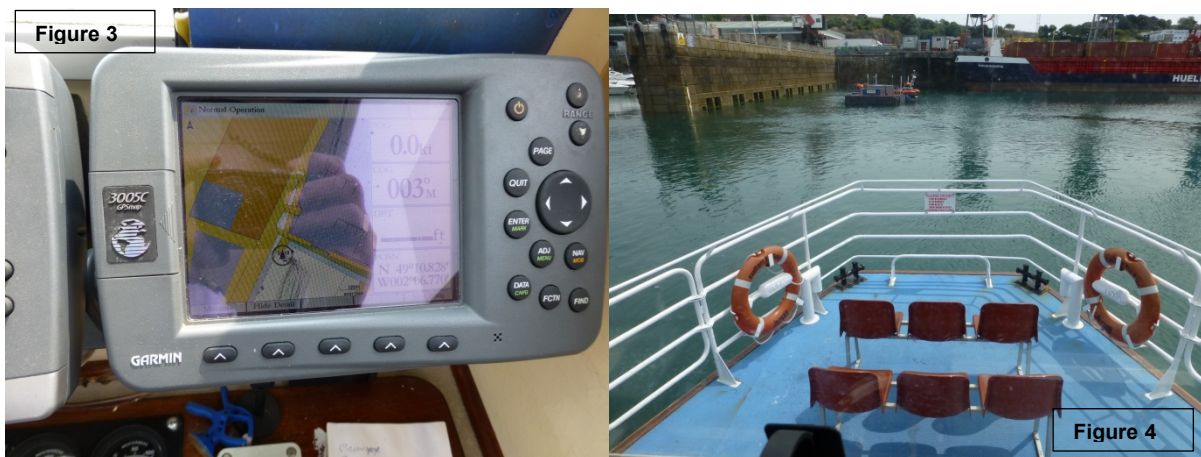
Figure 1 shows the general wheelhouse arrangement with the controls and instruments in a compact arrangement. Figure 2 shows the Garmin Fishfinder 400C echo sounder, which is kept running throughout the passage. Figure 3 shows the Garmin C3005C colour chart plotter, using “C-Map” display. The set is approximately four years old and the charts stored have not been corrected since purchase. Figure 4 illustrates the general view provided of the bow area from the conning position. Even when the seats are occupied the view forward is very good and small floating objects or obstructions can be easily spotted in sufficient time to react.

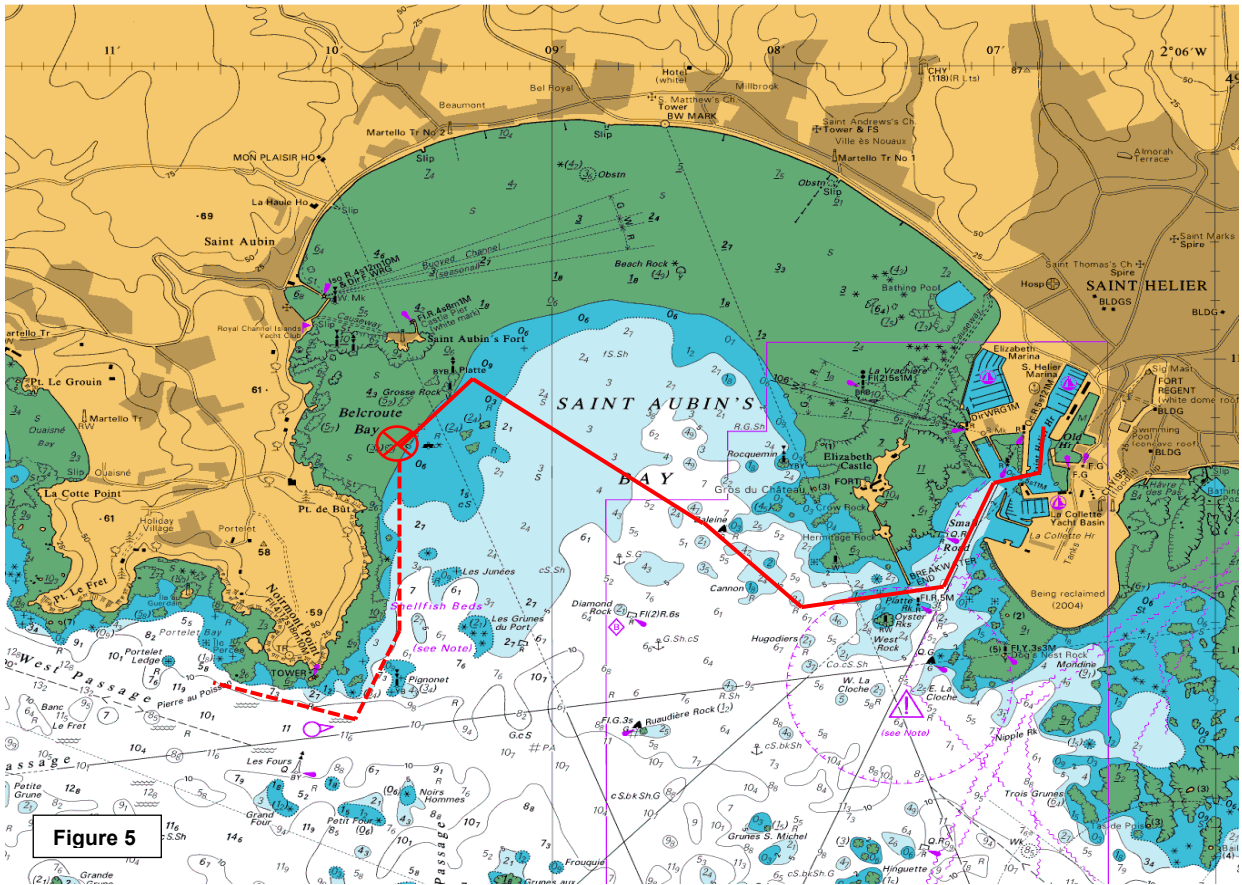
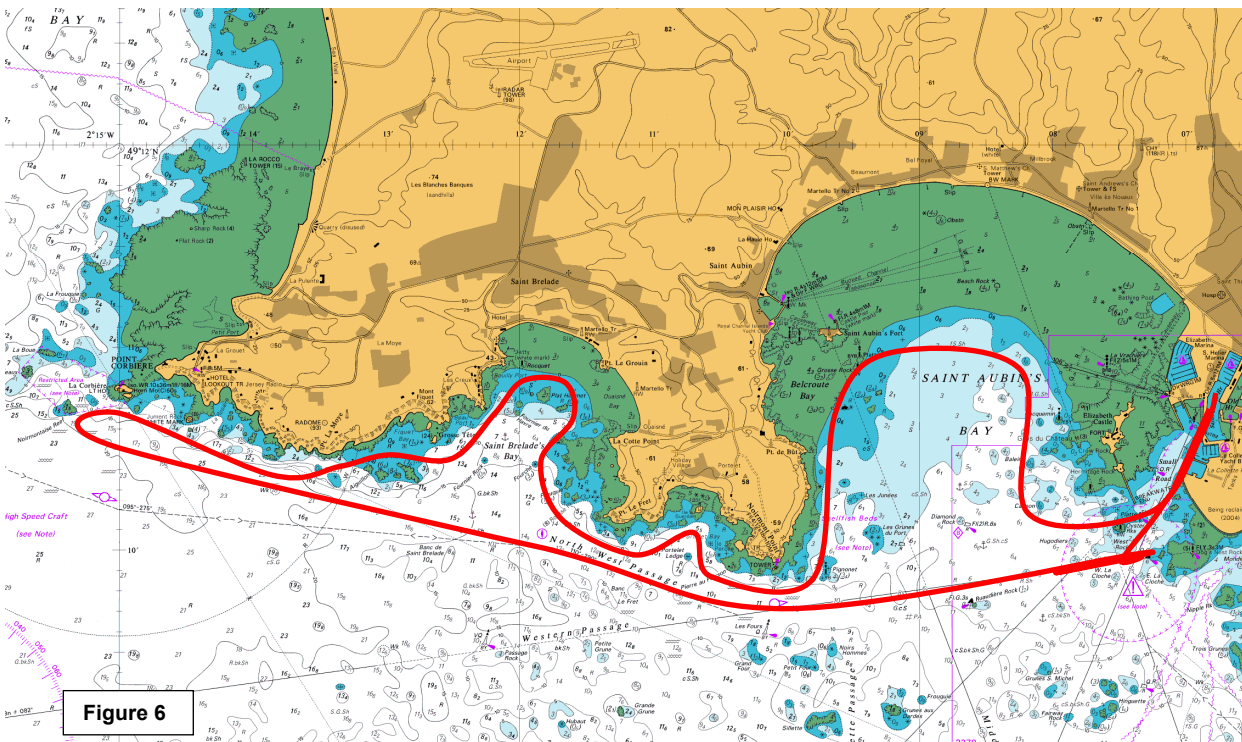
Figure 5 shows the actual track of the vessel on 25th June with the approximate grounding position being shown by the red "X". Figure 6 shows the intended track followed by the vessel on an average day time excursion. The vessel passes close inshore on the outward

leg of the voyage, but on a more direct return route to St Helier. The actual grounding position was 49° 10.723'N 002° 09.648'W

In Figure 5 it can be seen that the vessel passed close east of the Platte and Grosse Beacons before turning South West to cross the outer edge of Belcroute Bay. The vessel passed inside (west of) "The Slates" and was operating in very shallow water with an expected under keel clearance of not less than 0.9m

7.2 The vessel **SBR** has grounded twice in 13 years in the same approximate area, in similar states of tide. The vessel should be prohibited from using this inshore route, when there is insufficient water to pass safely between St Aubin's Fort and Grosse and Platte Rocks. This occurs at tide heights below 3.0m. On such occasions the vessel should remain to the eastwards of The Slates. The Permit issued under Regulation 6 of the Harbours (Inshore Safety) Regulations 2012 should be amended to reflect this.

8.1 A restriction on the operation of the Southern Bay Rose was put in place with immediate effect so that no approach is made to the inshore route off Belcroute Bay and St Aubin's Fort at tidal heights of less than 3.0m.

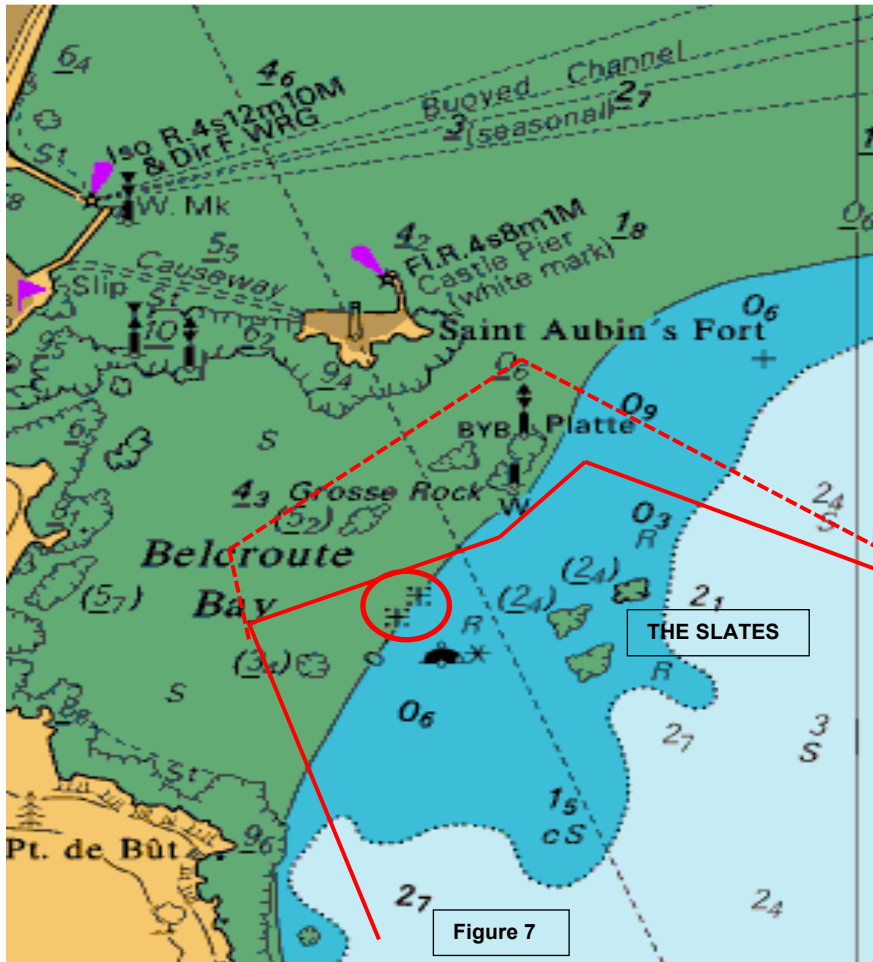
6.5 The Admiralty chart BA 1137 Approached to St Helier does not provide sufficient detail to navigate safely in this area at extreme low water situations.

Figure 7 shows the route taken by **SBR** on 26th June. A similar track was followed on the 25th June. The encircled area shows the outcrop of rocks, which the skipper described as three heads, but unfortunately turned out to be more extensive. It was the east side of this reef that the vessel grounded on the previous day. The dashed red line shows the track used by **SBR** on days when the tide is above half tide.

6.6 The Garmin colour chart plotter fitted to **SBR** does not provide sufficient detail to navigate safely in this area at extreme low water situations.

7.3. The hydrographical data provided on Admiralty Chart BA 1137, Approaches to St Helier, is insufficient to permit safe navigation in this area in all states of tide. It should be noted that the data provided in most electronic chart display systems will be similarly unreliable. It is therefore recommended that detailed surveys are carried out in this area. The Harbour Master has permitted the laying of up to 90 moorings inside this bay for leisure users.

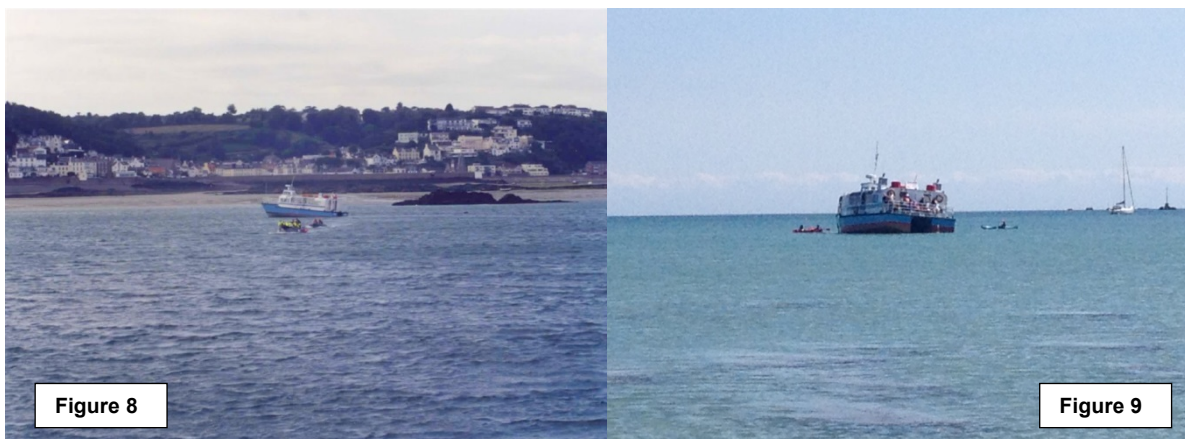
Footnote: Figure 8 shows the Southern Bay Rose aground on 5th June 2000, whilst Figure 9 shows the same vessel aground on 25th June 2013.
