**INVESTIGATION INTO THE CAUSES OF AN ALLISION BETWEEN THE WINDFARM SUPPORT VESSEL
NJORD FORSETI AND A WINDFARM TOWER IN THE SOUTHERN NORTH SEA ON 23RD APRIL 2020.**

FINAL REPORT

Derrick A Thorrington

Jersey Maritime Administration

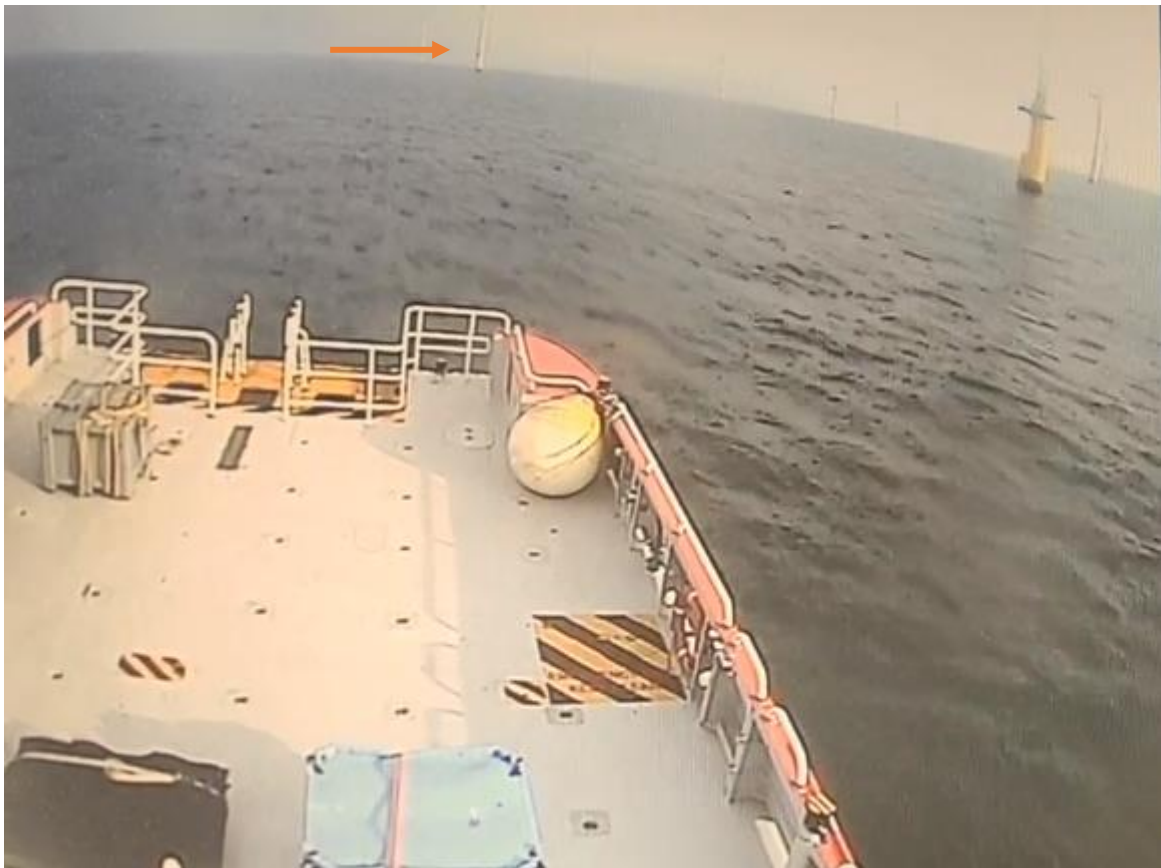
Vessel CCTV coverage showing Njord Forseti passing a turbine tower close to starboard shortly before impact with Tower Q05 (marked by the arrow).

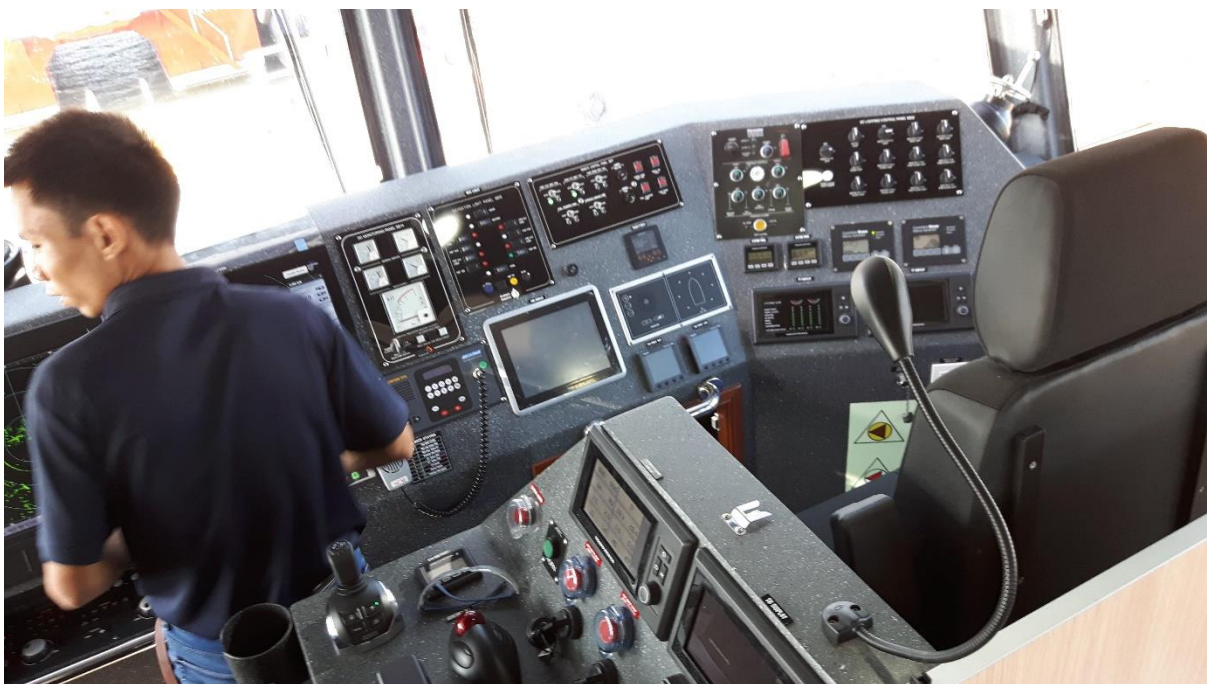
9.1 To the starboard side of the master's seat is a console to which engine and vessel controls are fitted. Engine panels are fitted at the high level on the vertical panel, and on the horizontal surface is fitted with a VHF radio. It is possible that the Master was distracted by this piece of equipment, although the CCTV coverage suggests that the Master was not using it for communication.

9.2 In the Njord commissioned incident report, the engineer reported that following the impact when he tried to use the VHF to summon assistance, the unit was not on its usual setting but was displaying a different screen. This supports the possibility that the Master may have been making adjustments to the settings of the set immediately prior to the incident.

Photograph of bridge front. The engineer's seat is to starboard, the Master's seat out of shot at the left-hand corner, the Masters console centre bottom with the VHF radio just out of shot.

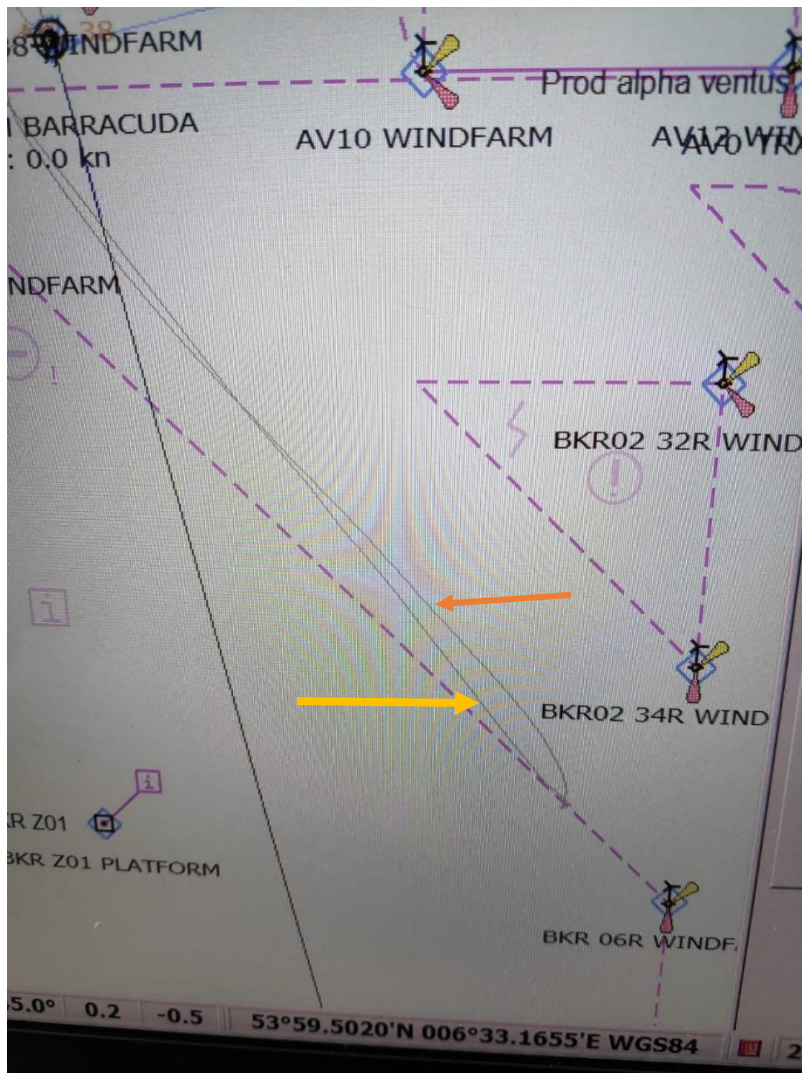
10.4 The methods for monitoring the vessels position, course and track by visual means and using the vessels navigation aids prior to the incident have not been provided to the undersigned and therefore have not been positively determined. The extent to which the direction and strength of tidal current through the windfarm was known to the Master has also not been able to be determined.

Screen shot of the electronic chart system. The yellow arrow indicates Njord Forseti's outward track between Borkum Riffgrund 1 and 2 windfarms. The orange arrow indicates the return track to the Siem Barracuda following the collision. The consistent nature of the track suggests that tidal offset might not have been taken into account for the transit between windfarms, and that the effect of this offset has not been identified during the transit.

4.3 The company should review the methods by which masters monitor the safe progress of a vessels passage and make changes as necessary to its procedures. Where necessary additional training should be provided to masters and other relevant personnel in the associated techniques applicable to these vessels.
