MARITIME INCIDENT INVESTIGATION REPORT INTO INJURY TO CREW MEMBER ON PRIVATE SAILING CATAMARAN “SKYLARKS”

13TH MAY 2021

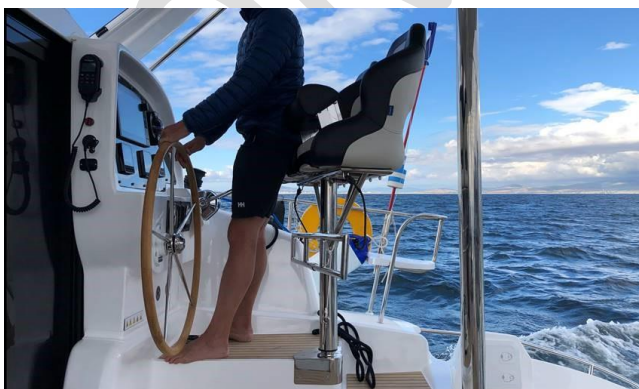
(Fig 1- Helm seat as originally fitted)

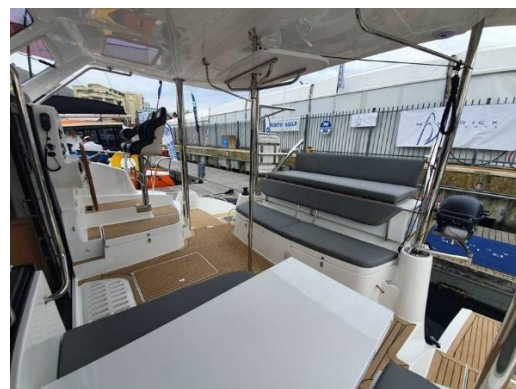
(Fig 2 – Cockpit general view – Original seat)

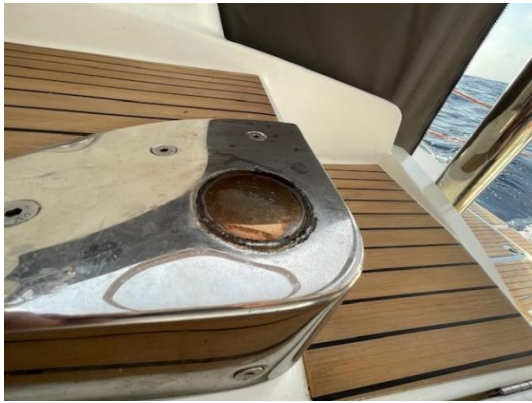
(Fig2: Base plate following failure)

4.2 The seat -mounting was constructed with a stainless-steel base and a stainless-steel tube pillar. A second stainless-steel tube, with a stainless-steel plate at the top onto which the actual seats are mounted, fitted over the first to enable the seat to rotate. A locking pin, when inserted, stopped the seat from rotating. (Fig 1) The failure involved a complete fracture of the weld between the seat mounting pillar and the base plate (see Figs 2 to 6)

5.6 It is probable that the weld failure commenced or became significant during the squall experienced on 6th May, and signs might have been evident if it had been inspected immediately after the squall.

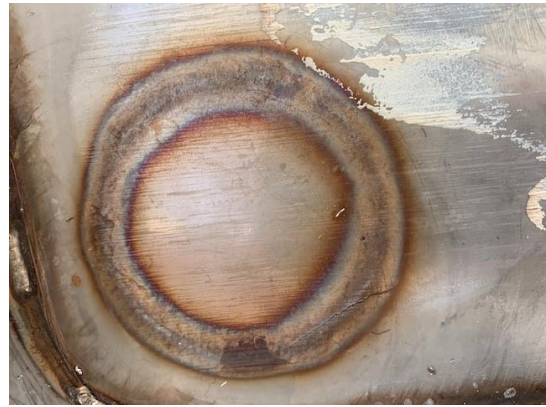
(Fig 3: Crack on underside of base plate)

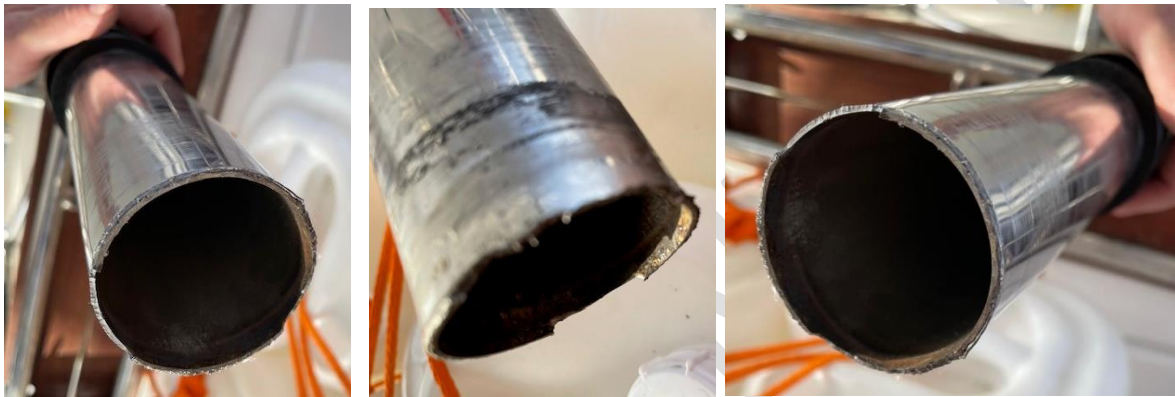
(Fig 4, 5, & 6: bottom of seat support pillar following failure)

4.3 The builders were notified of the accident, by the owners, and tried to ascertain the cause of the failure. From the photos received they were unfortunately not able to determine why the welding at the base of the seat pillar broke. Their consultant engineer reported that the failure could have been caused by a number of factors, but that no definite cause could be identified.

5.3 From the photos available, the builders were unfortunately not able to determine precisely why the failure occurred. A consultant engineer concluded that the failure could have been caused by a number of factors, but no definite cause could be identified.

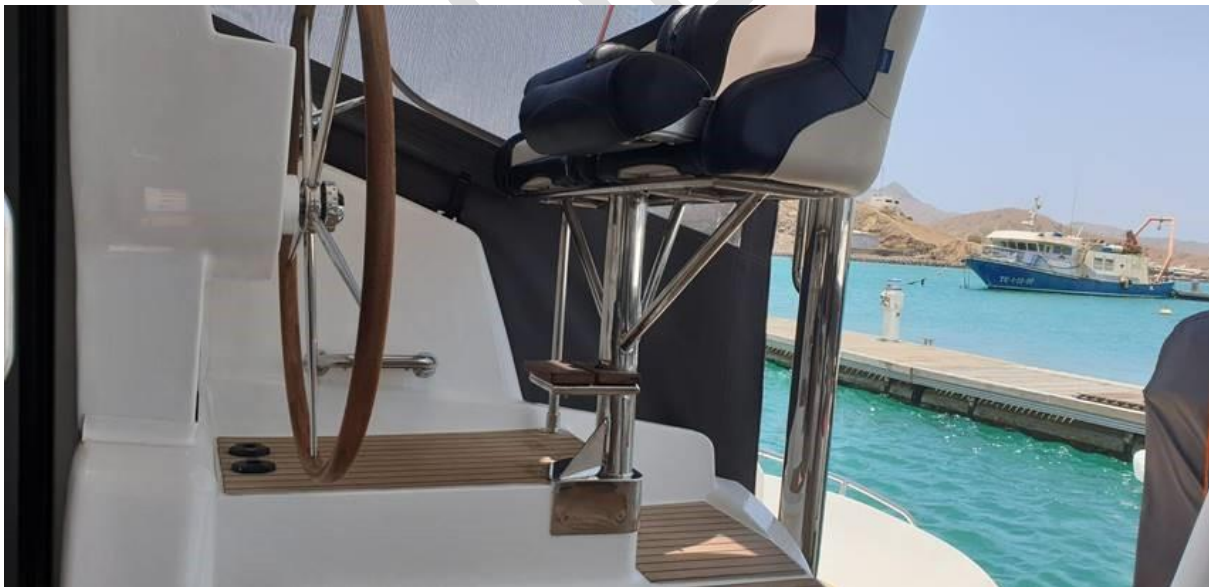
Fig 7 Helm seat as modified (from Port side)

4.15 The subsequent modifications to the Helm seat, along the lines proposed by the skipper, were carried out in Cape Verde. They increased support but at the expense of the ability of the seat to rotate

5.5 The seat was been repaired by the owners in Cape Verde; gussets being added to the base of the original pillar together with an additional support pillar to starboard. This modification however prevents the seat from being able to rotate as was possible in the original design (see Figs 1, 7 & 8)

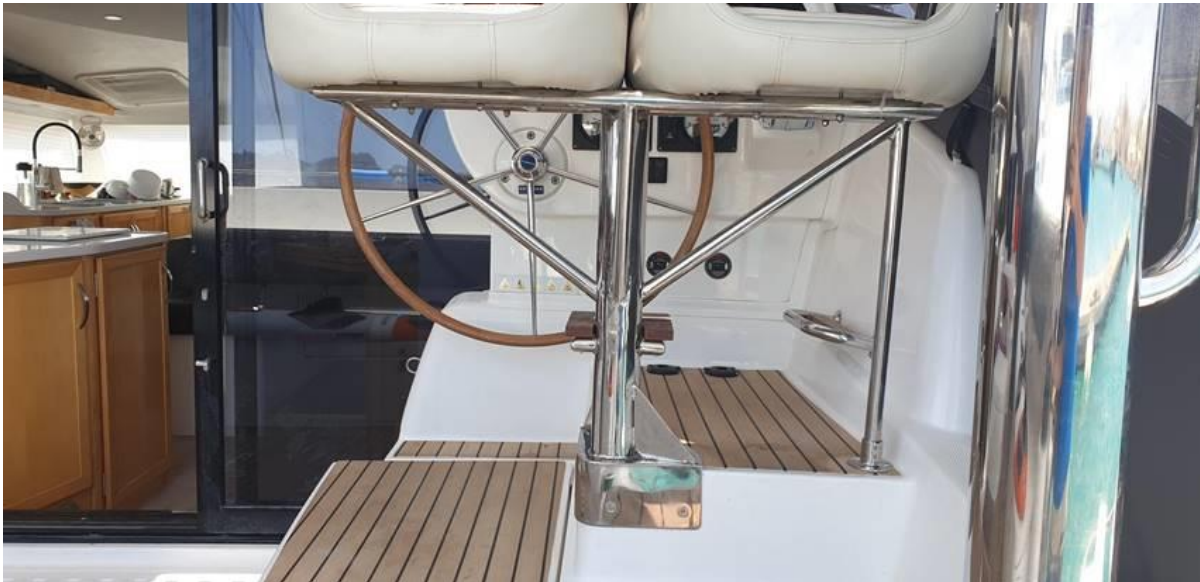
(Fig 8 Helm seat as modified from Aft)
