SITE ASBESTOS REGISTER AND MANAGEMENT PLAN

Ports of Jersey Jersey Airport

14JM1785
Engineering Hangar
Jersey Airport
L'Avenue De La Reine Elizabeth II
St Peter
Jersey JE1 1BY

NAS LABORATORIES

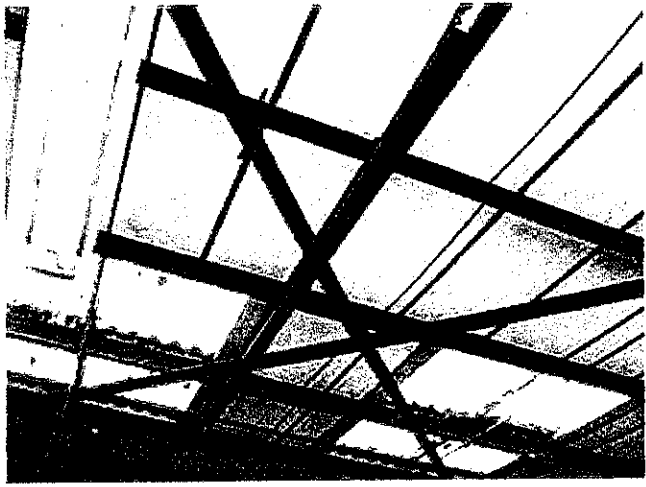
| Sample No. / inclusion reference: | Row 1 - EPA7562/174 & 1175 | |

| Row No | Sample Reference Number | Position of Asbestos Inclusion inspected | Assessment date | MAA | PAA | Total | Action to be taken as a result of inspection | Action to be completed by | Cert no Date Signature |
|---|---|---|---|---|---|---|---|---|---|
| 1 | EPA7562/1174 and 1175 | Whittinghams maintenance workshop, ceiling tiles, Insulation Board. | 08/12/2014 | 6 | 7 | 13 | Encapsulated and labelled as Asbestos. Re-inspect every 6 months. | June 2015 | |

| Location & description of material: | Whittinghams maintenance workshop, ceiling tiles, Insulation Board | |

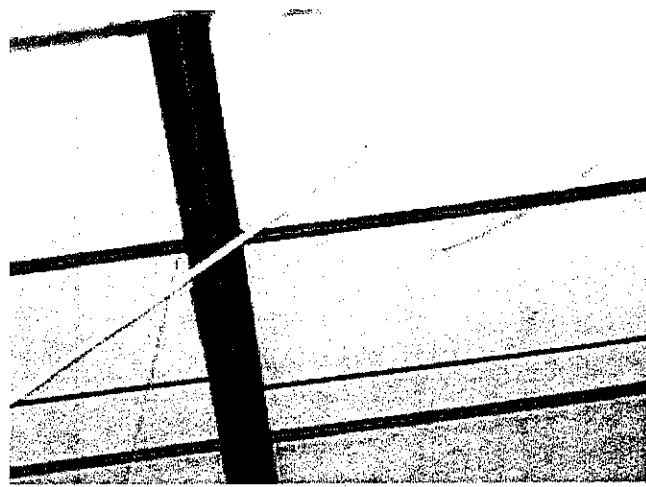
| Sample No. / inclusion reference: | Row 2 - EPA7562/Presumed | |

| Row No | Sample Reference Number | Position of Asbestos Inclusion inspected | Assessment date | MAA | PAA | Total | Action to be taken as a result of inspection | Action to be completed by | Cert no Date Signature |
|---|---|---|---|---|---|---|---|---|---|
| 2 | No sample taken presumed | Side extension to main hangar, Flybe engineering offices & archive store, panels to high level ceiling and above windows, Insulation Board. | 08/12/2014 | 6 | 7 | 13 | Encapsulated and labelled as Asbestos. Re-inspect every 6 months. | June 2015 | |

| Location & description of material: | Side extension to main hangar, Flybe engineering offices & archive store, panels to high level ceiling and above windows, Insulation Board | |

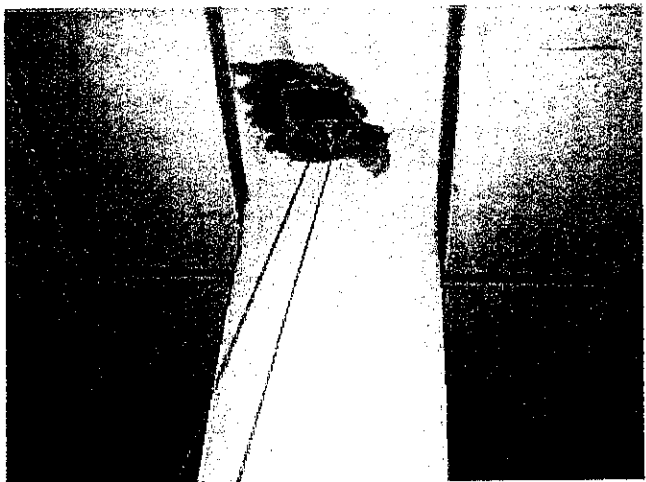
| Sample No. / inclusion reference: | Row 5 – EPA7562/1174 & 1175 | |

| Row No | Sample Reference Number | Position of Asbestos Inclusion inspected | Assessment date | MAA | PAA | Total | Action to be taken as a result of inspection | Action to be completed by | Cert no Date Signature |
|---|---|--|---|---|---|---|---|---|---|
| 5 | EPA7562/1174 and 1175 | Engineering Offices x 3, above suspended ceiling, Paper Clad Ceiling Tiles and upper wall coverings. | 07/05/2014 | 6 | 5 | 11 | Restricted access into ceiling void. Consider repair/removal. Re-inspect every 12 months. | May 2015 | |

| Location & description of material: | Engineering Offices x 3, above suspended ceiling, paper clad ceiling tiles and upper wall coverings | |

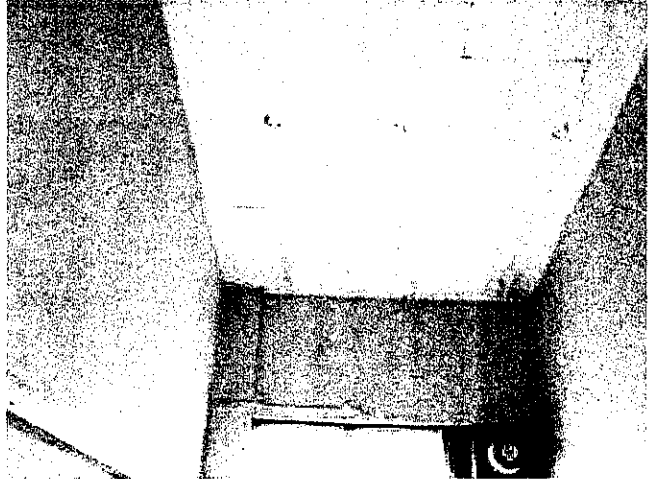
| Sample No. / inclusion reference: | Row 5D – EPA7562/1174 & 1175 | |

| Row No | Sample Reference Number | Position of Asbestos Inclusion inspected | Assessment date | MAA | PAA | Total | Action to be taken as a result of inspection | Action to be completed by | Cert no Date Signature |
|---|---|--|---|---|---|---|---|---|---|
| 5D | EPA7562/1174 and 1175 | Battery room, Paper Clad Ceiling tiles & upper wall coverings. | 08/12/2014 | 4 | 4 | 8 | Encapsulate tiles Re-inspect every 6 months until encapsulated | June 2015 | |

| Location & description of material: | Battery room, Paper Clad Ceiling Tiles & upper wall coverings | |

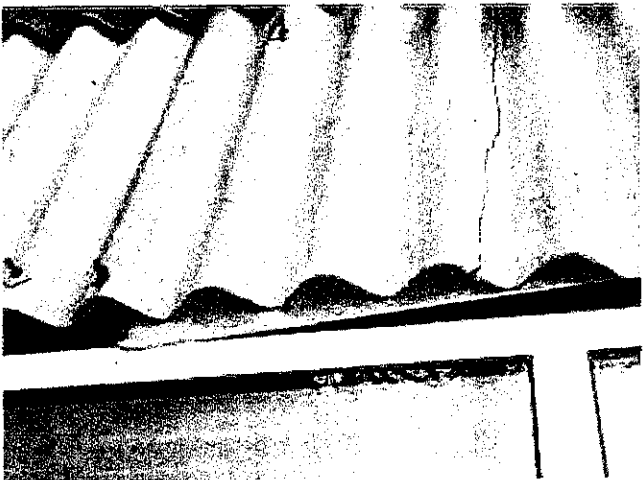
| Sample No. / inclusion reference: | Row 6 – EPA7562/1174 & 1175 | |

| Row No | Sample Reference Number | Position of Asbestos Inclusion inspected | Assessment date | MAA | PAA | Total | Action to be taken as a result of inspection | Action to be completed by | Cert no Date Signature | |
|---|---|---|---|---|---|---|---|---|---|--|
| 6 | EPA 7562/1176 and 1177 | Engineering hangar, corrugated roofing and side cladding sheets, Cement. | 07/05/2014 | 5 | 6 | 11 | End Profile Gable End sheets (towards Arrivals) high level requires repair. Repair/cover holes and any loose or visible Insulation Board. Re-inspect every 12 months. | May 2015 | | |

| Location & description of material: | Engineering hangar, corrugated roofing and side cladding sheets, Cement | |

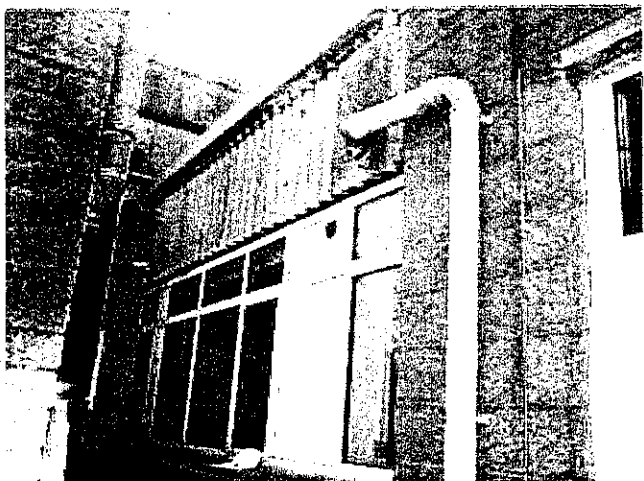
| Sample No. / inclusion reference: | Row 6A – EPA7562/1176 & 1177 | |

| Row No | Sample Reference Number | Position of Asbestos Inclusion inspected | Assessment date | MAA | PAA | Total | Action to be taken as a result of inspection | Action to be completed by | Cert no Date Signature | |
|---|---|---|---|---|---|---|---|---|---|--|
| 6A | EPA 7562/1176 and 1177 | Engineering hangar, profile edging sheets, Cement. | 07/05/2014 | 5 | 2 | 7 | Re-inspect every 12 months. | May 2015 | | |

| Location & description of material: | Engineering hangar, profile edging sheets, Cement | |

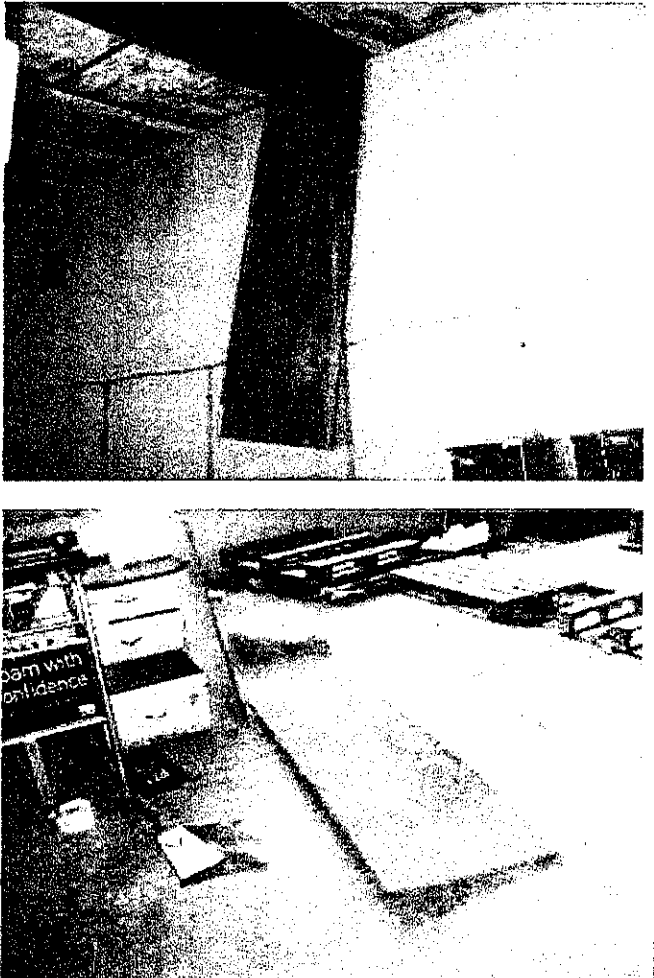
| Sample No. / inclusion reference: | Row 8 - Strongly Presumed | |

| Row No | Sample Reference Number | Position of Asbestos Inclusion inspected | Assessment date | MAA | PAA | Total | Action to be taken as a result of inspection | Action to be completed by | Cert no Date Signature | |
|---|---|---|---|---|---|---|---|---|---|--|
| 8 | Strongly Presumed | Bonded Store, Suspended ceiling tiles, Paper clad Paper backed tiles | 08/12/2014 | 6 | 5 | 11 | 2 tiles fallen to floor Restricted / isolated access into store. Remove if area to be accessed Re-inspect every 6 months. | June 2015 | | |

| Location & description of material: | Bonded Store, Suspended ceiling tiles, Paper clad Paper backed tiles | |
