Investigation into the sinking of fishing vessel on 25 March 2014

AQUARIUS II J307

Harbour Master's Department

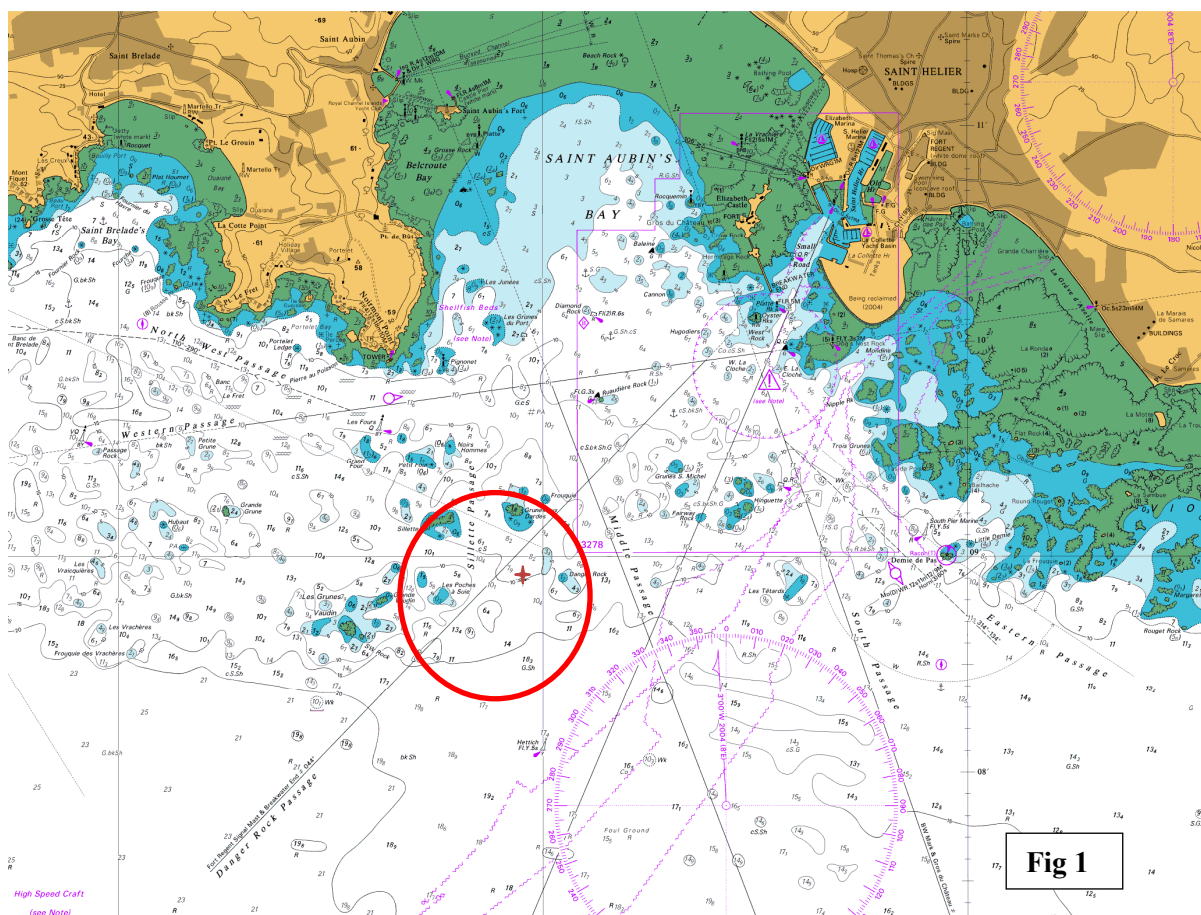
Figure 1 shows the position the life raft was retrieved from. The encircled area shows the general area of operation for *Aquarius II* at the time of the sinking.

7.1 Fishing vessels should avoid this area of the Danger Rock Passage at low water periods when there is a large W or SW ground swell because of the risk of encountering larger than average waves. The chart should be marked with the symbol for overfalls either side of the axis of the Danger Rock Passage between Grunes aux Dardes and SW Rock.

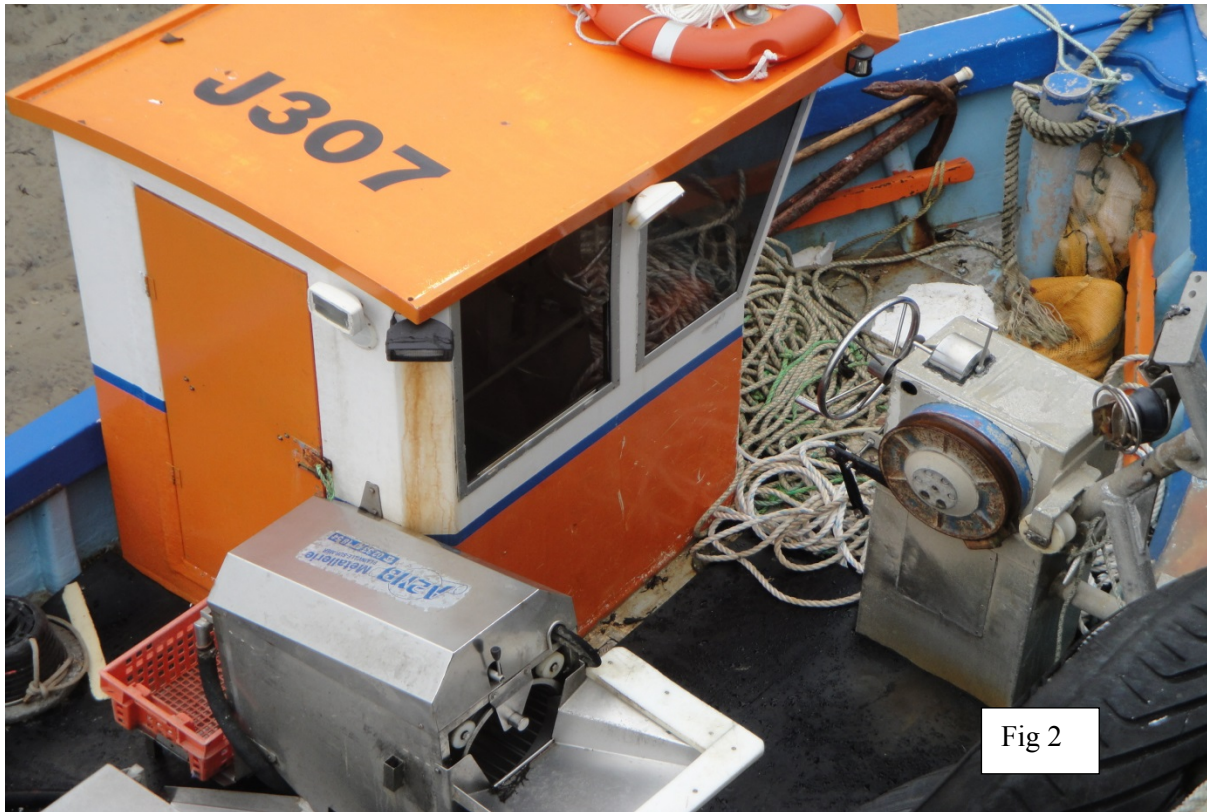
2.3 The stainless steel device located just aft of the wheelhouse shown in the picture above (Fig 2) is no longer fitted. It is a whelk sorting unit, known as a Whelk Riddler, which was fitted when the vessel was operated by Heritage Shellfish Limited, the previous owners of this vessel. This unit had been removed when the vessel was sold leaving a clear area between the aft end of the wheelhouse and the engine hatch

5.8 There were no reported stability problems with this type of vessel and the modifications made in removing the whelking equipment would have lowered the craft's centre of gravity.

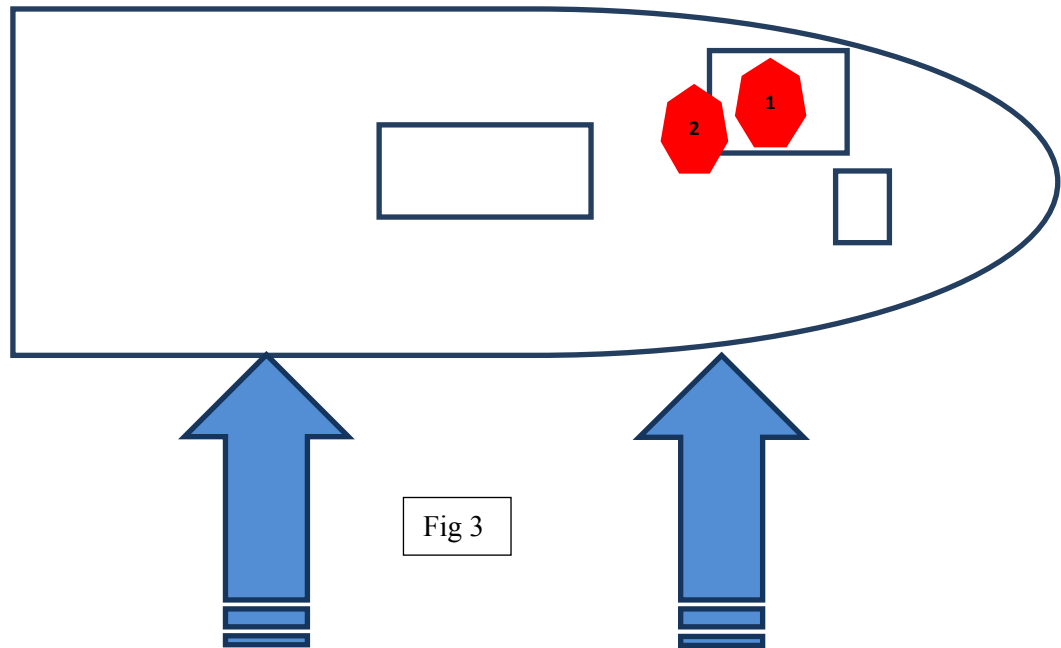
4.1 The vessel had left port at 0540 and headed directly for the area to the east of Sillette Rock and Les Grunes Vaudins Reef. They had already shot a first string and were half way through shooting the second string with approximately 15 pots remaining on deck. The vessel was on an approximate southerly heading in about 12m of water. Gibby Gordon was at the wheel in position 1 inside the small wheelhouse. Gideon was standing in position 2 in the open doorway of the wheelhouse standing clear as the pots were being shot.

4.2 Gibby Gordon was running the vessel slowly at about 20° to the swell which was observed to be 1.0 to 2.0m when he spotted a particularly large wave approaching from the starboard side. He tried to turn the vessel to starboard to meet this wave more bows on. The wave was much larger than those previously observed and the vessel was unable to turn in time. The wave swamped the vessel and destroyed the wheelhouse. Both crewmen were thrown overboard and the vessel began to sink rapidly.
