MARITIME INCIDENT INVESTIGATION REPORT:

Stranding, temporary abandonment, and subsequent re-floating of Fishing Vessel

L'ECUME II (J158)

14TH MAY 2020

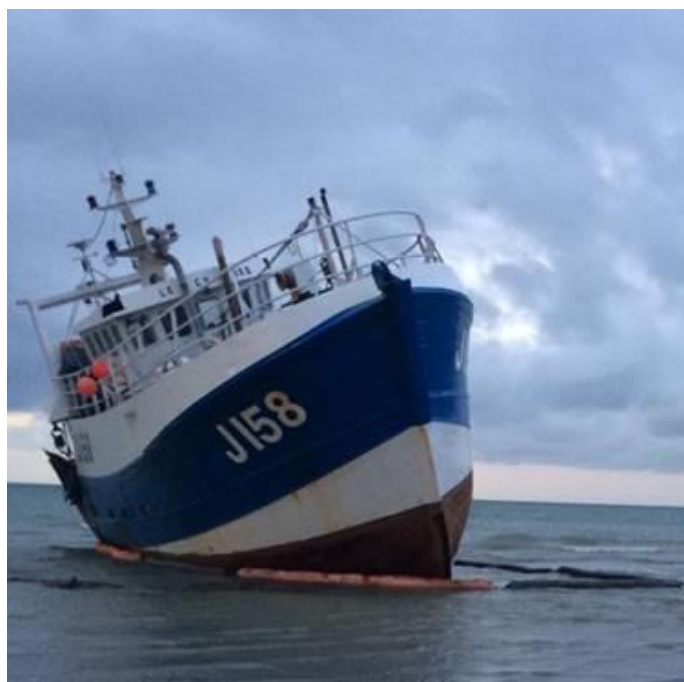
FIG 1 – L'ECUME II aground in Belcroute Bay

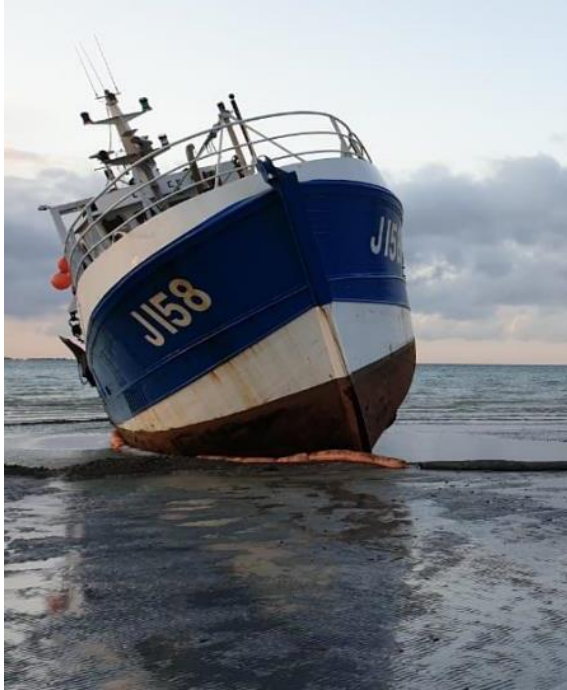
1.3 As a precaution a pollution prevention boom was prepared, transported to the scene, and deployed around the vessel by Ports of Jersey staff. By 0550 the vessel was dry and sitting almost upright, the boom was in place there were no signs of pollution.

FIG 2 – L'ECUME II, aground with pollution control boom in place.

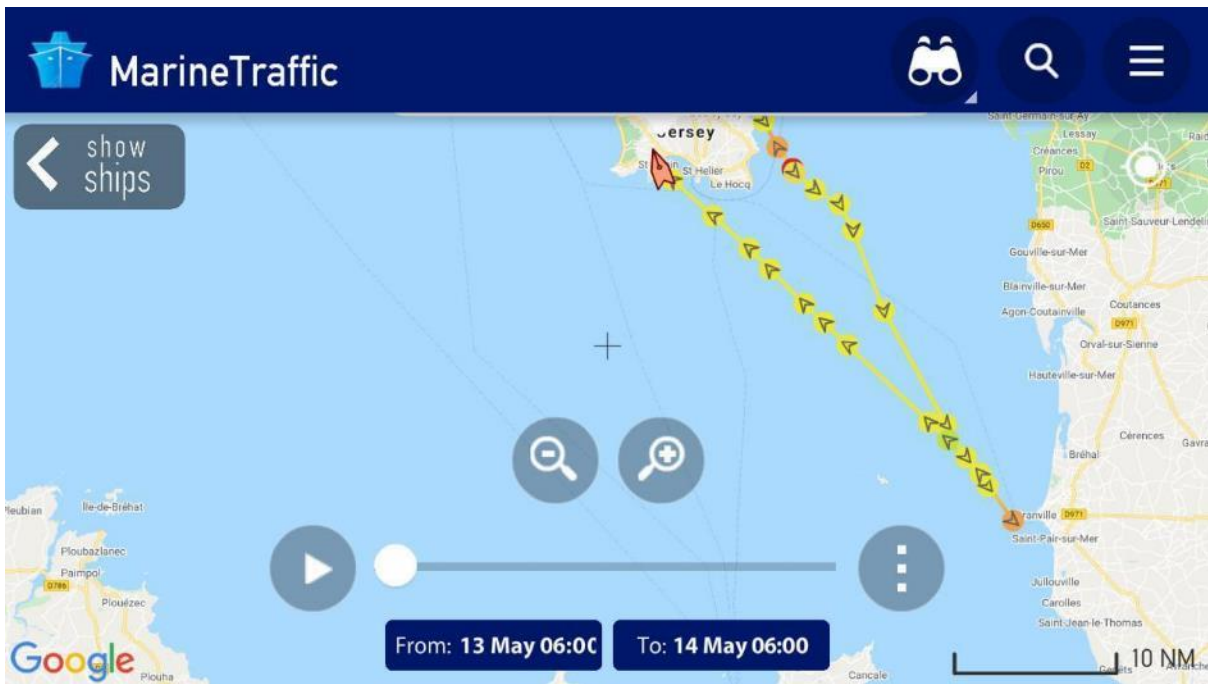
FIG 15 – L'Ecume II AIS Track (download from Marine Traffic)

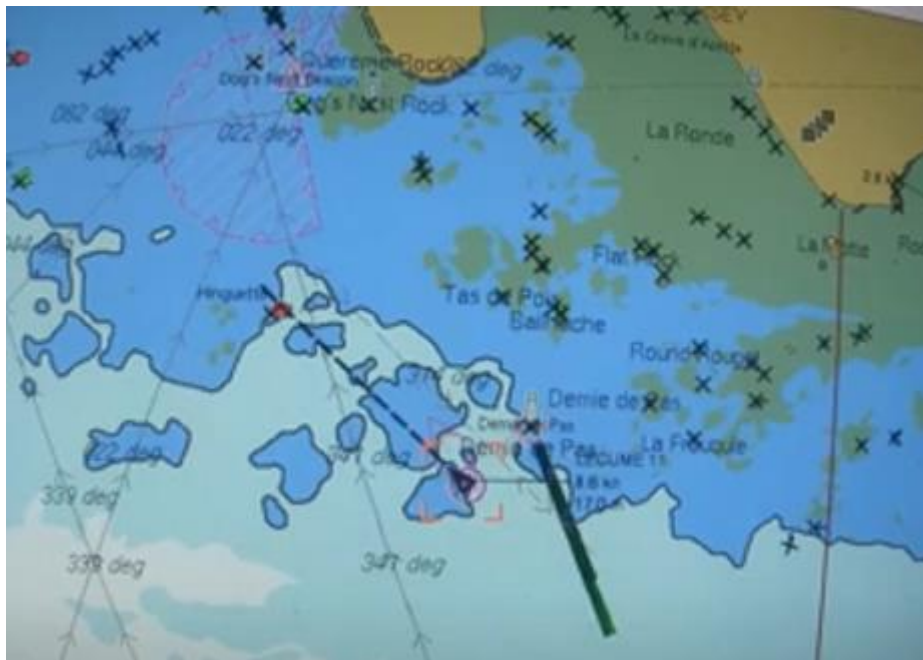
2.2.10 **L'ECUME II** passed Demie de Pas light (Fig 17) with a track in safe water between the South East Passage and the South Passage approaches, at which point she would have normally contacted St Helier VTS on VHF Ch 14, she left the Hinguette light buoy (Port Lateral mark with Quick flashing Red light) to port (Figs 18 & 19), before crossing both the Small Roads leading marks to Saint Helier (Fig 20) and the Western Passage leading marks for vessels transiting to or from the west (Fig 21).

FIG 17 L'ECUME II passes Demie de Pas (VTS screenshot)

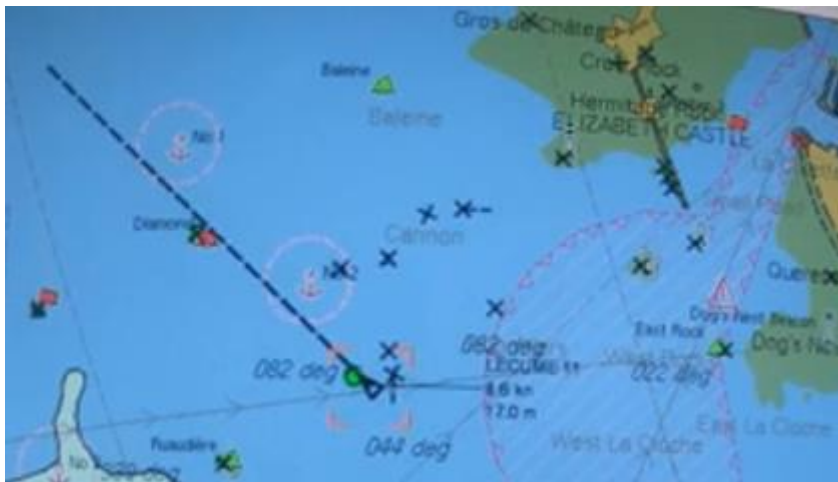
FIG 21 L'ECUME II crosses Western Passage Leads for turn to west (heading towards Diamond buoy)

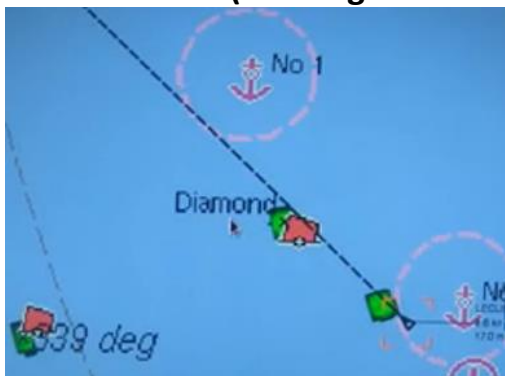
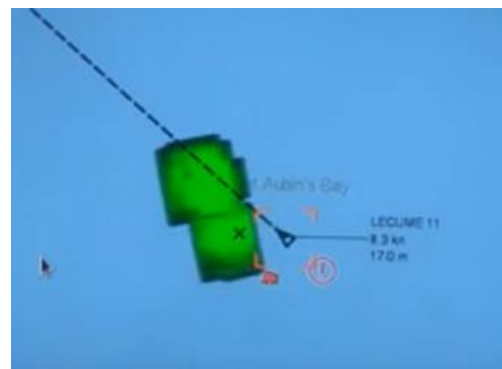
2.2.11 After crossing the Western Passage **L'ECUME II** continued into Saint Aubin's Bay, and passed close to the Diamond Buoy (Port hand lateral mark, Fl (2) R 6s) (Figs 22 & 23).

FIG 22 & 23 L'ECUME II leaves Diamond Buoy to port

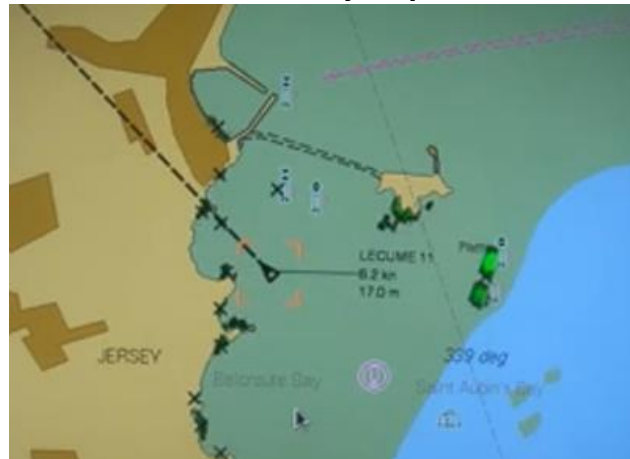
FIG 24 & 25 L'ECUME II having passed south of the outlying rocks crosses the 0m sounding and then runs aground at 8 knots.

e) The passage planning for the voyage from Granville to St Helier was inadequate and full use of all the available navigational aids was not included, e.g. no echo sounder alarm was set.
