Samares Nurseries Ecological Enquiry

Phase 1 Geotechnical and Geo-environmental Desk Study Report

Samares Nursery
MS Planning
November 2009

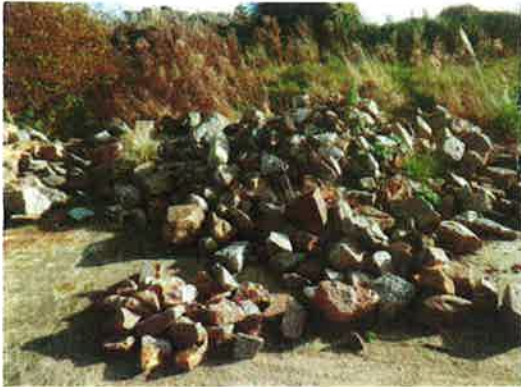
Areas of stockpiled material and waste dumping were noticed on site. Construction rubble was noted on the eastern border in two discrete locations comprising slate, tile and brick and concrete and building stone respectively. Stockpiles of PVC drains were found in two locations to the east and west. Some discarded machinery was also observed. Other general windblown litter and dumped waste was observed around the site. Broken glass was also observed around the site.

Stockpiled rubble on eastern side of site

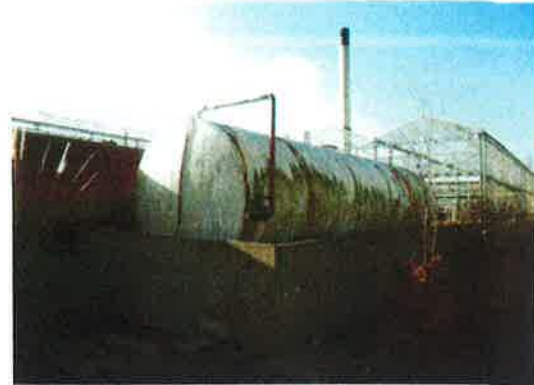
Tank area by southern greenhouse. shows tank within a concrete bunded structure.

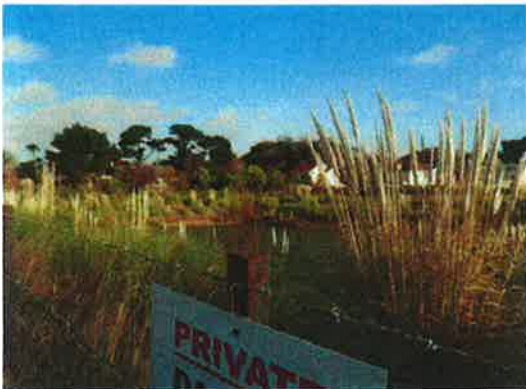
Eastern reservoir, looking north east

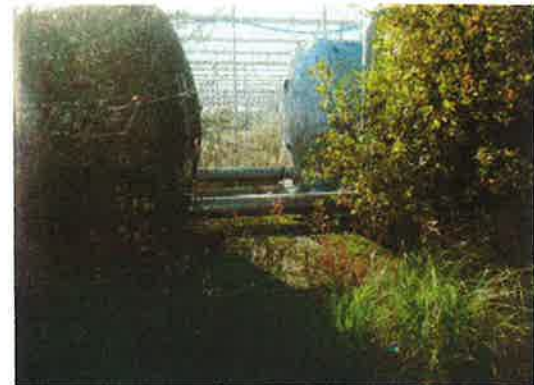
These boilers are fed by five tanks to the east. At least four of these tanks appear to be modified BRT Tank Wagons (British Rail) which are connected by metal pipes. The wagons have been taken off their rollers but are still sitting on their metal frames. The tanks are located on an area of hardstanding. One of the tanks appears to have been damaged and is misshapen. This is likely to have compromised its structure and so leaks may have occurred. The fifth tank is raised off the ground on concrete footings within a bunded area. All of the tanks are rusted and stained. The staining looks to be the result of both weathering and petroleum staining. It should be noted that these tanks are not featured on the site layout plan (Figure 1).

Contamination may have arisen through leaks and spills of fuels and oils around storage areas where bunding has not been provided or through residual contamination from the tank wagons brought to site. Some staining is evident on the tanks, thought to be a combination of both weathering and fuel staining.

Modified tank wagon with metal pipes connecting tanks.

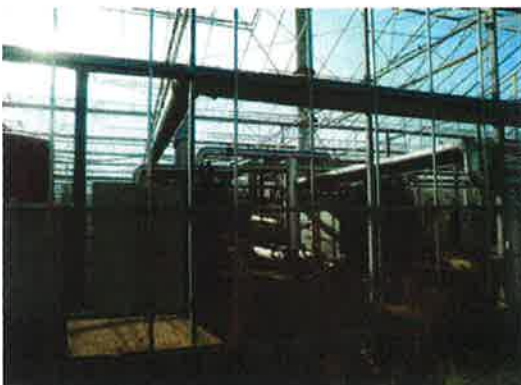
Two boilers within southern greenhouse structure

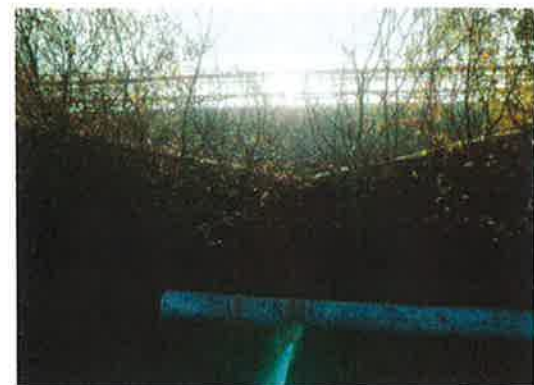
One of the tanks is heavily damaged and appears to have been crushed. Therefore, leaks and spillages may have taken place as a result of the structure having been compromised. A number of other, smaller tanks are also present. The current site owner has indicated that there are at least two oil tanks on site, one at the old boiler house in the north and one at the newer boiler house in the south. Both are thought to have been run down to a low level. A portable green plastic tank was also observed which may contain oil, perhaps used for refuelling. This looked relatively new and did not show signs of leaks or damage.

View of misshapen tank in foreground, looking south

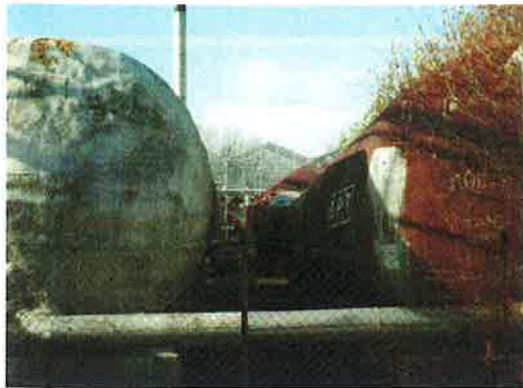
Looking west at tank area, showing misshapen tank wagon on right

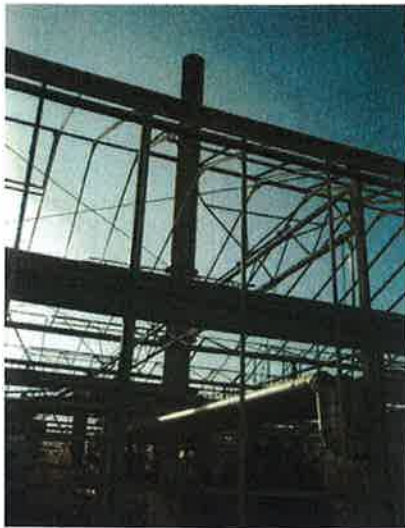
Chimney/flue attached to boiler

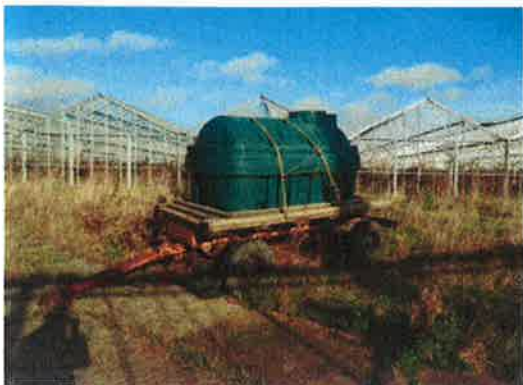
Green plastic tank on trailer – thought to contain oil

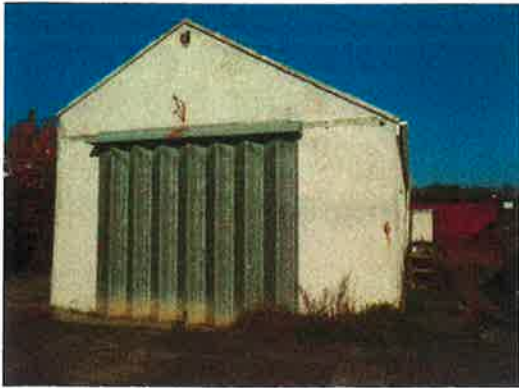
Boarded up concrete building to the north west

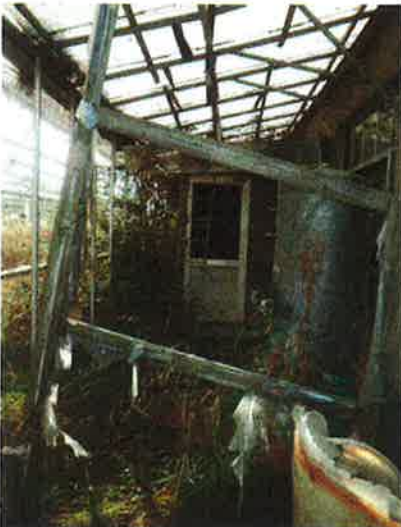
Derelict interior of northern greenhouse with upright tank to right

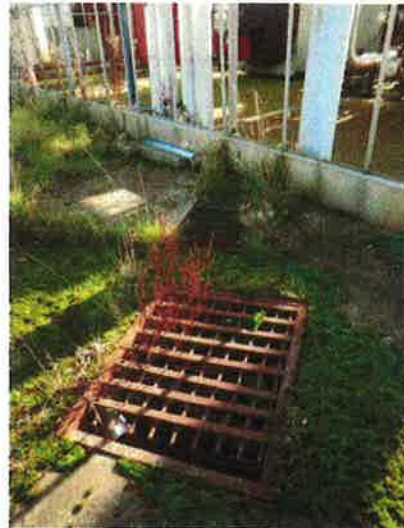
Drain covers fed by pipes from the boiler complex

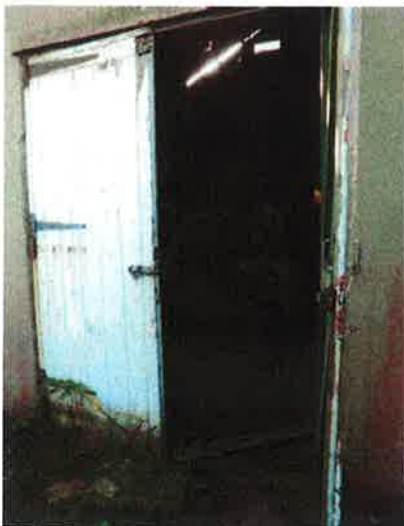
A boiler complex is associated with each greenhouse. The northern greenhouse is thought to be of older construction. Two boilers were noted inside the concrete building to the north. These were noted to be rusted and the main boiler doors were open. Two orange tanks were located to the south of the building but could not be accessed as these were inside the greenhouse structure. A further upright tank was noted immediately to the east of the building.

Concrete building by northern greenhouse with two boilers inside.
