BATHING WATER PROFILE

Environmental Protection (EP) has produced a bathing water profile for all monitored bathing waters in Jersey. The profile summarises EP's knowledge of a bathing water, including its quality and details of any improvements aimed at providing better water quality for bathers.

The bathing water profiles are a requirement of the revised Bathing Water Directive 2006/7/EC.

Name: Bonne Nuit

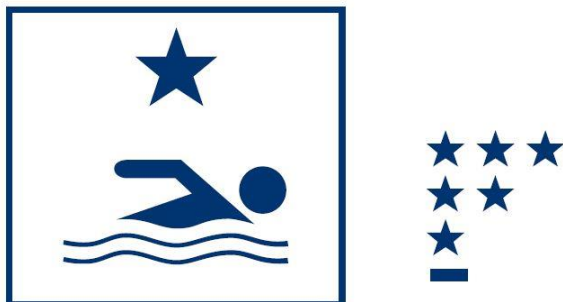
Annual water quality classification

2015: Sufficient bathing water quality

A classification for each bathing water is calculated annually, based on all of the samples from the previous four years. These classifications, from best to worst, are “excellent”, “good”, “sufficient” or “poor”.
