## BATHING WATER PROFILE

The bathing water profiles are a requirement of the revised Bathing Water Directive 2006/7/EC.

**Name: Archirondel**

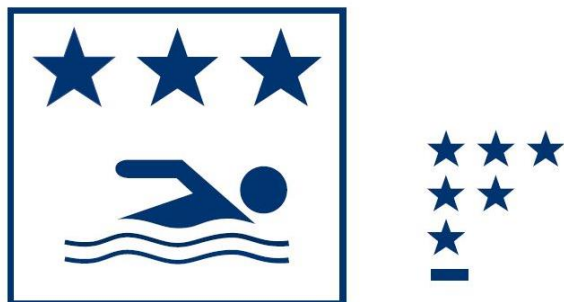
2017: Excellent bathing water quality

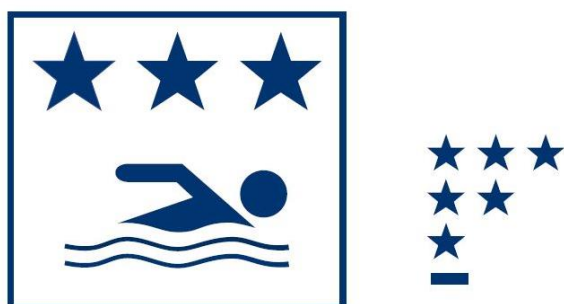
2016: Excellent bathing water quality

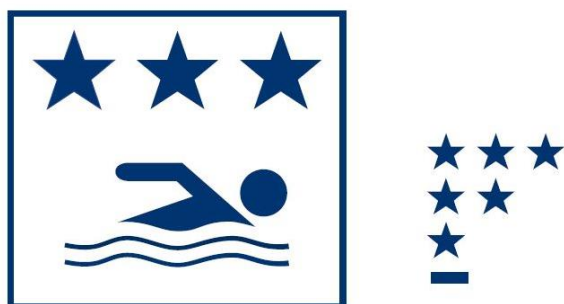
2015: Excellent bathing water quality
