BATHING WATER PROFILE

The bathing water profiles are a requirement of the revised Bathing Water Directive 2006/7/EC.

Name: St Brelade's Bay

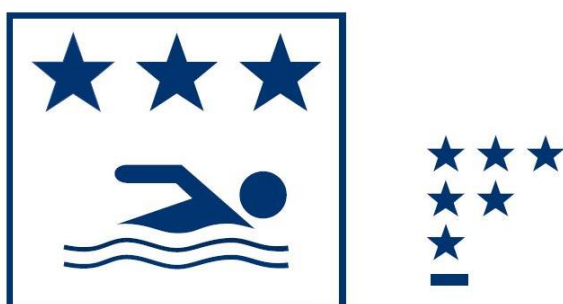
2016: Excellent bathing water quality

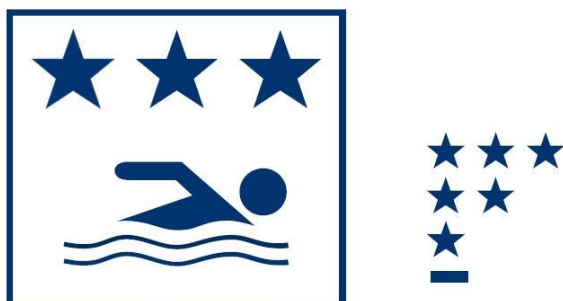
2015: Excellent bathing water quality
