Collision on 27<sup>th</sup> June 2016

Tunnell Street, St Helier

HIGHWAY REPORT

Prepared by A.E.A Luck

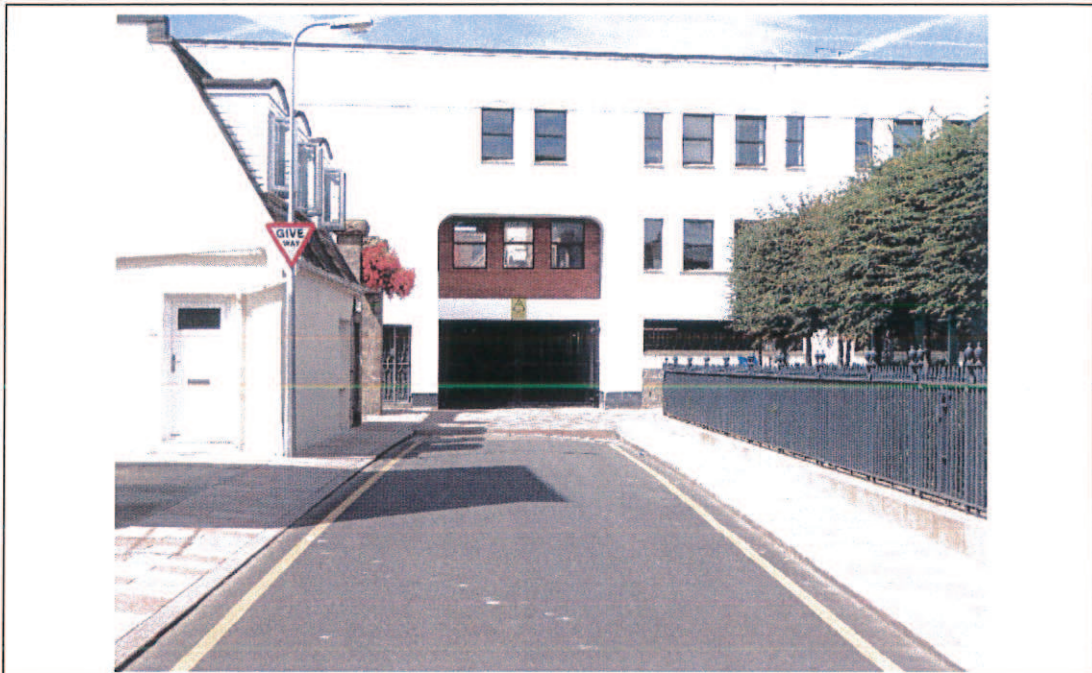
D3 Tunnell Street on the approach to the 90° right-hand bend (photograph taken by A Luck on 8<sup>th</sup> July 2016)

2.8 Approaching this area in a west-bound direction, a vehicle would pass a 'Give-way' post-mounted sign accompanied by a yellow 'give-way' line on the carriageway surface<sup>(D3 and D14)</sup>. The transition between the two types of surfacing and layout is also marked by a shallow road hump immediately preceded by a row of paving slabs and several rows of setts<sup>(D14)</sup>. The slope of the hump itself is surfaced in a red bituminous material and marked with two white road hump markings for west-bound traffic<sup>(D15)</sup>.

- 4.6 The reason for the give-way sign and carriageway marking on the Tunnell Street approach to the 90° bend at the end of the cut-through was not clear as, at that point, a driver would be unable to see a pedestrian, cyclist or vehicle approaching the exit to the cut-through, as they would be masked by the high stone wall.

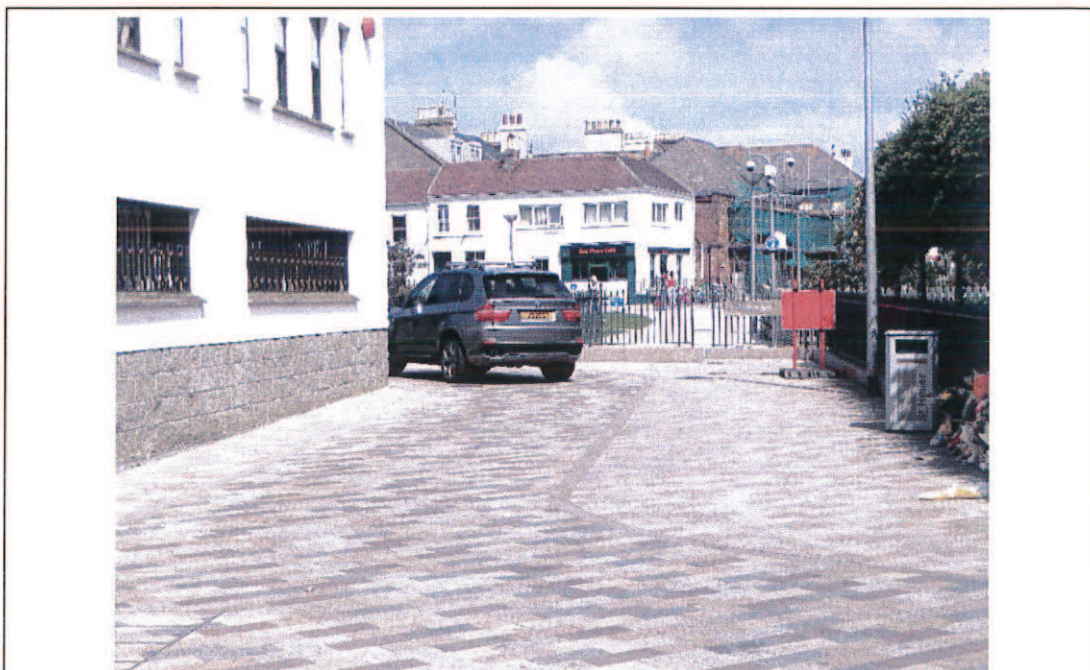
D4 The second 90° bend where Tunnell Street joins Robin Place (photograph taken by A Luck on 8<sup>th</sup> July 2016)

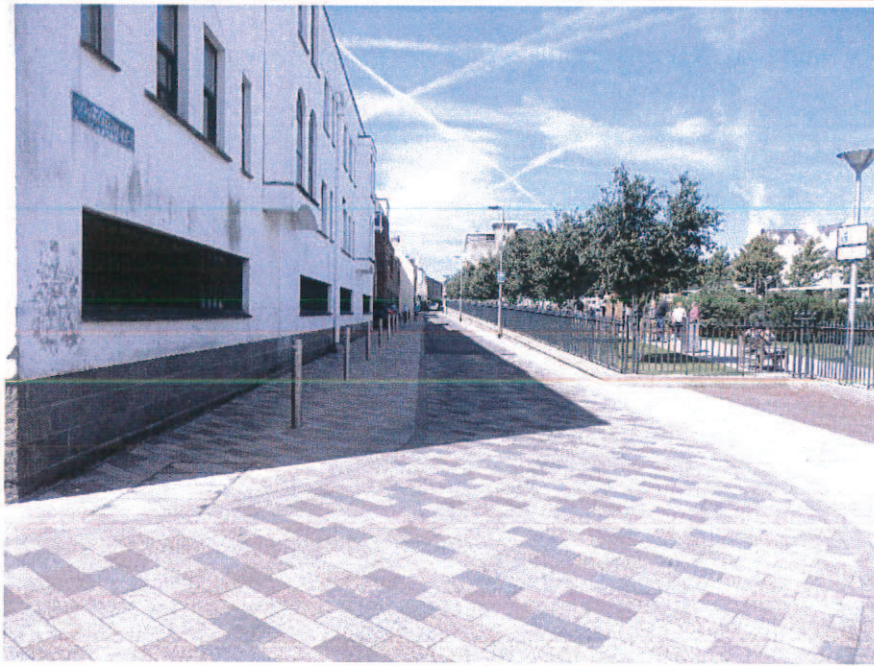
D5 Robin Place looking towards its junction with Bath Street (photograph taken by A Luck on 8<sup>th</sup> July 2016)

2.1 Tunnell Street is a single carriageway orientated east to west, running between St Saviour's Road and Robin Place<sup>(D1)</sup>. Travelling from the junction with St Saviour's Road at its eastern end, Tunnell Street continues in a straight line<sup>(D2)</sup> until the point where a pedestrian and cycle path running between Belmont Road to the south and Tunnell Street, emerges<sup>(D3)</sup>. At this point Tunnell Street travels around a right-hand 90° bend, continuing northwards towards a pedestrian entrance to Millennium Park, at which point it turns around a second 90° bend, this time to the left<sup>(D4)</sup>. At this bend the road becomes Robin Place which continues in a straight line towards Bath Street to the west<sup>(D5)</sup>.

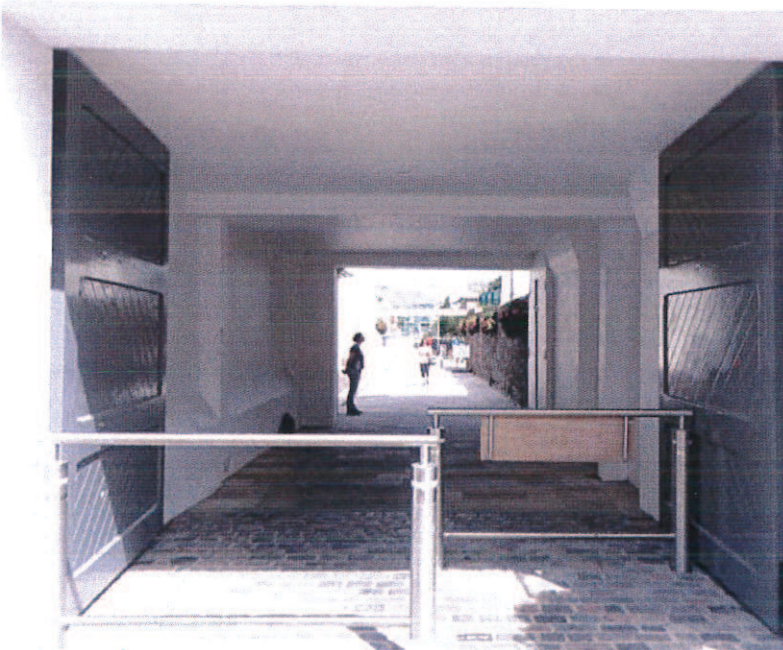
D6 The Belmont Road entrance to the cut-through (photograph taken by A Luck on 8<sup>th</sup> July 2016)

- 2.3 The cut-through between Belmont Road and Tunnell Street is for use by pedestrians and cyclists. However, there is vehicular access to and from Tunnell Street to a private parking area which has spaces marked for 5 vehicles. Direct vehicular access from Belmont Road is prevented by two metal post and bar fences forming a chicane<sup>(D6)</sup>.

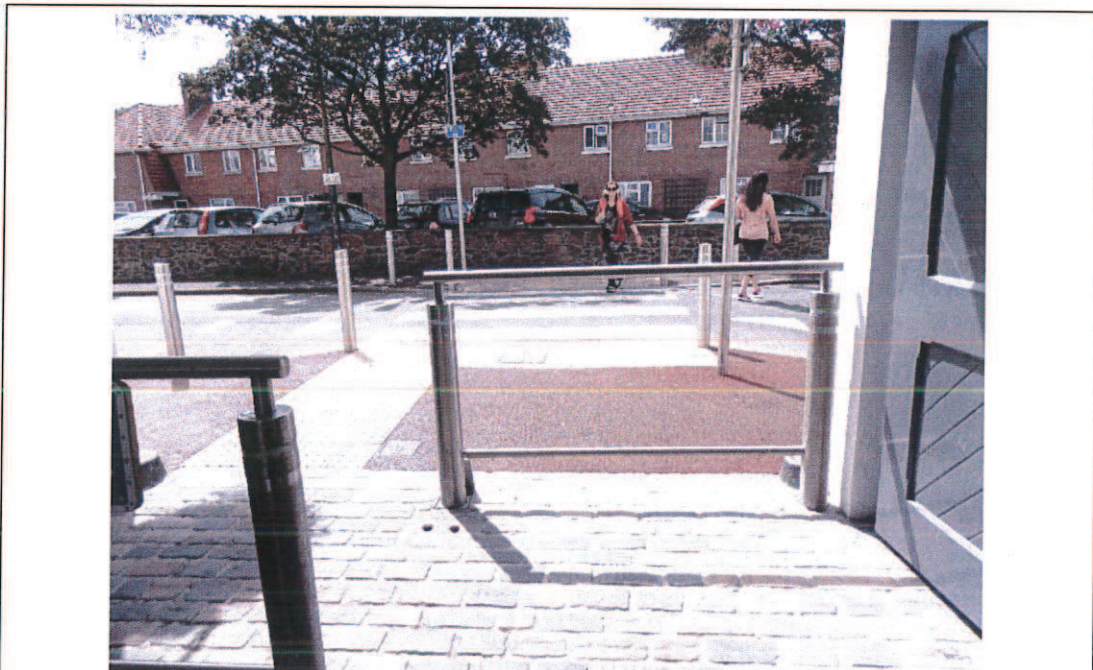
D7 The footway and zebra crossing on Belmont Road by the entrance/exit to the cut-through (photograph taken by A Luck on 8<sup>th</sup> July 2016)

- 2.4 Alongside Belmont Road the footway is surfaced with a red bituminous material with tactile paving and metal bollards highlighting the location of a raised zebra crossing immediately opposite the entrance/exit of the cut-through<sup>(D7)</sup>. From Belmont Road the cut-through passes through a deep archway formed by buildings on either side and above<sup>(D6)</sup>.

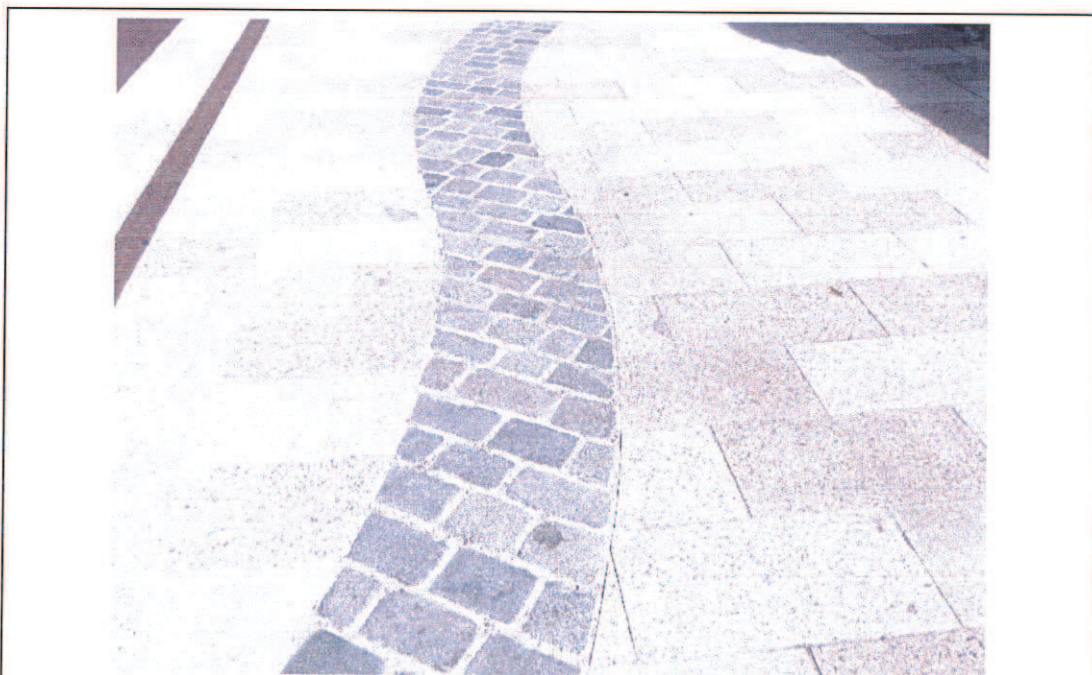
D8 The paving and setts used on the surface of the cut-through (photograph taken by A Luck on 8<sup>th</sup> July 2016)

- 2.5 The surface of the cut-through is constructed from a palette of pink/red, cream and grey paving slabs with dark setts used to form a feature in the path<sup>(D8)</sup>. Coloured setts, from the same type of palette as the paving slabs but including a number which are darker grey, have also been used to provide a wide strip across the full width of the path where it joins with Belmont Road and Tunnell Street<sup>(D9 and D10)</sup>. While the paving slabs provide a smooth surface, the setts have an uneven surface texture with exposed mortar between.

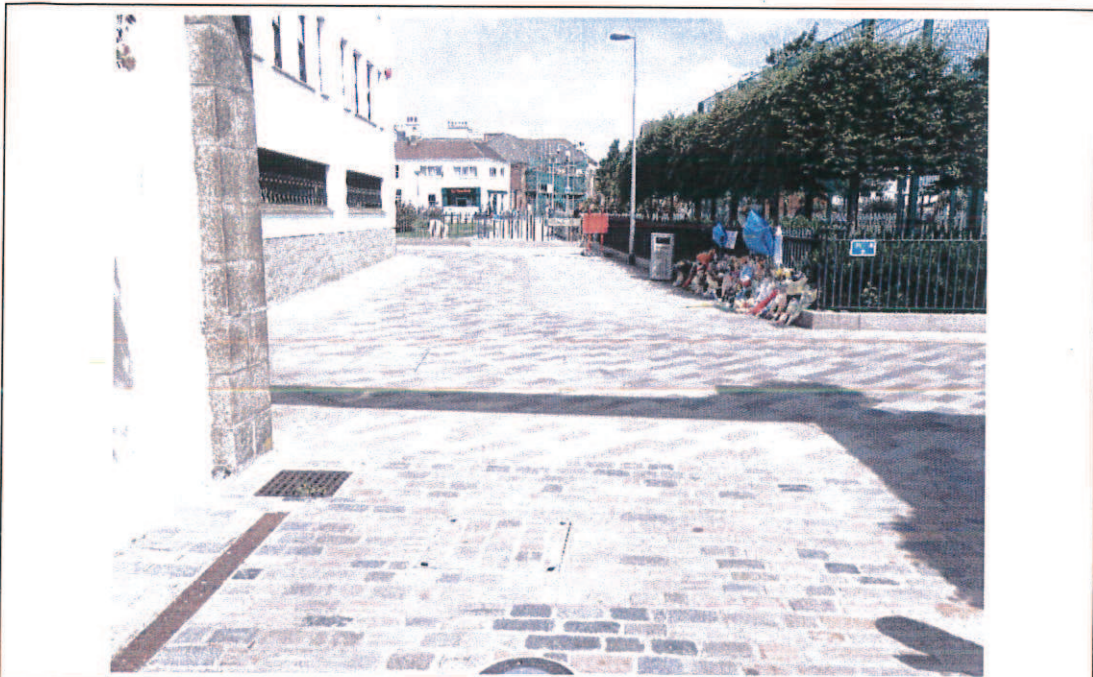
D9 The setts used at the entrances/exits to the cut-through – Tunnell Street end  
(photograph taken by A Luck on 8<sup>th</sup> July 2016)

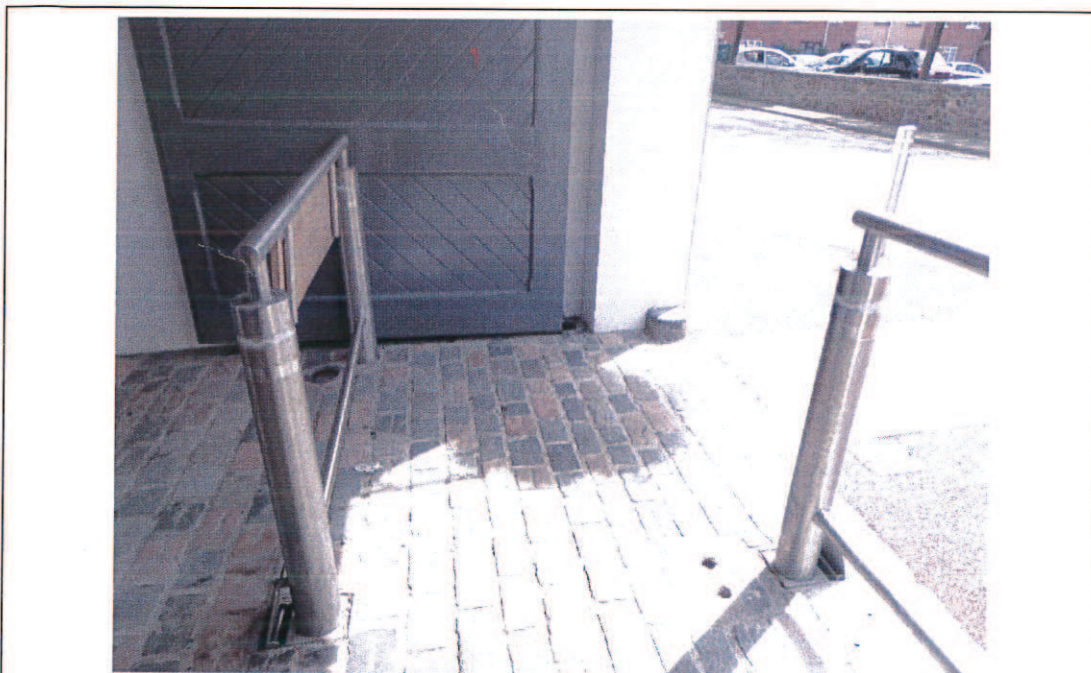
D10 The setts used at the entrances/exits to the cut-through – Belmont Road end  
(photograph taken by A Luck on 8<sup>th</sup> July 2016)

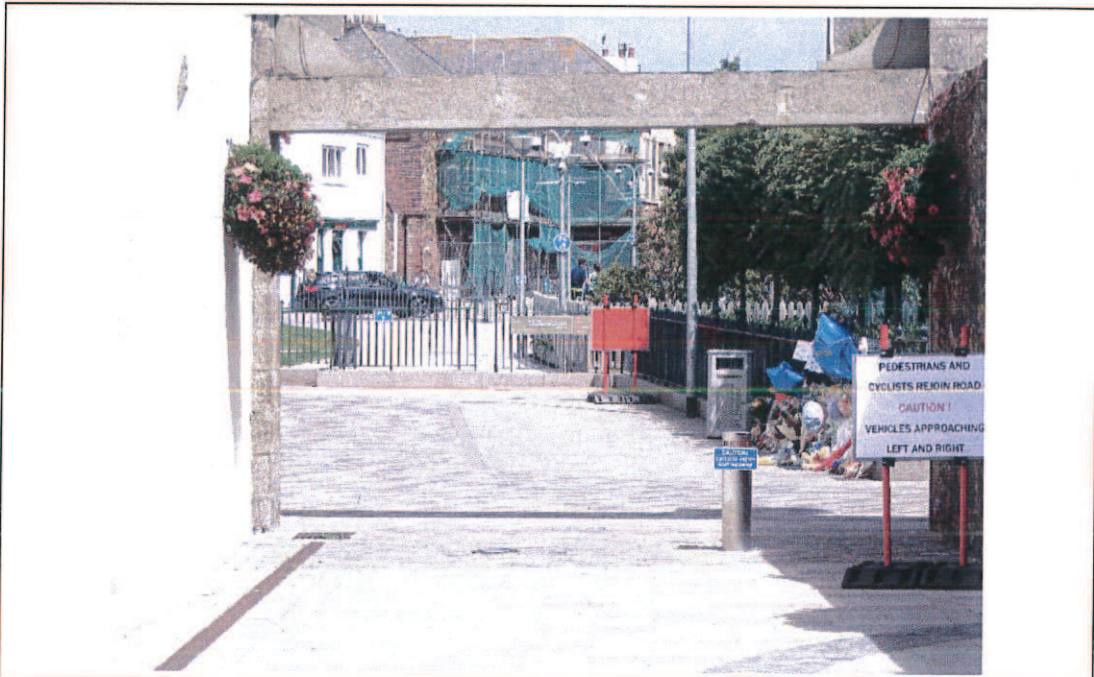
D11 The metal bollards (one in the raised and one in the down position) at the end of the cut-through by Tunnell Street (photograph taken by A Luck on 8<sup>th</sup> July 2016)

- 2.6 Within these setts at the Tunnell Street end there are two metal bollards, with the left-hand one appearing to be moveable such that it can be left permanently in its up or down position<sup>(D11)</sup>. Almost directly above these bollards is a stone lintel between the building on the left-hand side and a high stone wall to the right.

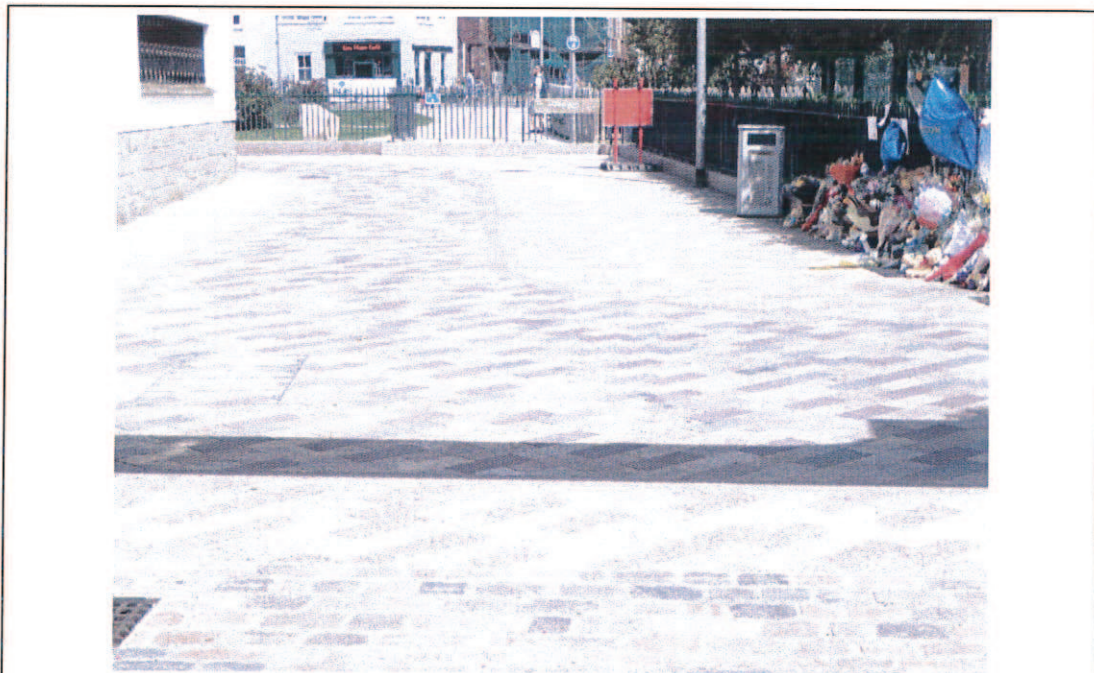
D12 The carriageway and footway surfaces on Tunnell Street at the end on the cut-through (photograph taken by A Luck on 8<sup>th</sup> July 2016)

- 4.3 The setts used to delineate the carriageway and footway, because of their position in what appeared to be, from the cut-through, the centre of the surfaced area, with the surface on either side appearing to slope into them, I believe could easily be mis-interpreted as the grating on a channel drain similar to that present on the cut-through. This further disguises the true nature of the layout on Tunnell Street and the potential presence of through-traffic.

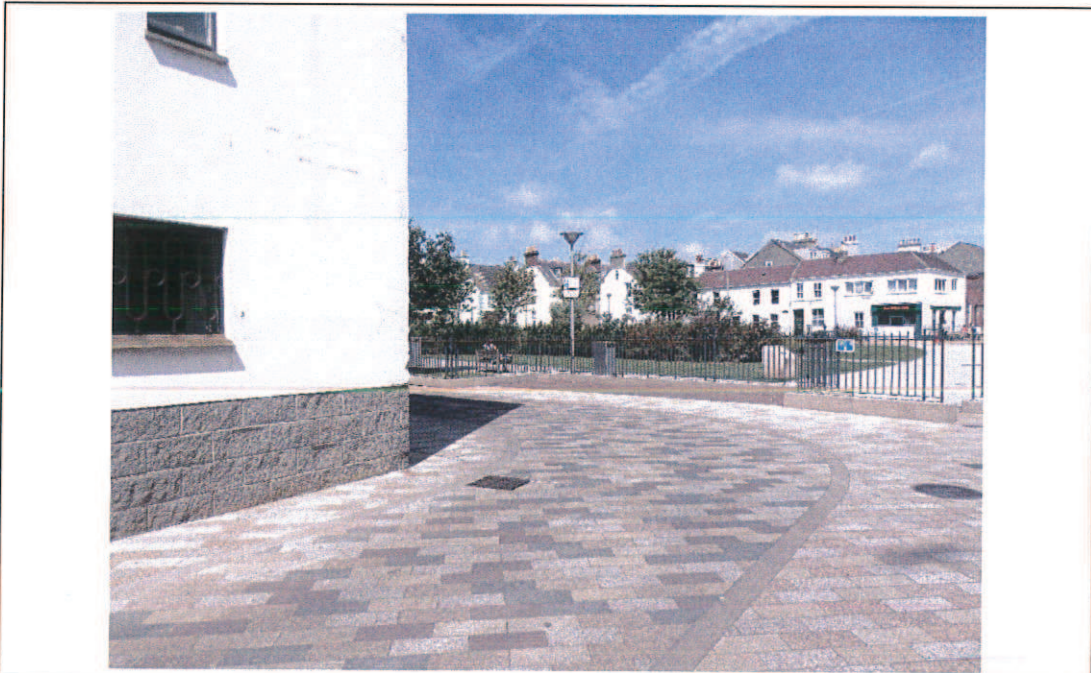
D13 The delineation between the carriageway and footway (photograph taken by A Luck on 8<sup>th</sup> July 2016)

- 2.7 The carriageway on Tunnell Street in the immediate vicinity of the two 90° bends is raised so that it is flush with the footways. While the rest of Tunnell Street is surfaced using a bituminous material, in this area both the carriageway and footway are surfaced with setts, laid diagonally, using a similar palette of colours to those on the cut-through. However, those used on the carriageway contain some that are darker than those used on the footway, as have been used in the areas at the end of cut-through<sup>(D12)</sup>. A continual line of grey setts, flush with the surrounding surfaces has been used to provide a visual demarcation of the carriageway and footways<sup>(D13)</sup>.

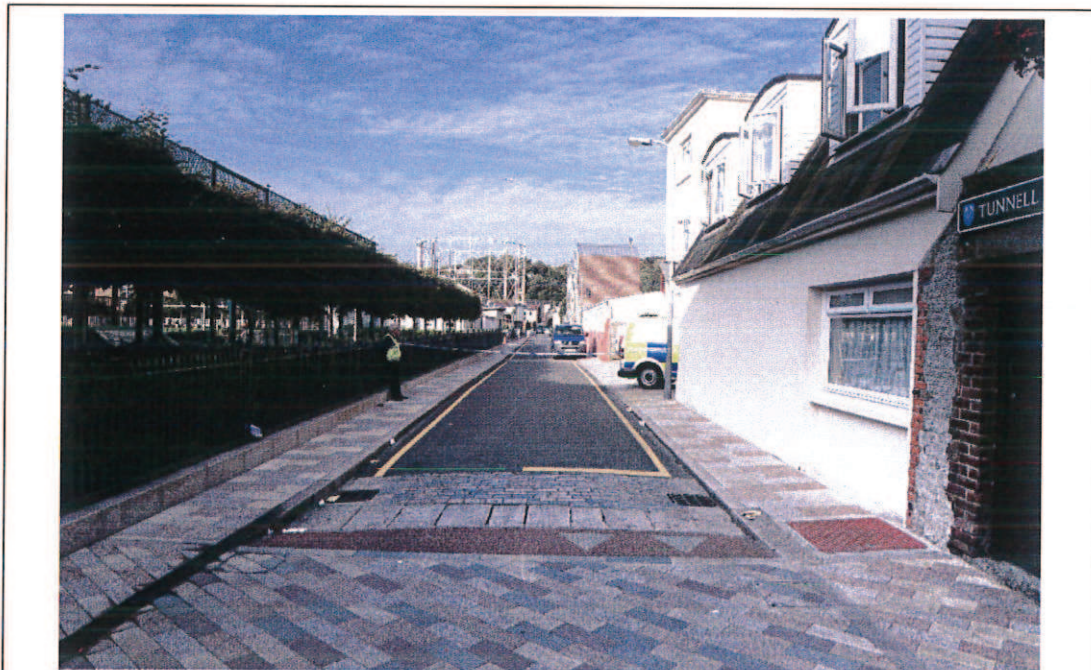
D14 The give-way line on road hump at the transition between the two surfaces (photograph taken by States of Jersey Police on 27<sup>th</sup> June 2016)

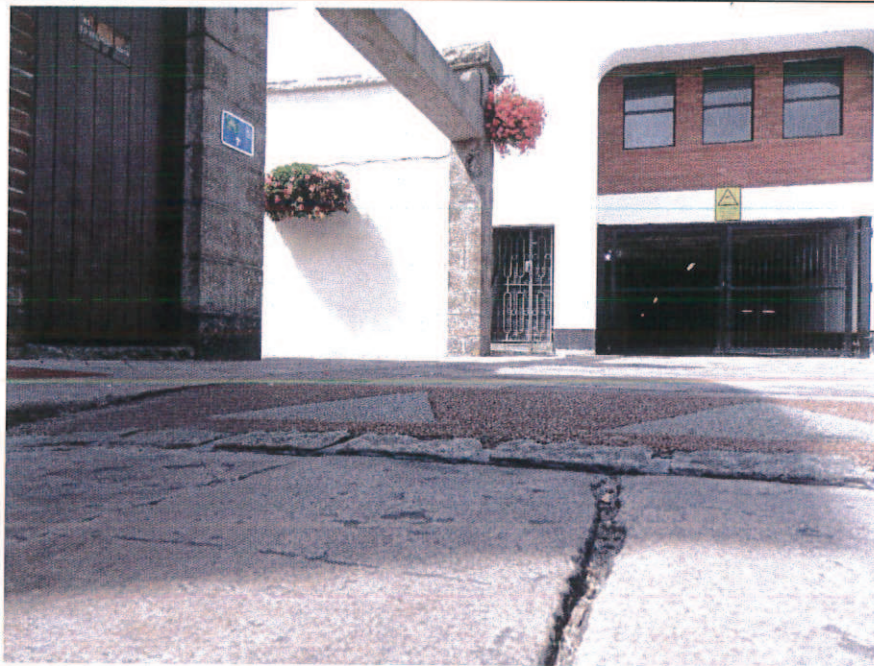
D15 Detail of the road hump at the transition between the two surfaces (photograph taken by A Luck on 8<sup>th</sup> July 2016)

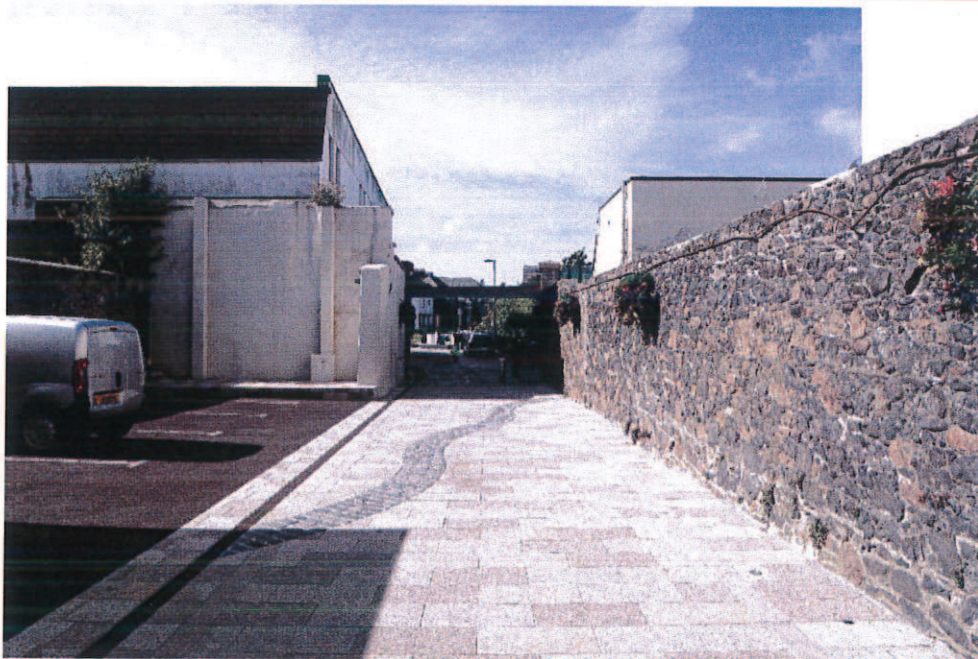
D16 View towards Tunnell Street from the cut-through (photograph taken by States of Jersey Police on 27<sup>th</sup> June 2016)

3.5 A vehicle was parked in the marked bays at the left-hand side of the cut-through<sup>(D16)</sup>. Another vehicle was parked in Tunnell Street on the footway

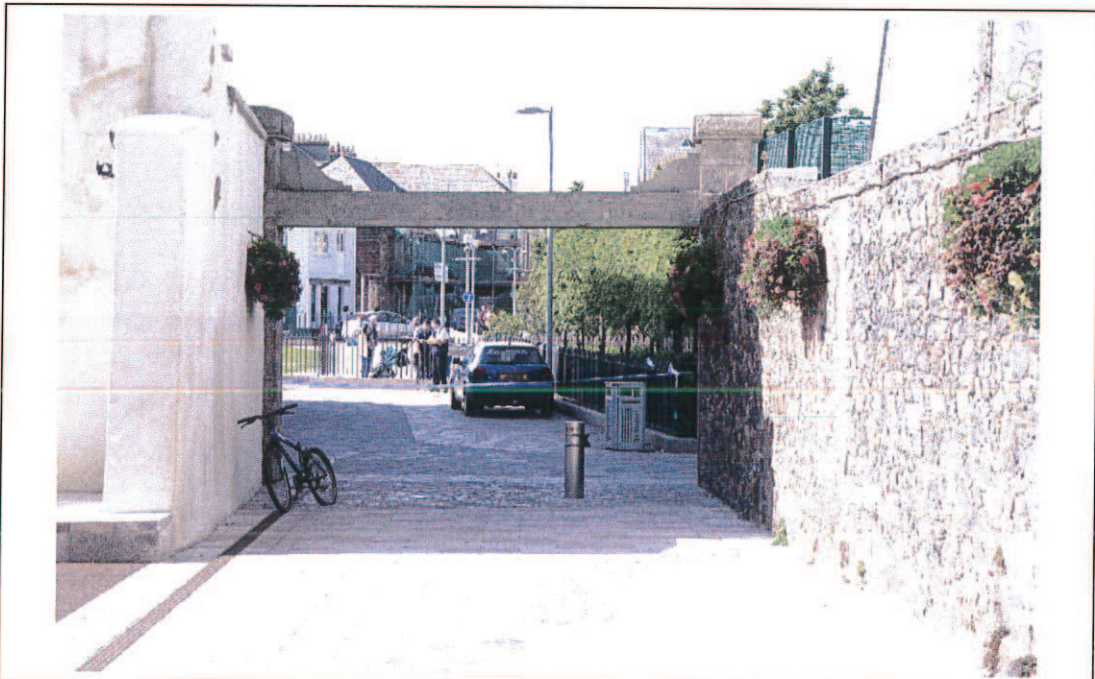
D17 View towards Tunnell Street from approximately half way along the cut-through (photograph taken by States of Jersey Police on 27<sup>th</sup> June 2016)

3.4 The right-hand bollard at the end of the cut-through was in the upright position, but the left hand one was flush with the road surface. The face of the small blue sign, mounted on the right-hand bollard and advising 'CAUTION cyclists rejoin carriageway', was facing towards Tunnell Street<sup>(D18)</sup> and not visible to anyone walking through the cut-through from Belmont Road. There was no other signage present warning pedestrians or cyclists that they were approaching a carriageway<sup>(D17 and D19)</sup>.

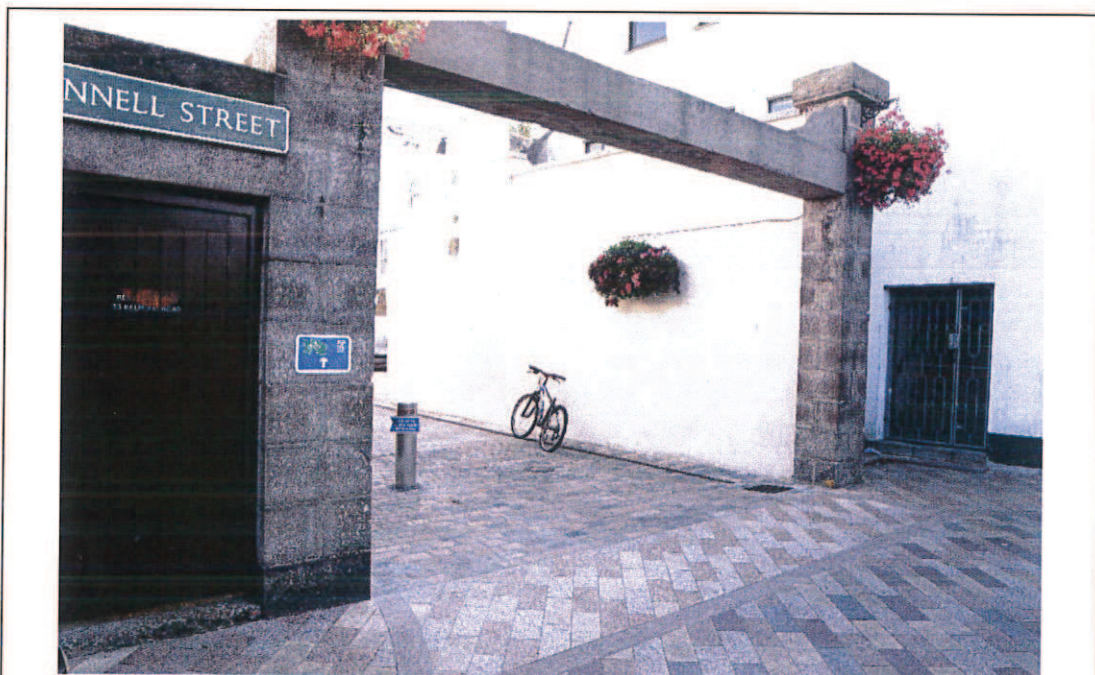
D18 The bollard-mounted sign advising to re-join the main carriageway (photograph taken by States of Jersey Police on 27<sup>th</sup> June 2016)

- 4.5 The bollard-mounted sign for cyclists had been turned to face cyclists exiting the cut-through onto Tunnell Street with a large new sign placed alongside warning pedestrians and cyclists of the presence of the carriageway and the possibility of traffic approaching from both the right and left.

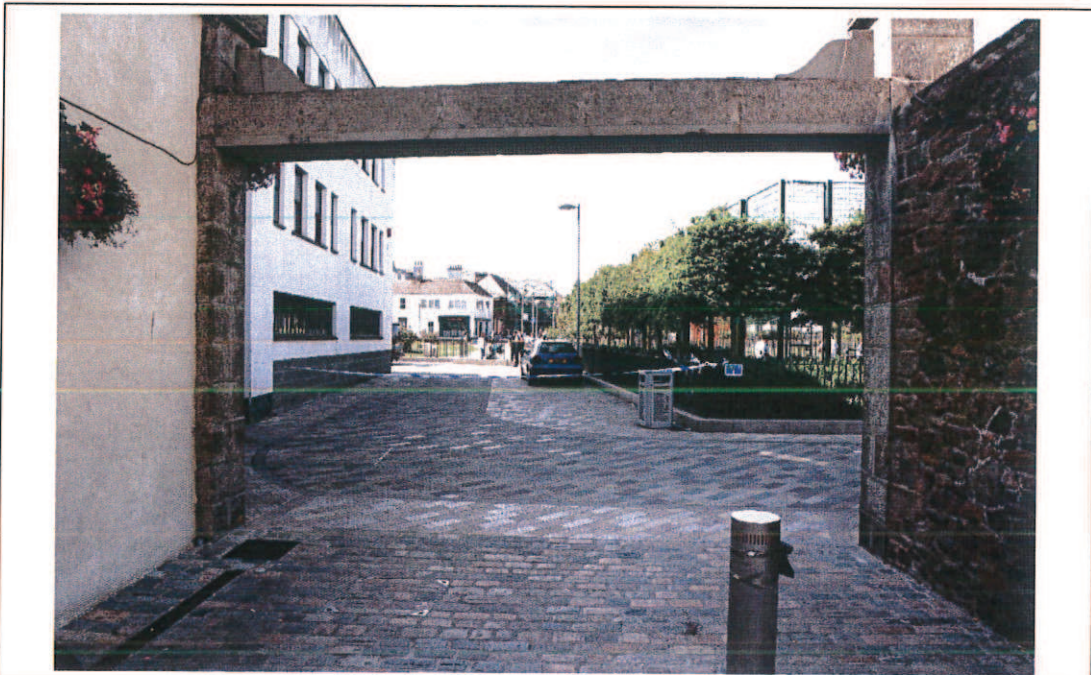
D19 The immediate approach to the end of the cut-through at Tunnell Street (photograph taken by States of Jersey Police on 27<sup>th</sup> June 2016)

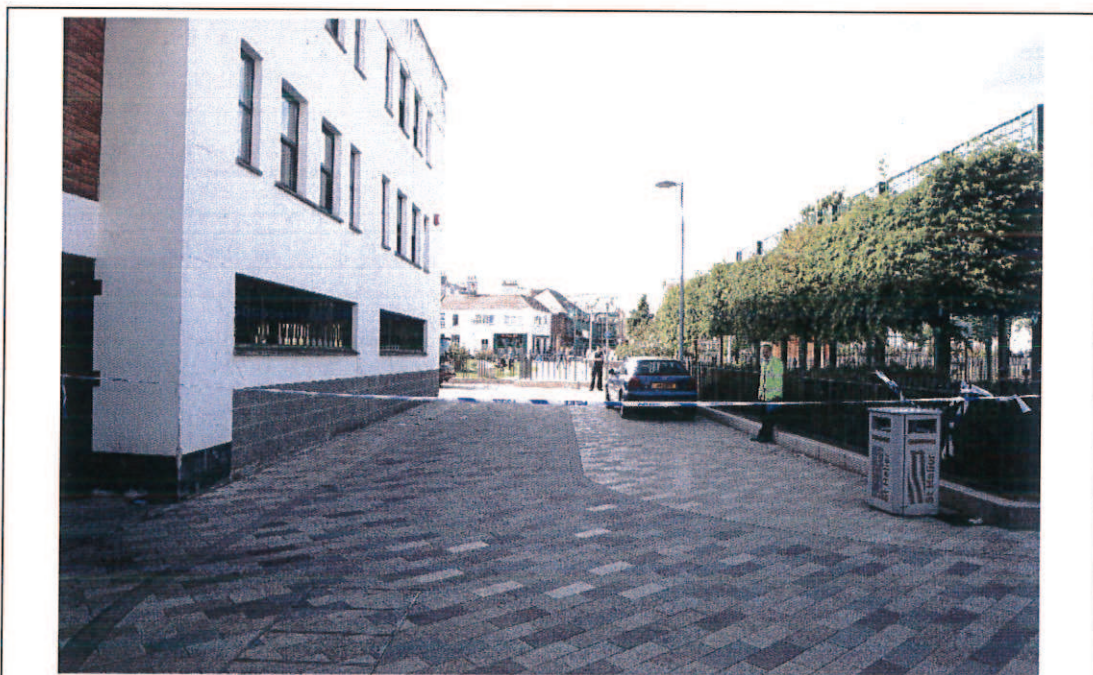
D20 The car parked on the footway on Tunnell Street adjacent to the park boundary at the time of the collision (photograph taken by States of Jersey Police on 27<sup>th</sup> June 2016)

area, parallel to the carriageway and adjacent to the railings of Millennium Park<sup>(D20)</sup>.

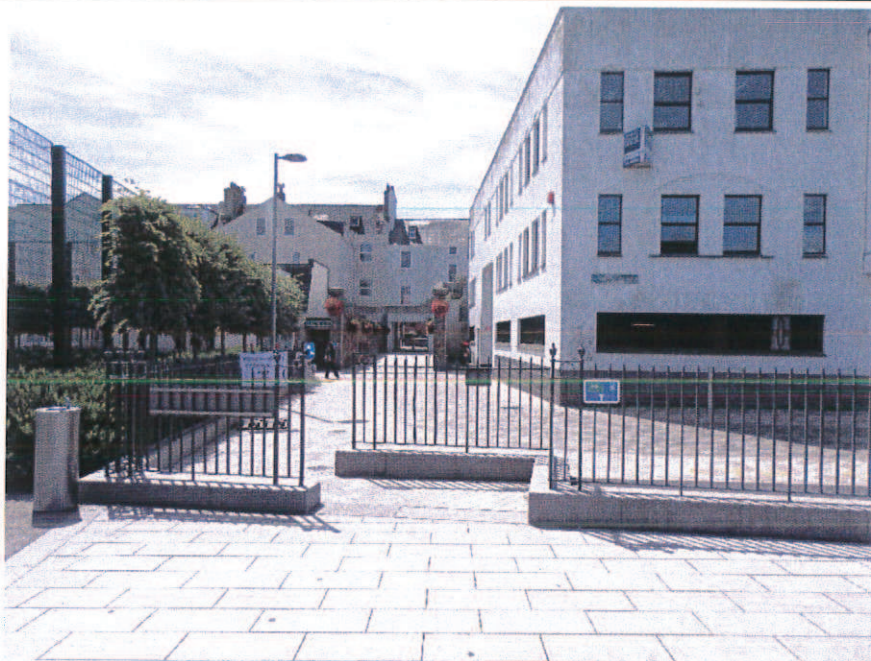
- 4.4 The difference between the two surfaces, on a sunny day, was also not that clear when walking towards the park exit<sup>(D21)</sup>. However, the view of

approaching vehicles was reasonable and therefore allowed pedestrians using the carriageway sufficient time to move out of the way if necessary.

D21 The area on Tunnell Street when exiting the park (photograph taken by A Luck on 8<sup>th</sup> July 2016)

- 10.6 In my opinion the differences in the colours of setts used on the carriageway and footway are also not apparent when exiting the park onto Tunnell Street in the conditions of bright sunlight present while I was site. However, it is my belief that design of the shared space area is considerably less of a safety concern from this direction as pedestrians and other vulnerable road users have a greater opportunity to perceive the surrounding area and cues as to the possible presence of vehicular traffic. They also have a longer period of time to react to an oncoming vehicle than a similar road user exiting the cut-through.

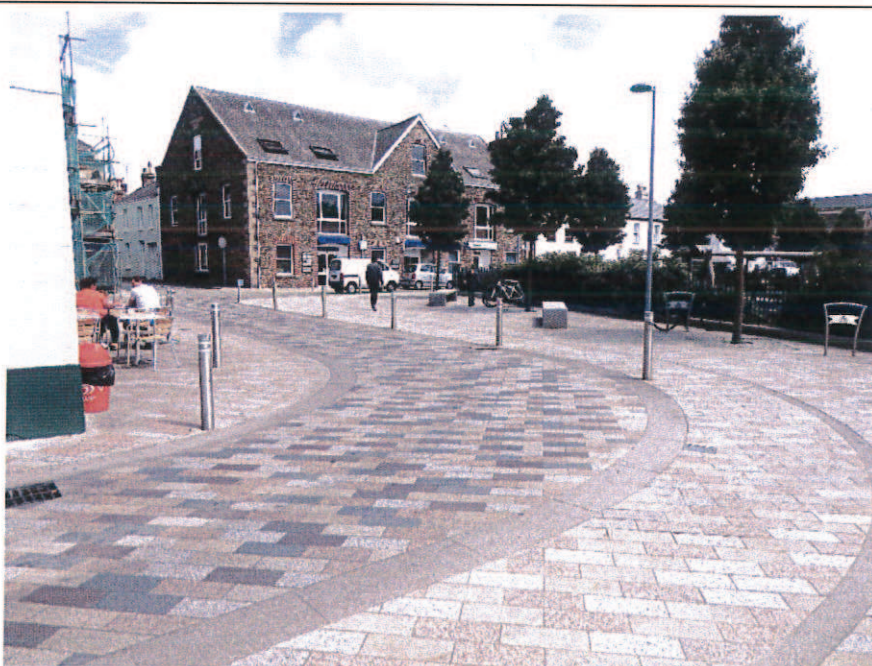
- 4.7 A similar surface treatment, with the setts laid diagonally, had been used on area outside the park entrance in the vicinity of the junction of Gas Place and Oxford Road<sup>(D22)</sup>. However, without any tunnel-like approach, the presence of bollards at the edge of the carriageway and the more generous width of the footway given the land available, I felt that the layout had much more clarity in relation to the interaction between pedestrians and motorised vehicular traffic.

D22 The area at the junction of Gas Place and Oxford Road (photograph taken by A Luck on 8<sup>th</sup> July 2016)

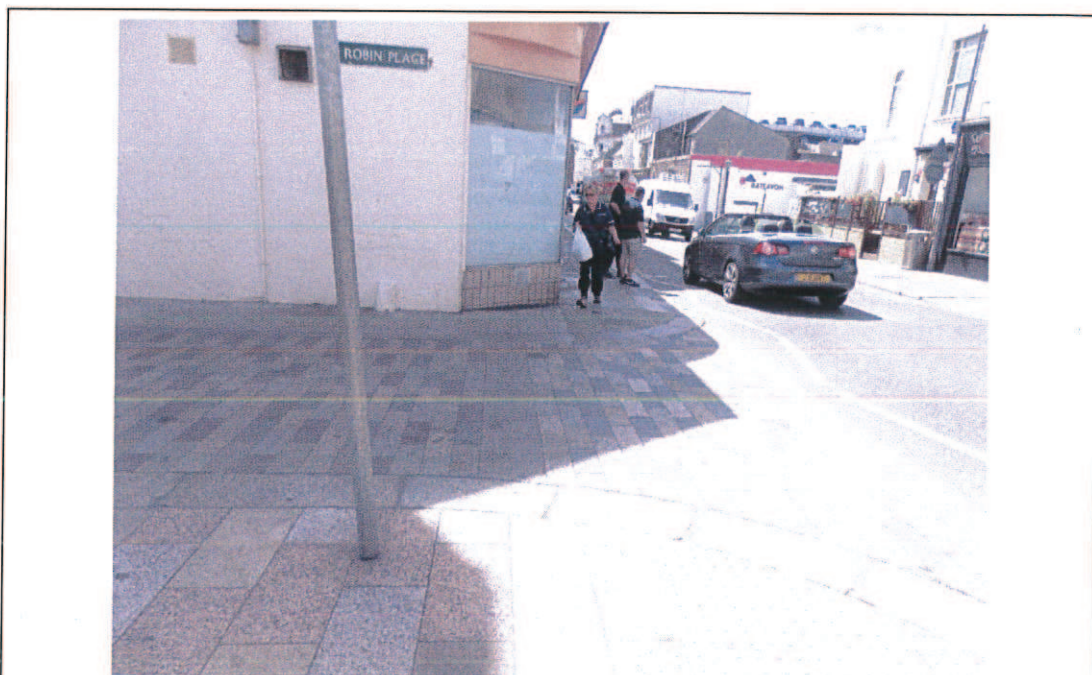
- 4.9 *Materials and layout used at other junctions in the area surrounding the Millennium Park*
- 4.9.1 The type and palette of setts used at the junctions of Tunnell Street with Robin Place and at Gas Place with Oxford Road, in the areas where vehicles and pedestrians were likely to interact, were replicated at the exit of Robin Place onto Bath Street, at the location where pedestrians would cross the mouth of the junction<sup>(D23)</sup>. However, here the setts in the carriageway

were laid at 90° to the direction of travel and were not accompanied by any give-way markings or signage for vehicular traffic. Tactile paving had been included at the edge of each footway.

D23 The junction mouth of Robin Place next to Bath Street (photograph taken by A Luck on 8<sup>th</sup> July 2016)

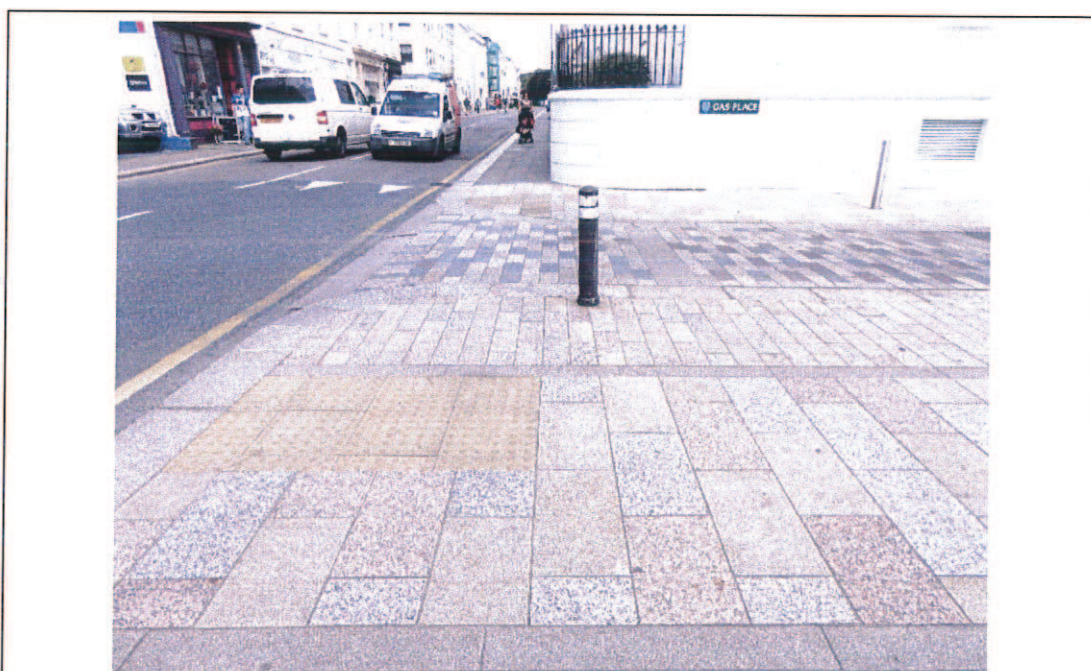
- 4.9.2 The same type of layout is used at the junction mouth of Gas Place, at the edge of Bath Street<sup>(D24)</sup> although the tactile paving was situated removed from the carriageway edge in order to accommodate the cycle lane section of the shared use footway.

D24 The junction mouth of Gas Place next to Bath Street (photograph taken by A Luck on 8<sup>th</sup> July 2016)

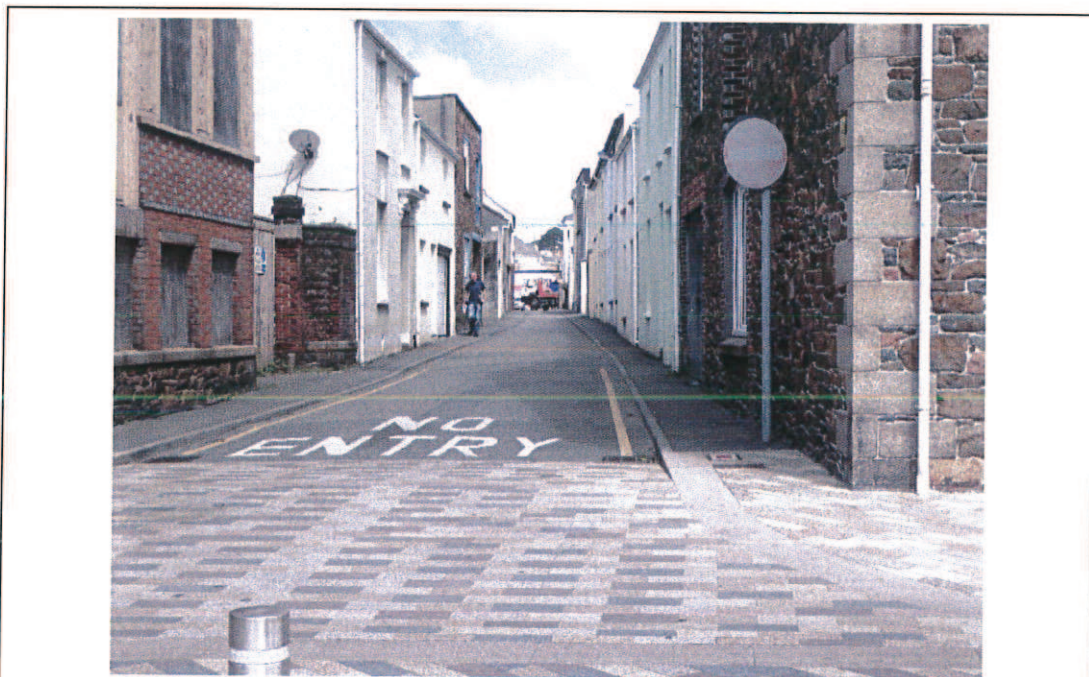
- 4.9.3 The layout is duplicated at the junction of Common Lane with Oxford Road, but without any tactile paving present in the footway and no give-way signage or marking for vehicles joining Oxford Road<sup>(D25)</sup>.

D25 The junction of Common Lane (photograph taken by A Luck on 8<sup>th</sup> July 2016)

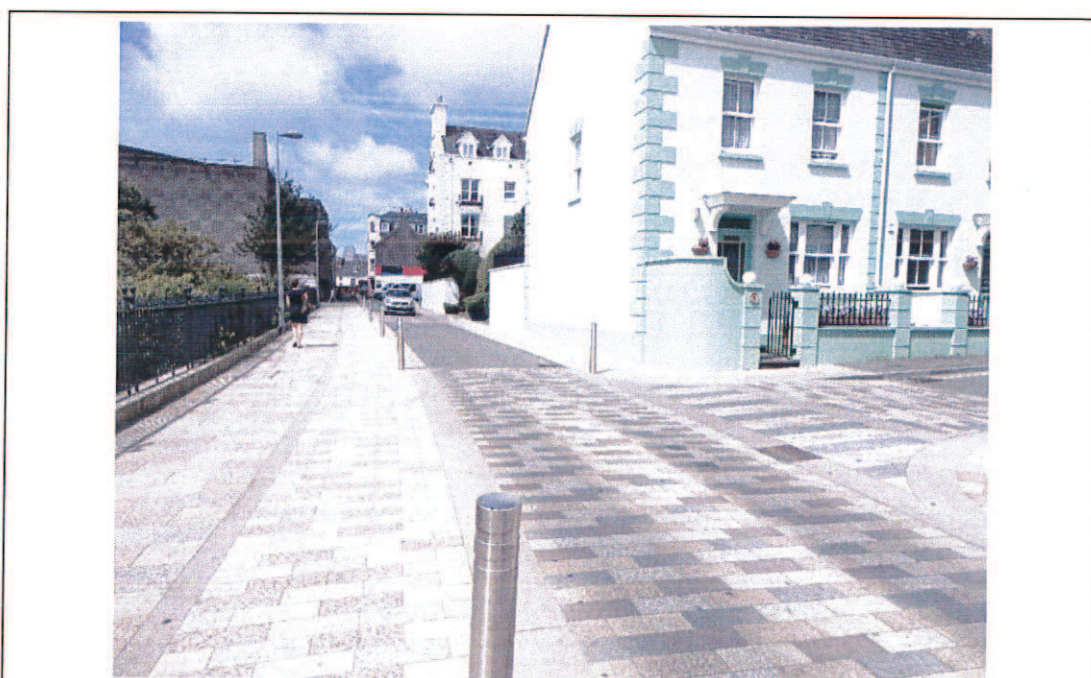
- 4.9.4 However, at the pedestrian crossing point in the junction mouth of Apsley Road with Gas Place the pedestrian crossing area had been marked by setts laid out to form coloured stripes instead of the more random pattern used elsewhere<sup>(D26)</sup>. In this location there was no tactile paving and no give-way signage or marking for vehicles. The same layout can be found at the junction of Chevalier Road with Gas Place.

D26 The junction of Aspley Road (photograph taken by A Luck on 8<sup>th</sup> July 2016)

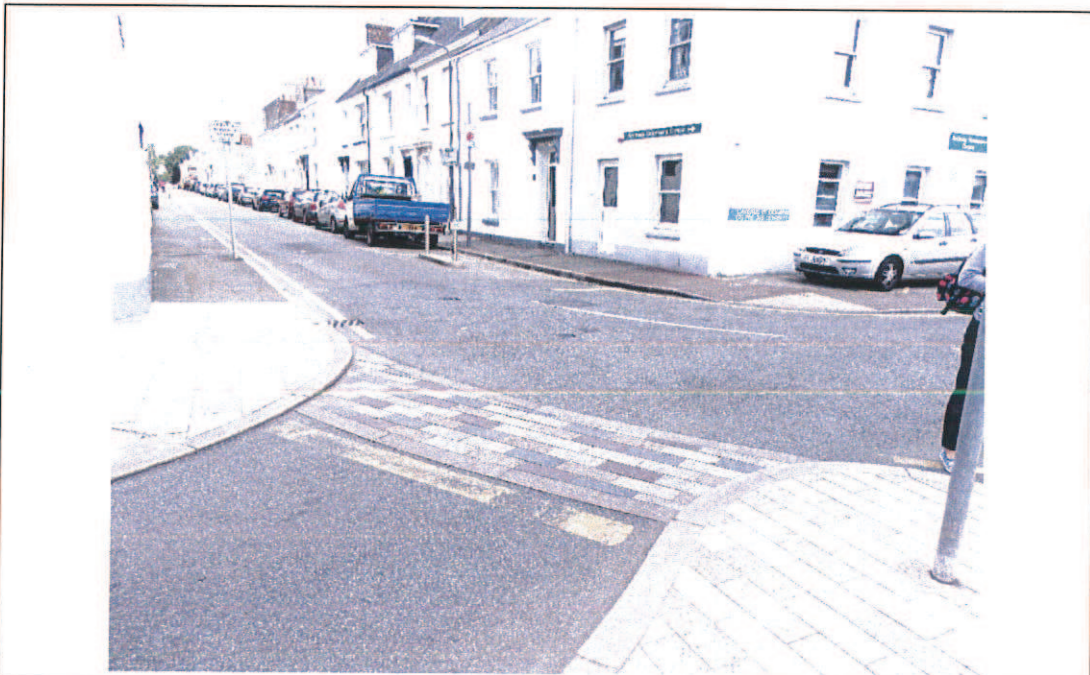
- 4.9.5 The more random pattern of setts is once again used at the junction of L'Avenue et Dolmen du Pré des Lumières with La Rue le Masurier, although here the area they cover is considerably narrower, and they are laid into the carriageway surface beyond the give-way line<sup>(D27)</sup>. While tactile paving is positioned close to the junction for a pedestrian to cross La Rue le Masurier, there is no tactile paving to indicate a crossing point across the junction mouth. The purpose of the setts here would therefore seem to be different from the other junction described.

D27 The junction of L'Avenue et Dolmen du Pré des Lumières with La Rue le Masurier (photograph taken by A Luck on 8<sup>th</sup> July 2016)

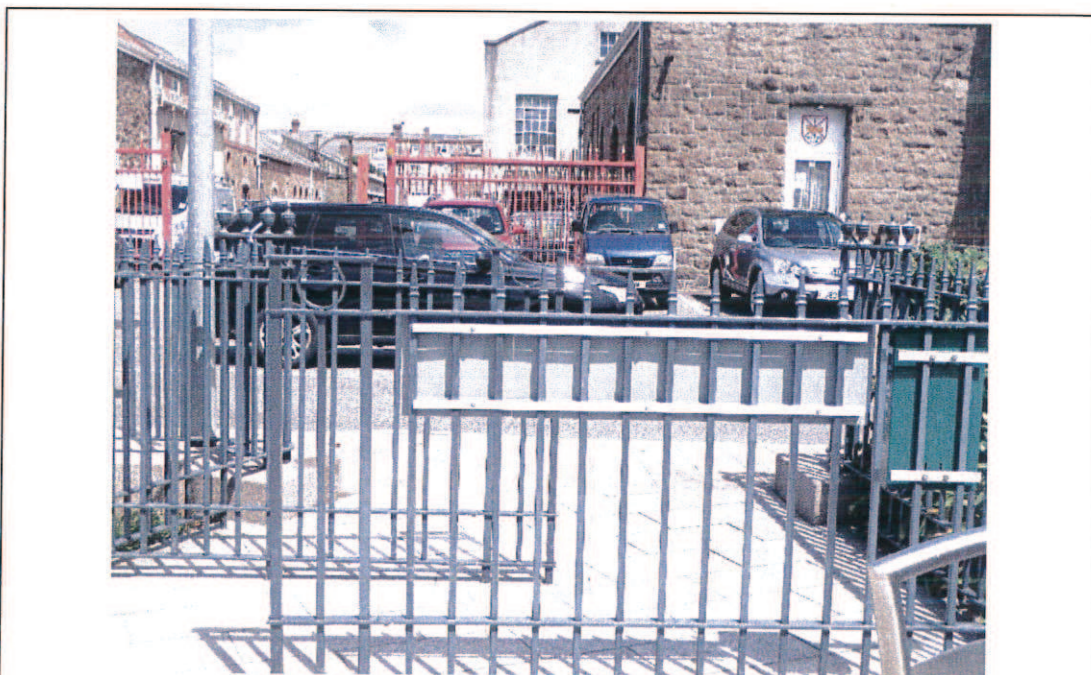
- 4.9.6 At the entrance at the eastern end of the park onto L'Avenue et Dolmen du Pré des Lumières the carriageway surface contains no setts to highlight the area<sup>(D28)</sup> but at the entrance directly opposite onto Tunnell Street, setts have again been utilised on the carriageway surface, laid at 90° to the direction of travel<sup>(D29)</sup>. In both locations the footway surface comprises paving slabs similar to those used on the cut-through from Belmont Road.

D28 The exit at the eastern end of the park onto L'Avenue et Dolmen du Pré des Lumières (photograph taken by A Luck on 8<sup>th</sup> July 2016)

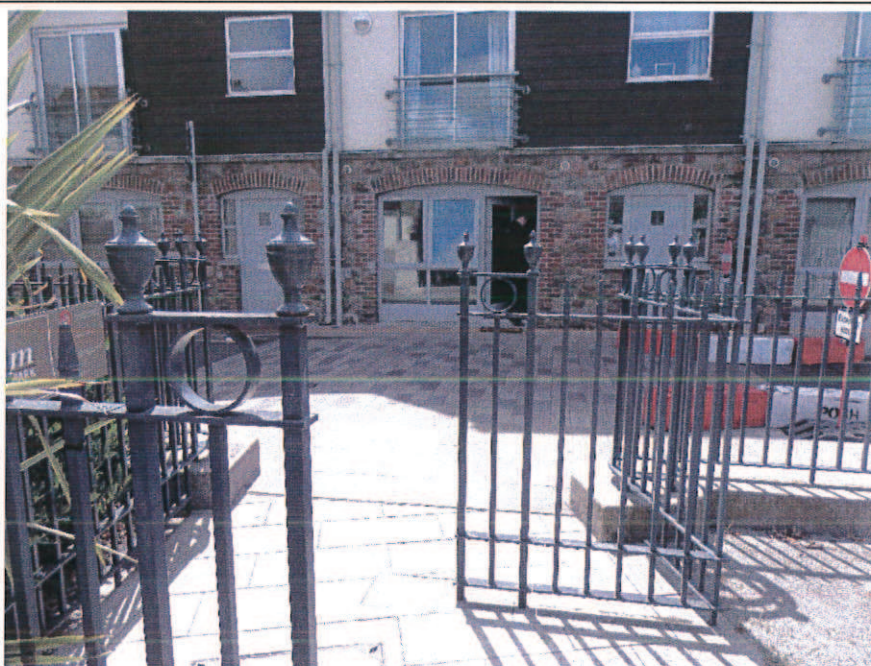
D29 The exit at the eastern end of the park onto Tunnell Street (photograph taken by A Luck on 8<sup>th</sup> July 2016)
