BATHING WATER PROFILE

Environmental Protection (EP) has produced a bathing water profile for all monitored bathing waters in Jersey. The profile summarises EP's knowledge of a bathing water, including its quality and details of any improvements aimed at providing better water quality for bathers.

Name: Beauport

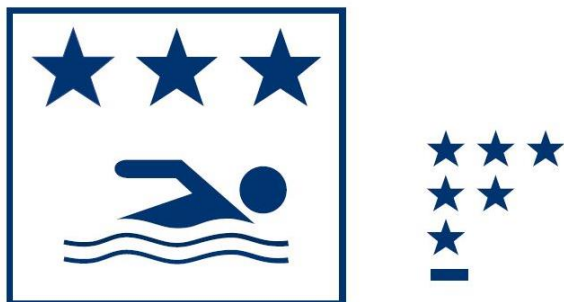
2017: Excellent bathing water quality

A classification for each bathing water is calculated annually, based on all of the samples from the previous four years. These classifications, from best to worst, are “excellent”, “good”, “sufficient” or “poor”.

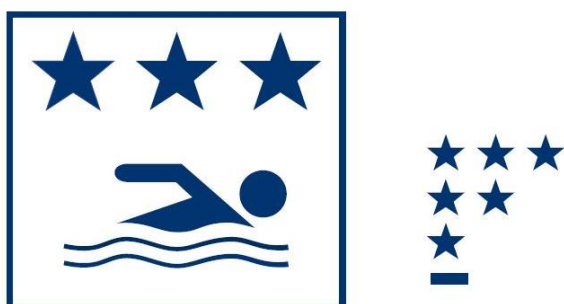
2016: Excellent bathing water quality

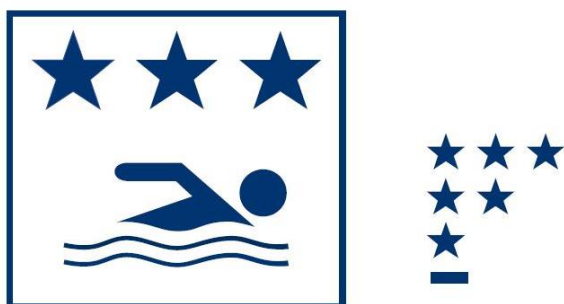
2015: Excellent bathing water quality
