BATHING WATER PROFILE

Environmental Protection (EP) has produced a bathing water profile for all monitored bathing waters in Jersey. The profile summarises EP's knowledge of a bathing water, including its quality and details of any improvements aimed at providing better water quality for bathers.

Name: Green Island

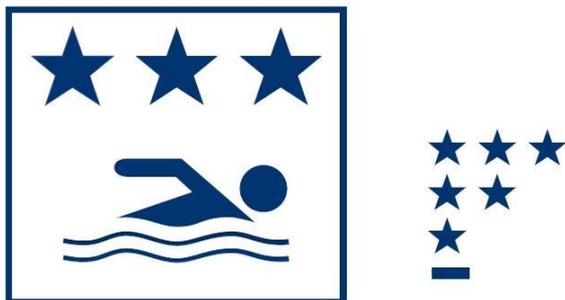
2017: Excellent bathing water quality

A classification for each bathing water is calculated annually, based on all of the samples from the previous four years. These classifications, from best to worst, are “excellent”, “good”, “sufficient” or “poor”.

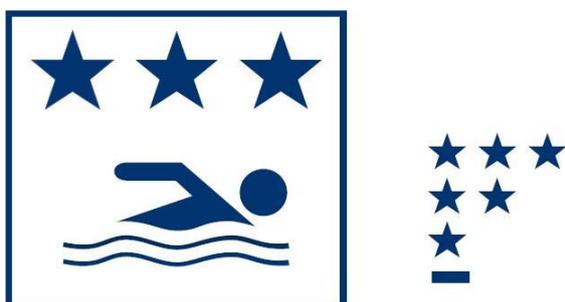
2016: Excellent bathing water quality

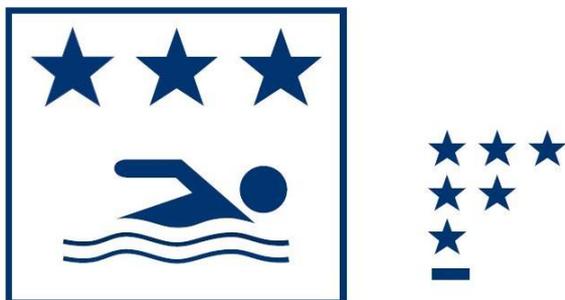
2015: Excellent bathing water quality

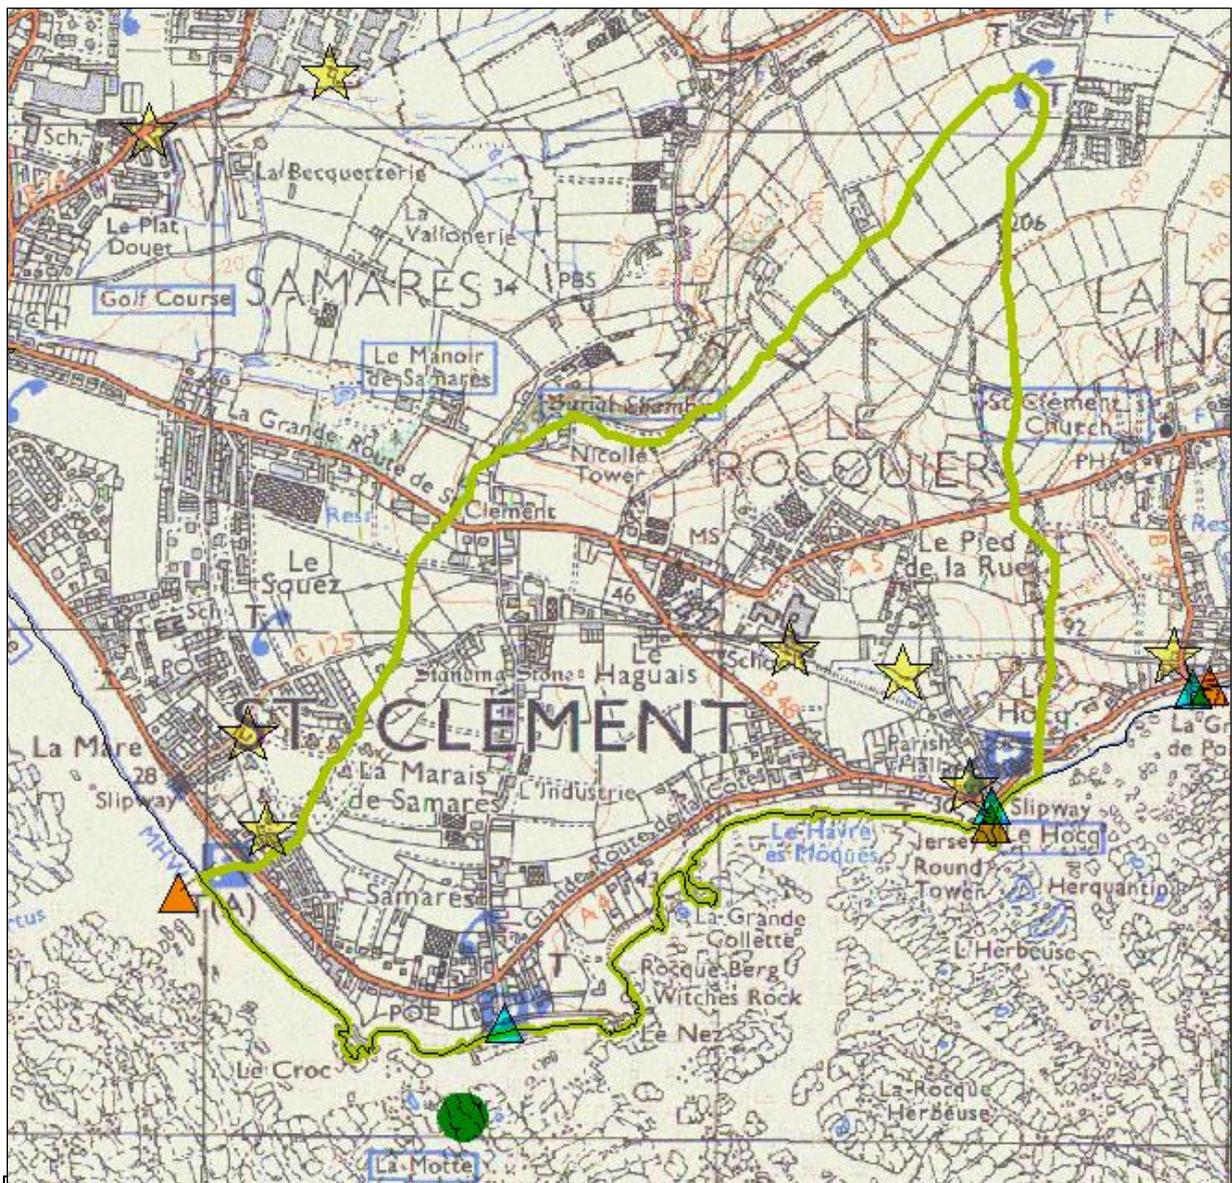
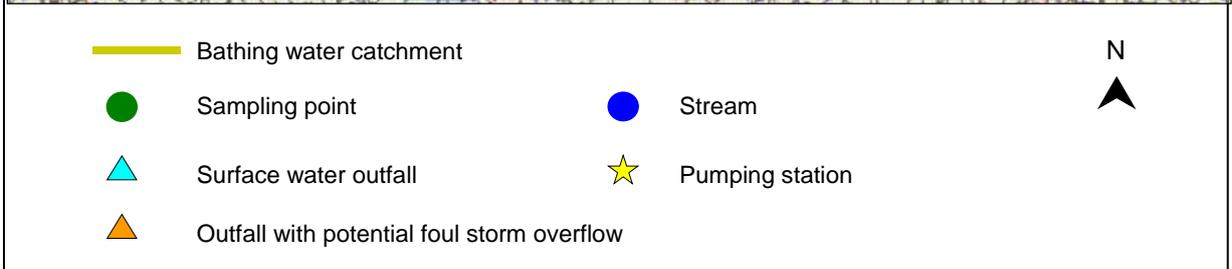
Bathing water map

The Green Island bathing water stretches approximately 2 km along the south-east coast of Jersey. The beach slopes gently, resulting in a long distance to the sea at low tide. The beach consists of sand with large areas of rock which become exposed at lower tides. The catchment is situated within a Ramsar site.

Sampling point location: Lat/Long 49.10 N 2.04 W (see map)

There is an outfall below the car park approximately 100 m east of the sampling point (see light-blue triangle on the bathing water map). There are two outfalls at Le Hocq near the eastern boundary of this catchment. There is an outfall at Greve D'Azette just outside the western boundary of this catchment, but within the Havre des Pas catchment. Any contamination entering surface water drains will discharge through outfalls onto the beach. This is most likely to occur after heavy rainfall. EP has historically monitored the water quality of the outfall near to Le Hocq slip.

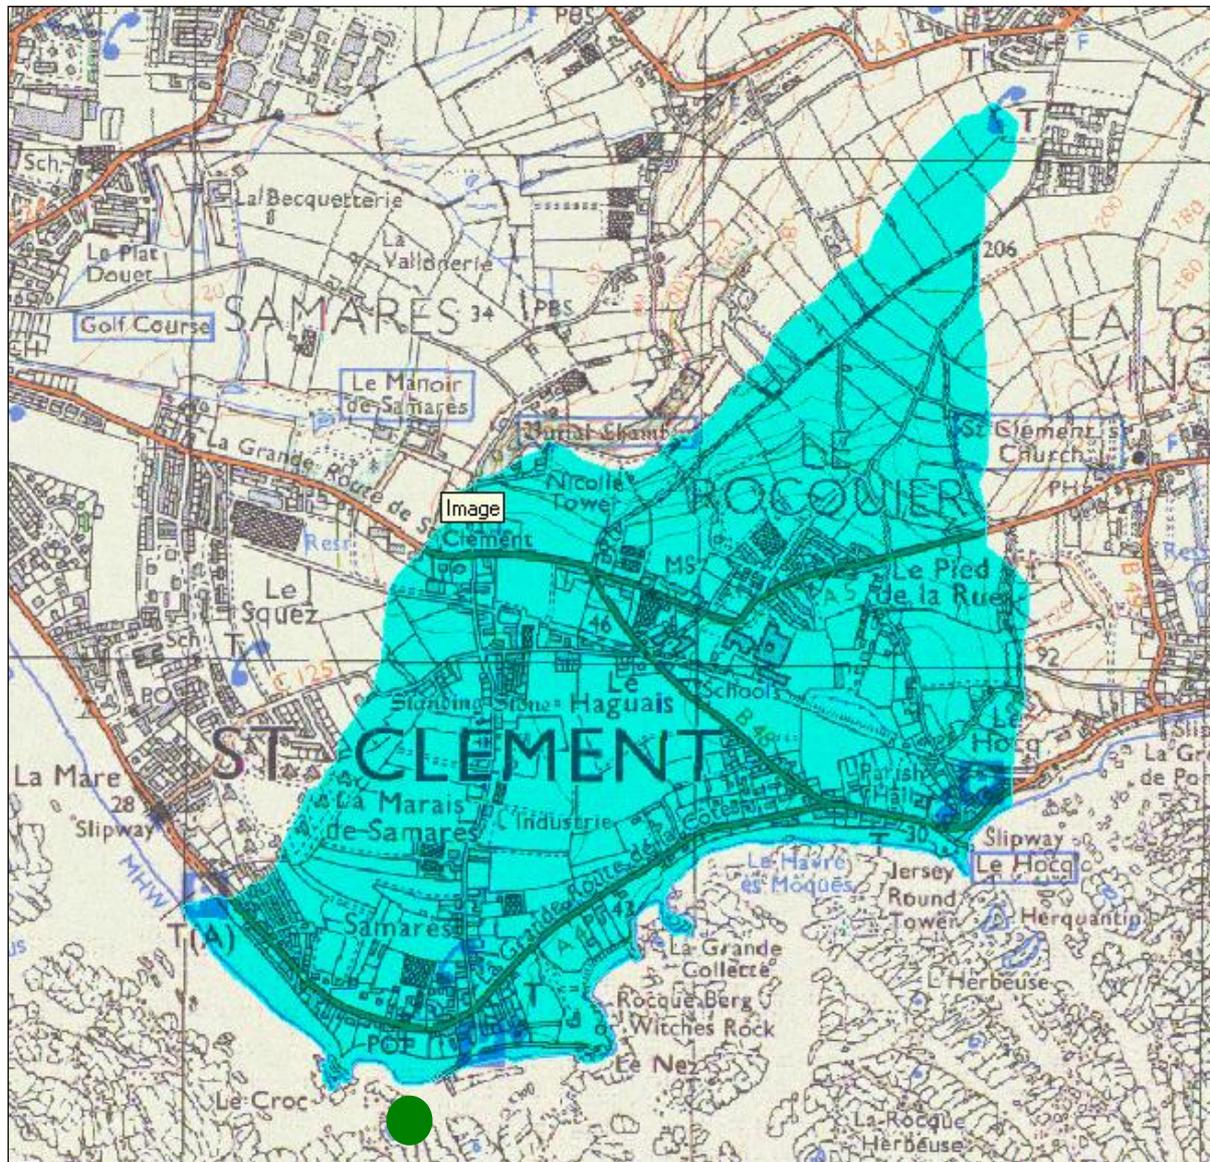
Catchment map

The natural drainage (hydrological) catchment surrounding the bathing water is approximately 150 hectares. The upper part of the catchment slopes fairly steeply whilst the lower catchment slopes more gently southwards.

Approximately half of the catchment is arable land (mainly potatoes). The remainder of the land is residential with a small amount of grassland.
