## BATHING WATER PROFILE

The bathing water profiles are a requirement of the revised Bathing Water Directive 2006/7/EC.

**Name: Grève de Lecq**

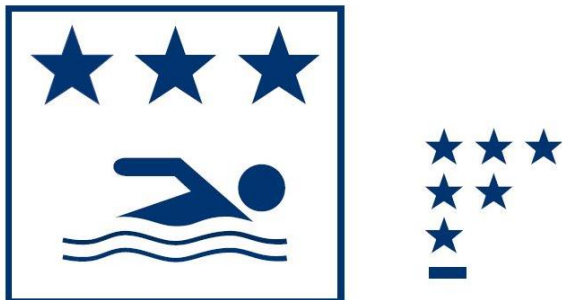
2017: Excellent bathing water quality

A classification for each bathing water is calculated annually, based on all of the samples from the previous four years. These classifications, from best to worst, are “excellent”, “good”, “sufficient” or “poor”.

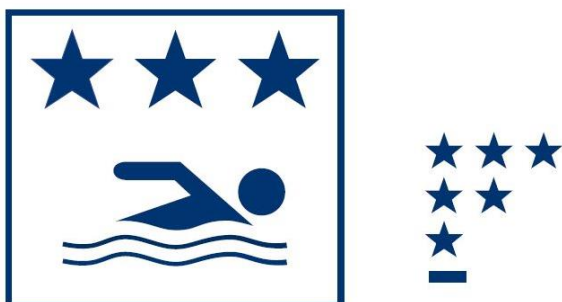
2016: Excellent bathing water quality

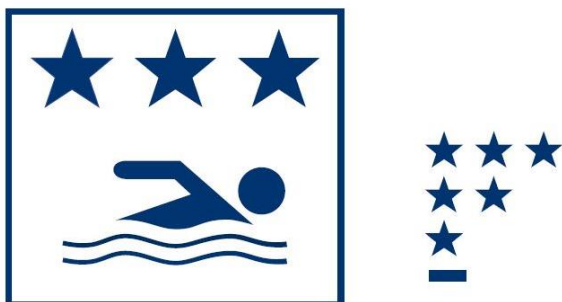
2015: Excellent bathing water quality
