**Cyril Le Marquand House, The Parade, St Helier, JE2 3QP**

**Geotechnical Investigation  
Phase II Intrusive Investigation and Risk Assessment**

**PROJECT NO: 2033**

**August 2021**

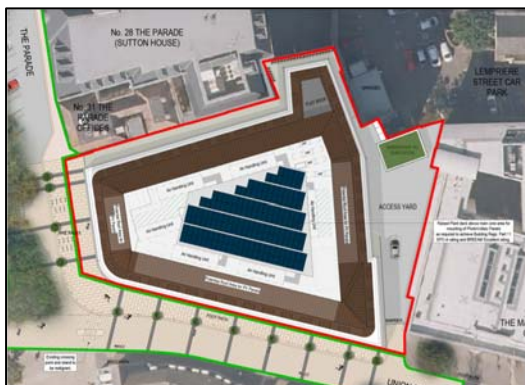
Extract from Proposed Plan (Axis Mason)

Demolish existing office building and associated podium car park structure. Construct 7 storey office building with associated landscaping and public realm improvements. 3D model available. AMEMDED PLAN REC'D.

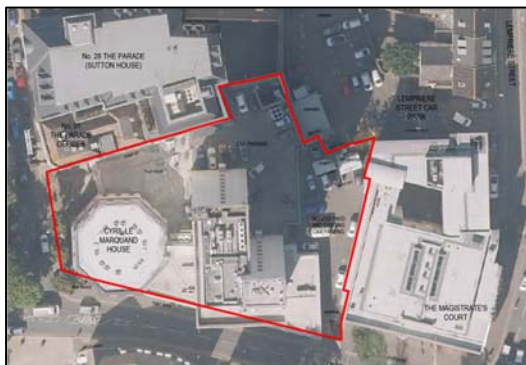
Extract Existing Site (Axis Mason)

The scope includes to demolish the existing office building and associated podium car park structure and construct a 7-storey office building.

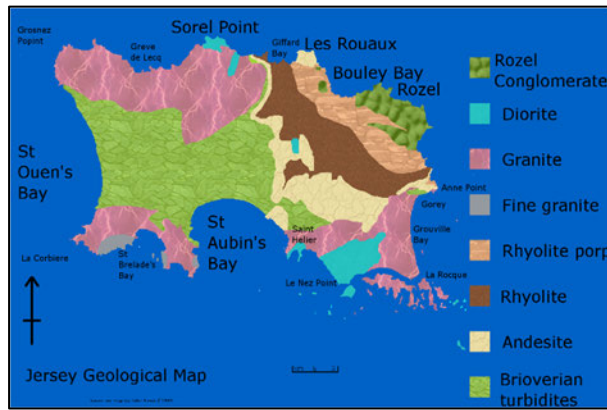
*Geology of Jersey*

The hydrogeological map of Jersey (British Geological Survey, 1992) indicates that the bedrock beneath the greater part of the area, and specifically in the Parade area, is composed of the Brioverian Jersey Shale Formation.

The greater part of the embayment is shown to be infilled with a variable thickness of Quaternary, alluvial deposits, brought in by the streams draining the upland areas to the north of the town. A strip extending some 300 metres inland from the line of the Esplanade (including the Castle Street/Esplanade site) is recorded as blown sand. Post-Glacial infilling of the embayment has taken place during a time of rising sea level and the alluvial materials extend seaward beneath the blown sands.

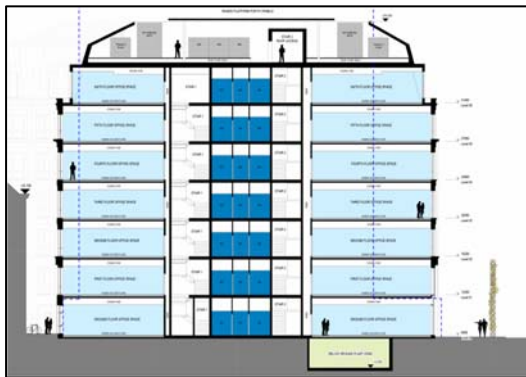
*Extract from Proposed Section A-A (Axis Mason)*

The basement slab should be designed to resist uplift pressures from any rise in groundwater or these pressures must be dissipated before they become effective. Hollow floors or a granular layer beneath the basement slab can be used to collect groundwater but then permanent pumping from sumps will be required to prevent the build-up of water pressure.

The final design of the basement slab will consider the groundwater pressure. There is much merit in considering the problem of groundwater in conjunction with the basement excavation support system and optimising the retention and cut-off characteristics.

In any event, the basement slab should be capable of resisting the larger of the heave pressure or the bearing pressure. If the foundation piles are utilised as anchor piles, heave will be much reduced, but the basement slab will have to be designed to resist the bearing, groundwater, and heave pressures. Alternatively, temporary anchors can be installed to cope with uplift forces during construction.

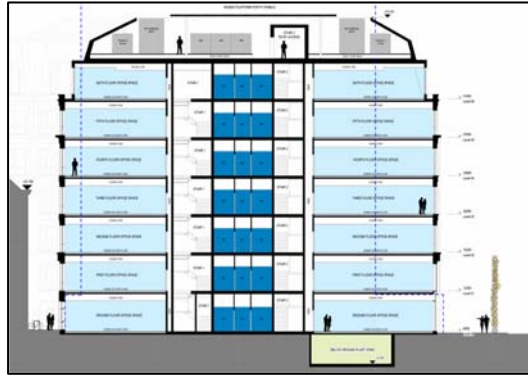
Extract from Proposed Section A-A (Axis Mason)

Careful consideration must be given to the effect of the basement excavation on neighbouring properties, roads, and services.

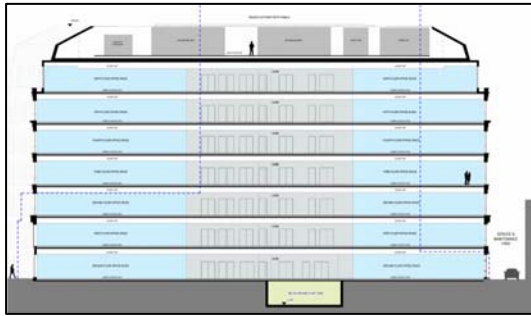
Extract Proposed Section B-B (Axis Mason)

The level of ground water is likely to not vary much across entire site due to change in geology and topography but may vary through seasonal variation from changes in precipitation.

The most recent water level reading that have been taken at the site since the fieldwork was carried out is 1.31m bgl in BH3. These levels may vary according to season.
