## BATHING WATER PROFILE

**Name: Bouley Bay**

Last update: May 2018

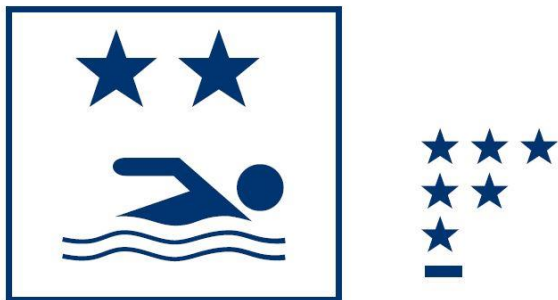
2017: Good bathing water quality

A classification for each bathing water is calculated annually, based on all of the samples from the previous four years. These classifications, from best to worst, are “excellent”, “good”, “sufficient” or “poor”.

Classification	Thresholds	Confidence level
Excellent	EC: $\leq 250$ cfu/100ml; IE: $\leq 100$ cfu/100ml	95 <sup>th</sup> percentile
Good	EC: $\leq 500$ cfu/100ml; IE: $\leq 200$ cfu/100ml	95 <sup>th</sup> percentile
Sufficient	EC: $\leq 500$ cfu/100ml; IE: $\leq 185$ cfu/100ml	90 <sup>th</sup> percentile
Poor	Values are worse than sufficient

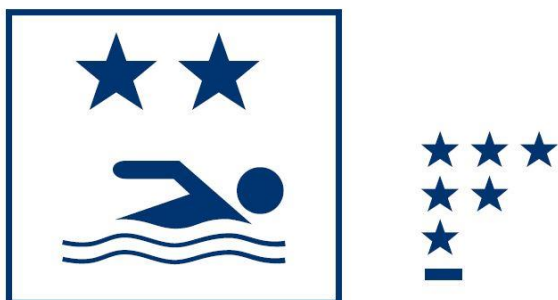
2016: Good bathing water quality

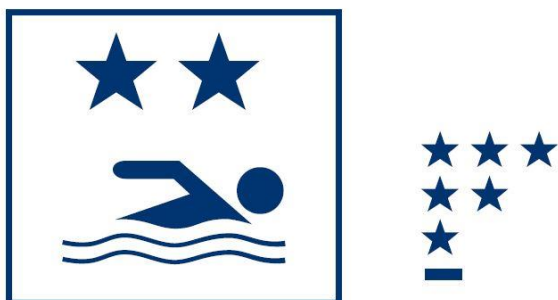
2015: Good bathing water quality
