A Report on a Ploughing Trial at St Aubin's Bay

Department of the Environment

- July 2017 -

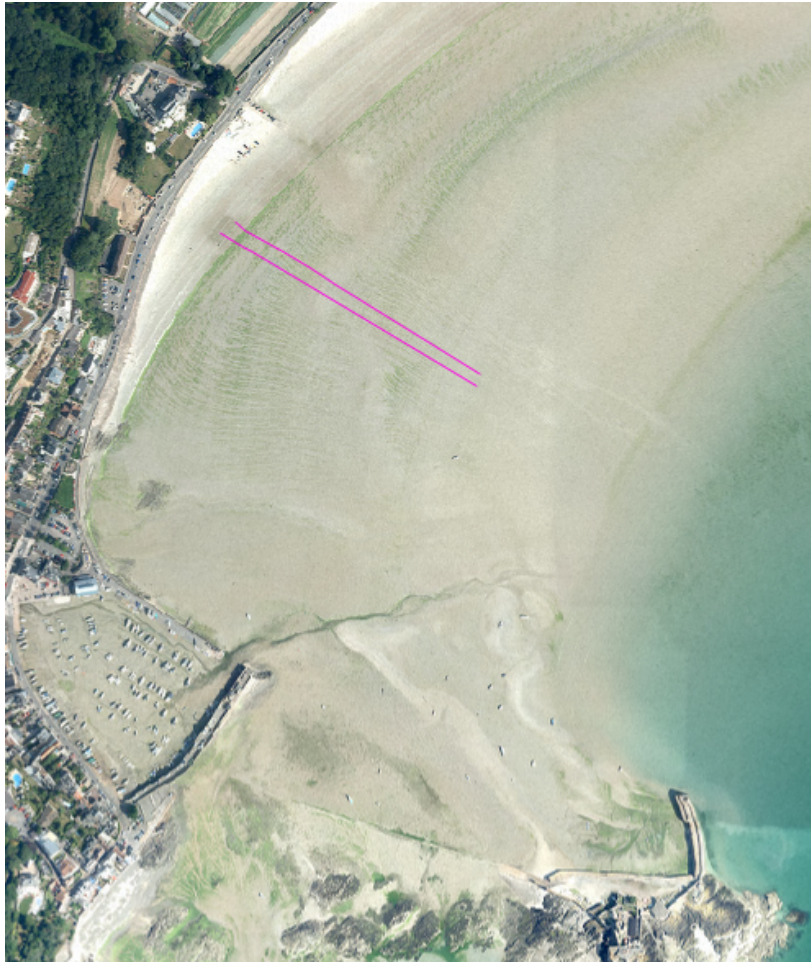
The exact position of the two furrows on an aerial photo, as plotted using a GPS unit.

Ploughing commenced at circa 16:37 and finished at circa 17:38. In this time two furrows were created which were 305 and 316 metres long and which started approximately 8.5 metres above chart datum (Mean High Water Neap) and terminated at 4.5 metres above chart datum (just above Mean Low Water Neap). The furrows were an average of 15.65 metres apart and were approximately 2.3 metres wide (80cm of this was the furrow, the rest was sediment splay).

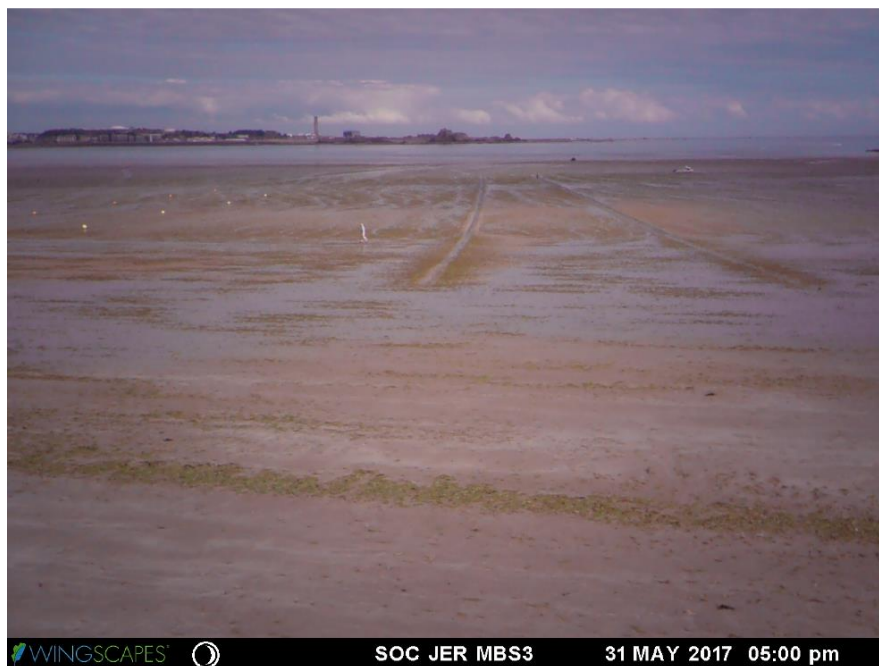
"1. At the top of the furrow where there was a steeper gradient, the mounds either side of the channel had almost completely dissipated and the channel itself was close to returning to the level of the surrounding beach (*circa* 3cm depth);

2. Where the gradient decreased and became relatively constant down to the low water mark the mounds remained intact in a relatively uniform state;

3. The mounds themselves were very compact, free draining and structurally quite sturdy (easily supporting my weight when walking on them as evidenced by the footprints on the photos);

4. In contrast to this, the sand filling the channel is saturated with water and very loose. Due to the high levels of interstitial water between the loose grains, the amount of sand required to refill the channel is (most likely significantly) less than the volume of sand removed from it. As a consequence, the depth of the lower gradient channels only ranged from between *circa* 3 cm to 10 cm in depth against the surrounding beach level, while the height of the mounds remained at 10 cm to 15 cm.

Day Two (24 hours)

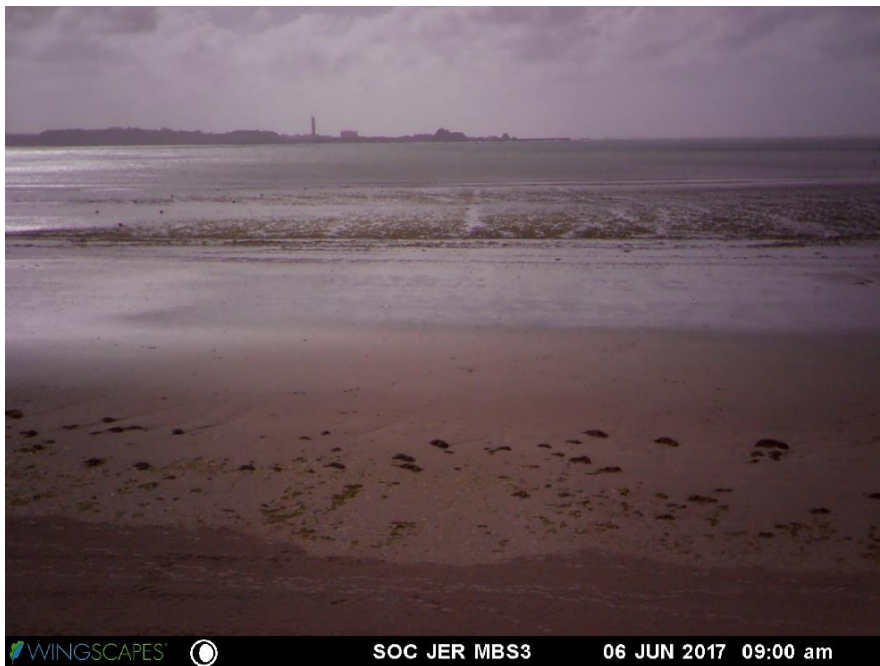
In the days that followed the furrows continued to infill and the side mounds levelled off until by 6 June (following stormy weather) the beach had become level. On 7 June the furrows could not be seen at all.

Day Eight
