La Collette Phase 3B Reclamation Site

Cell 30 Construction Works

Construction Quality Assurance Report

November 2013

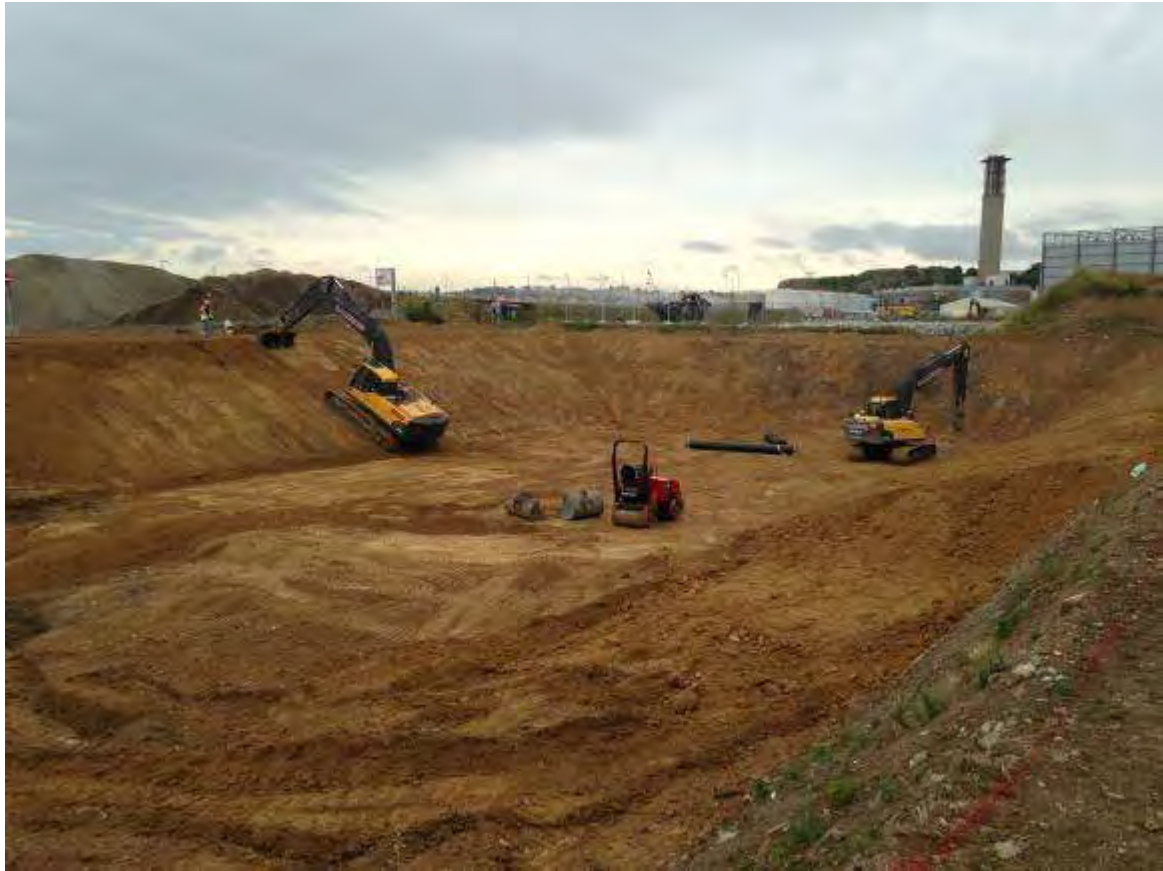
Plate 1

Plate No.	Description
1	Cell 30 Formation Works.
2	Placing Geogrid Above the Formation Layer.
3	Placing Sand Protection Layer Above Geogrid.
4	Sand Protection Layer.
5	Placing GCL Above Sand Protection Layer.
6	Placed LLDPE Geomembrane.
7	Geotextile and LLDPE Geomembrane Secured in Anchor Trench.
8	Placed Geotextile Within Cell.
9	Placing Drainage Stone Above Geocomposite in Base of Cell.
10	View of Completed Cell.

3.1.1 Whilst compaction and fill material conformance during the earthworks portion of the Cell 30 Construction works was the responsibility of A.A Langois, the CQA Inspector has a watching brief between 3rd June and the 18th June. During this exercise the final formation surface was observed to be sufficiently firm and free from oversize particles and any objects that could cause damage to the overlying layers. (Reference: Appendix 8, PLATE 1 – Cell 30 Formation Works).
