Report on the investigation of  
two accidents during berthing and unberthing  
of

***Logos II***

St Helier, Jersey

**Report No 1/2008  
January 2008**

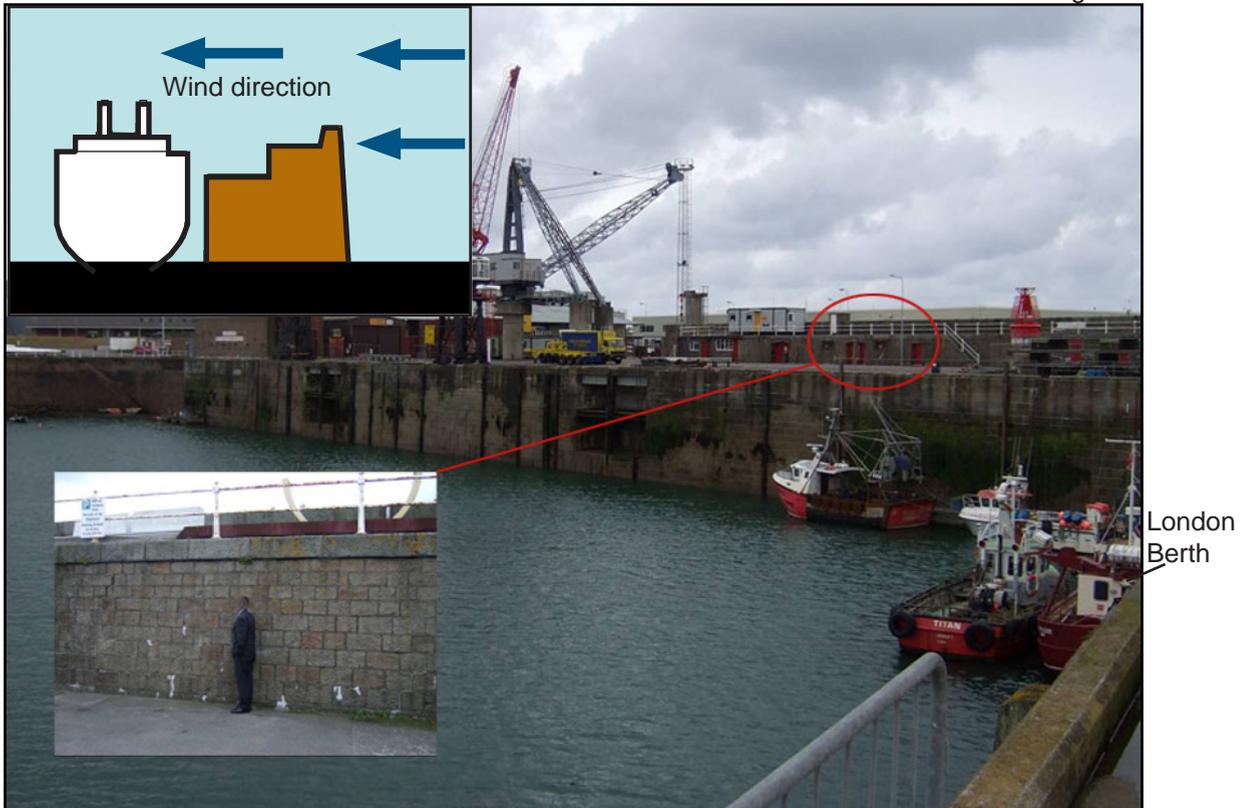
Figure 2

Victoria Pier

Before *Ronez* sailed, the DHM called the port control to arrange for three small boats moored on the western cross pontoon on Victoria Pier (**Figure 2**) to be moved by the duty officer, as he considered that they could potentially hinder the berthing of *Logos II*. Two other small boats moored alongside each other at the south end of London Berth (**Figure 3**) were not considered to be at risk. Using the VHF radio, the DHM also provided a briefing to the skippers of the tugs *Titan* and *Marineco Toomai* on his intended berthing plan.

The inner harbour of St Helier is entered through Albert Pier head and Victoria Pier head (**Figure 1**). On entering the inner harbour, Victoria Pier is located to the south. It is 135 metres in length and is used mainly for general cargo operations and the discharge of cement. The largest ship to use this berth was *Logos II*, in September 2005, although it is occasionally used by vessels of up to 90 metres LOA. A small fixed floating pontoon used by small boats is sited at the western end of the pier. The unusually high harbour walls (**Figure 2**) provide good shelter from strong winds, particularly from the south.

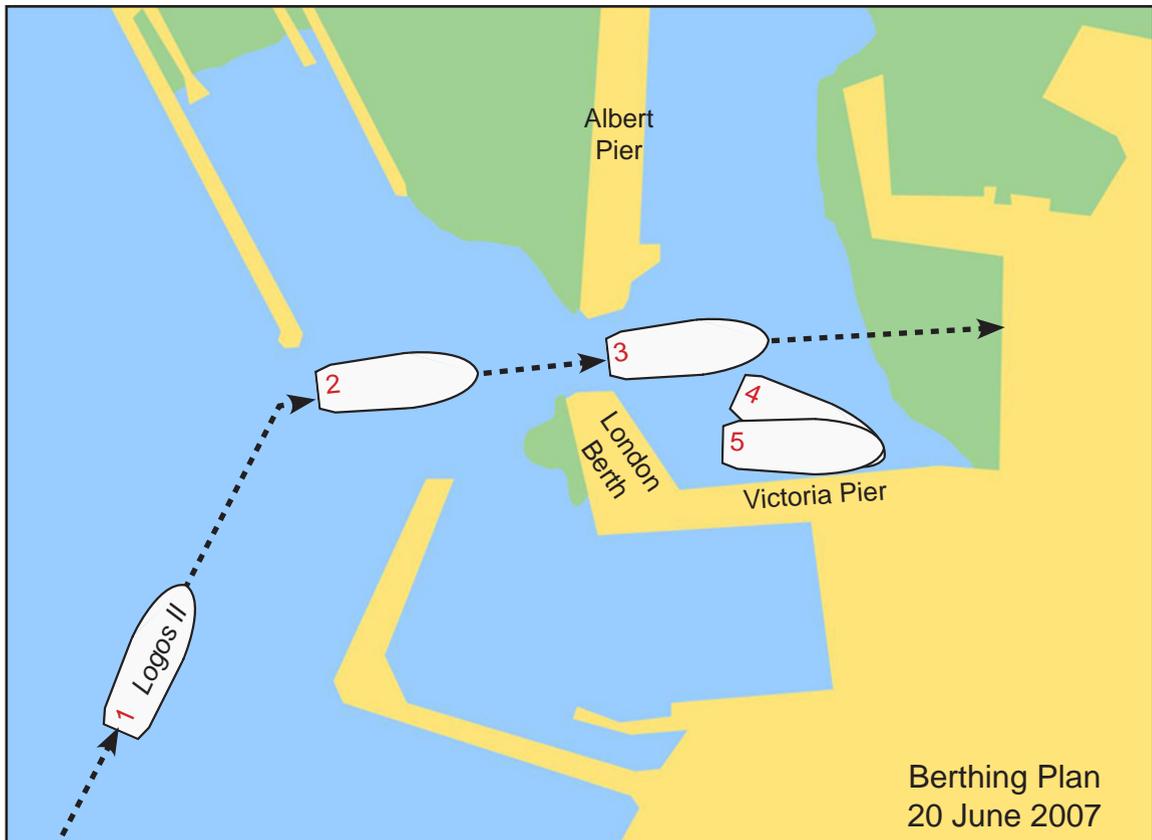
Figure 3

Diagram of the berthing plan of *Logos II*

The master and pilot then exchanged information. The master gave the DHM a pilot card (**Annex A**) and advised him that *Logos II* had two inward turning controllable pitch propellers with a single rudder amidships. The master also highlighted that the vessel's stern was easily influenced by the wind. The DHM then briefed the master that the vessel would enter and stop in the inner harbour where she would be met by *Titan* and *Marineco Toomai*. The intention was to position *Marineco Toomai* on the port quarter to hold the stern up against the fresh southerly breeze, and for *Titan* to push the bow towards the quay. Once sufficient lines were made fast forward, the stern would be pushed in with the assistance of the tug aft (**Figure 3**).

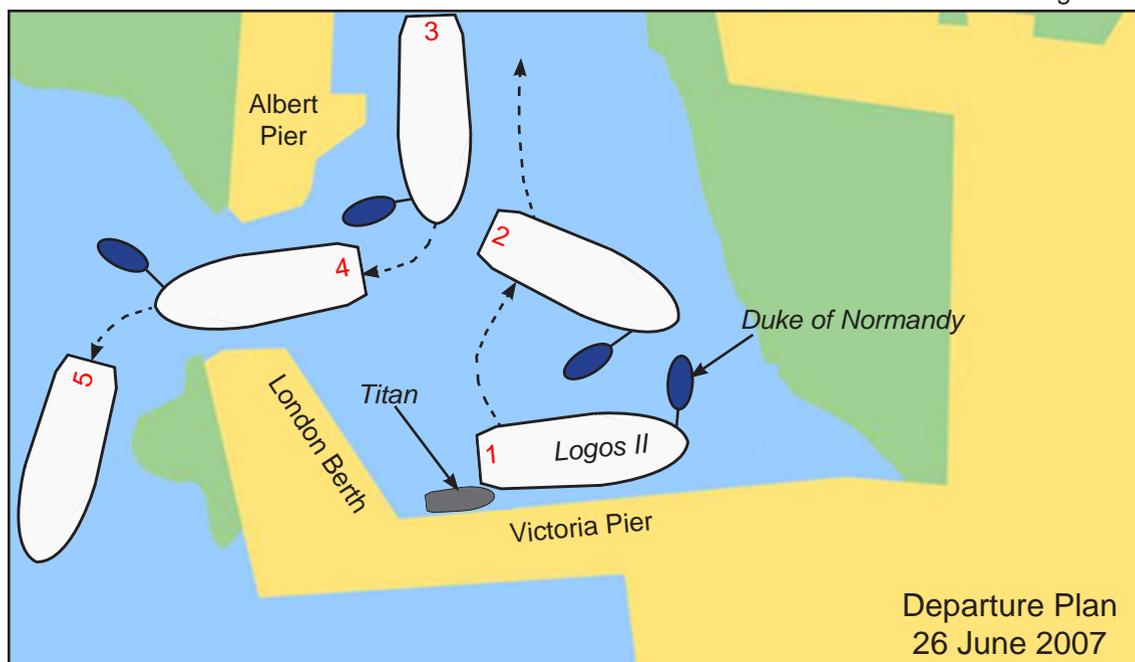
Figure 10

Diagram of the departure plan of *Logos II*

The advancement of the time of departure in view of the height of tide and forecast wind conditions indicated the departure was well considered by the pilot. Indeed, the intended plan (**Figure 10**) worked well until the vessel approached the gap between the pier heads. Given the difficulty experienced by the AHM to turn *Logos II* away from Victoria Pier head, which was probably due to the poor manoeuvring characteristics of the vessel, his instruction to *Duke of Normandy* to pull the bow to the north was logical. It was unfortunate that the tow line parted as the tug attempted to manoeuvre on to the starboard bow of *Logos II*.
