PRELIMINARY RISK ASSESSMENT

REPORT NO. 14502

Plémont Bay Holiday Village,

Jersey

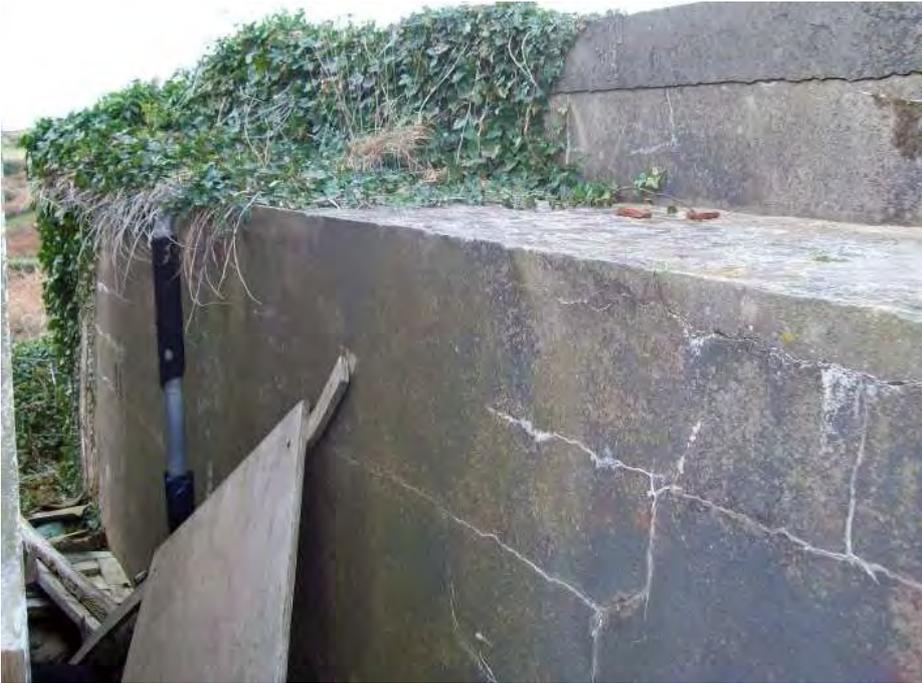
To the south of the tennis court there is the water treatment tank. This consists of a large rectangular concrete structure, which extends approximately 1.2m above ground.

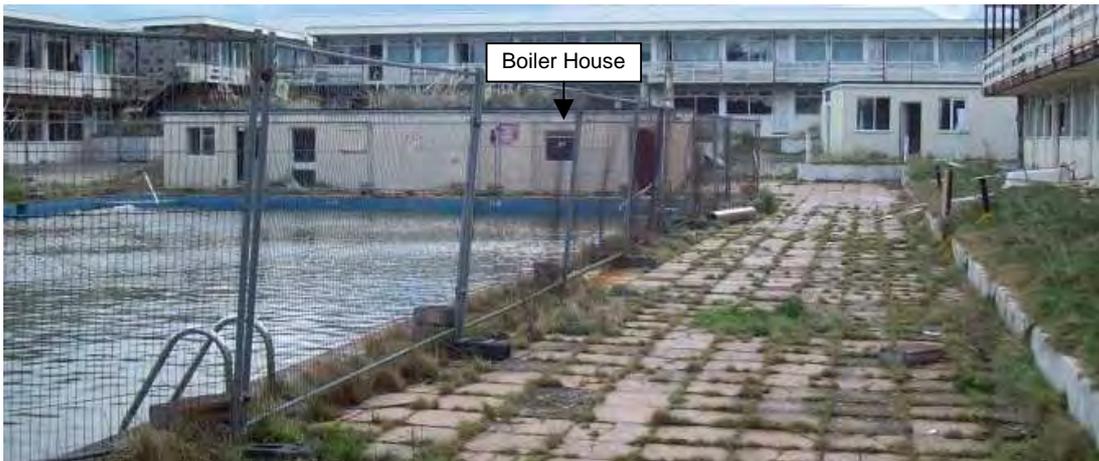
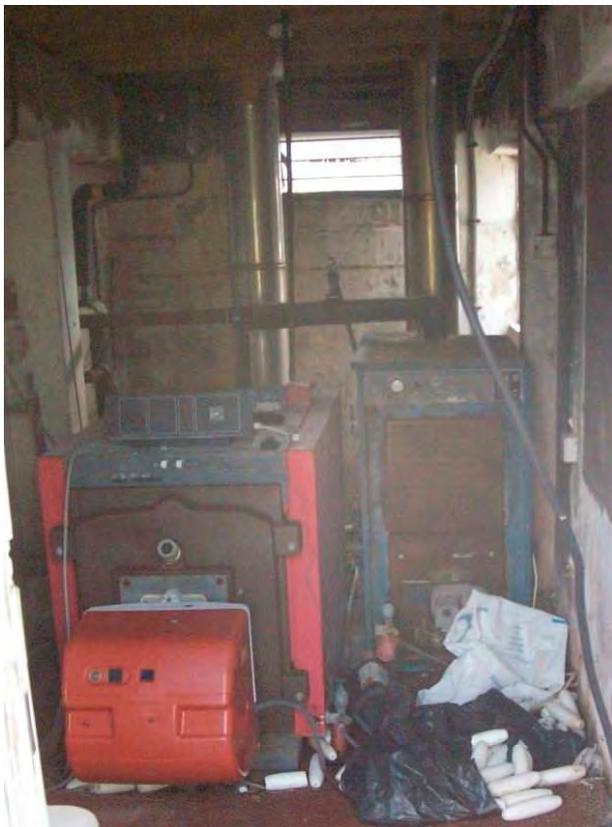
The boilers are located at the south end of the building. These are then connected to the chlorine tank (in yellow) which will in turn pump into the pool.

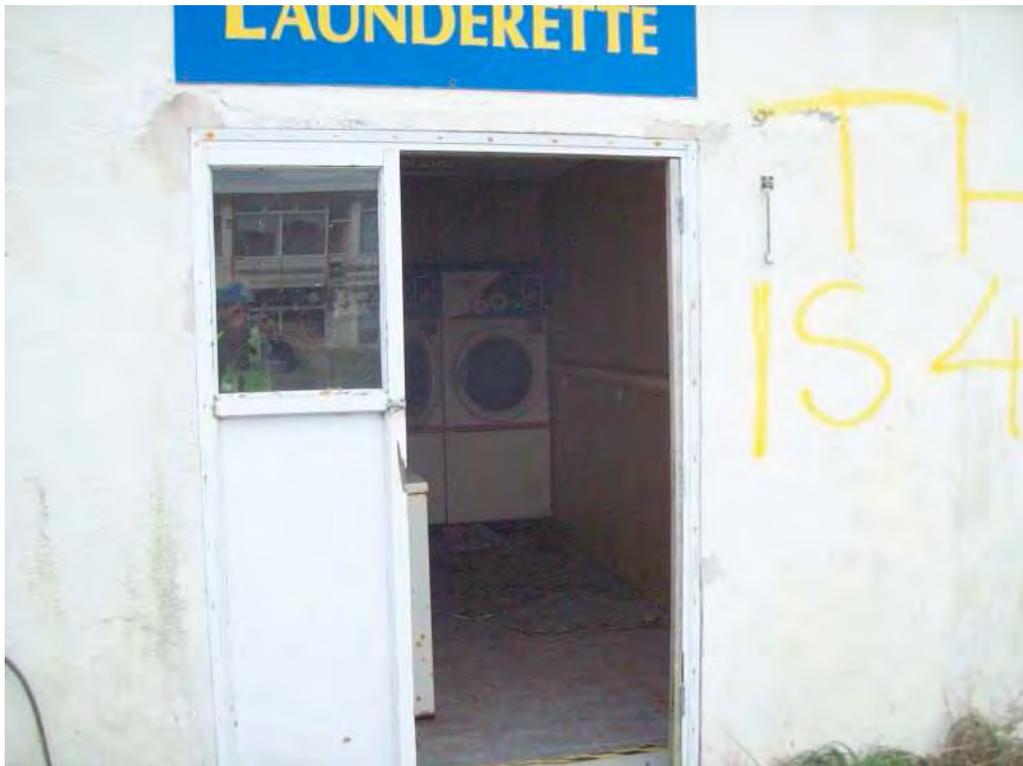
To the SE of the swimming pool and boiler house there is the site electrical substation, which is still in use. It is understood that this still feeds the manager's bungalow to the east of the site. On the otherside of the sub-station is the Laundrette.

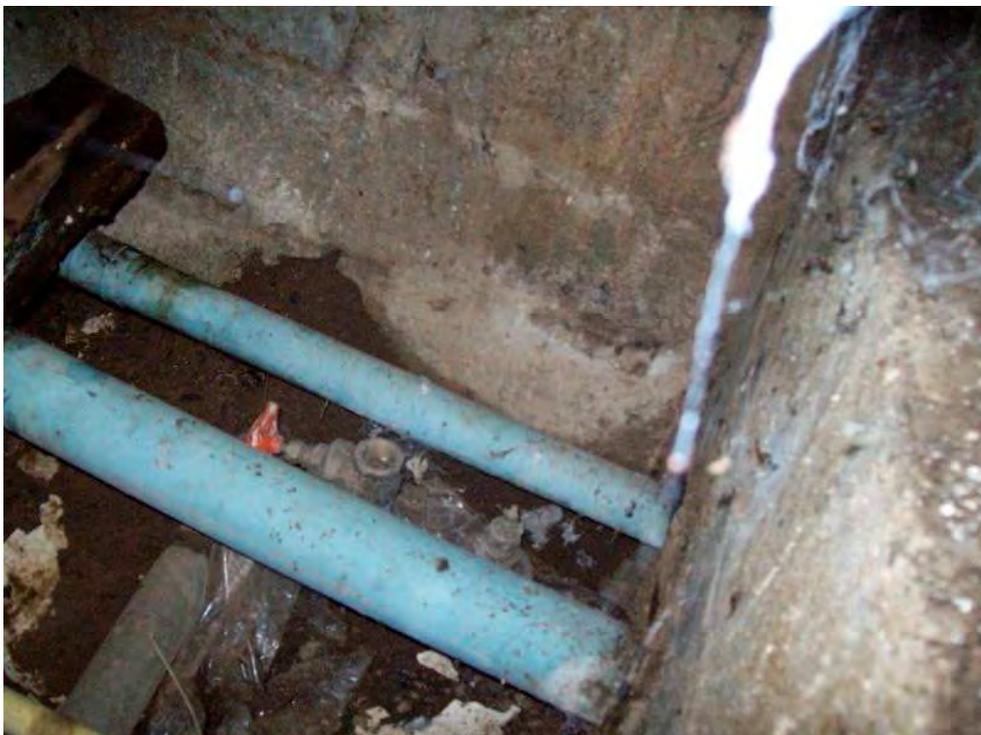
To the east of the sub-station there is wood(rotten) /felt covered service trench. The trench is breeze block lined. It was most likely covered by something more durable when the camp was still working. Permanent access to the pipework must have been needed within this area.

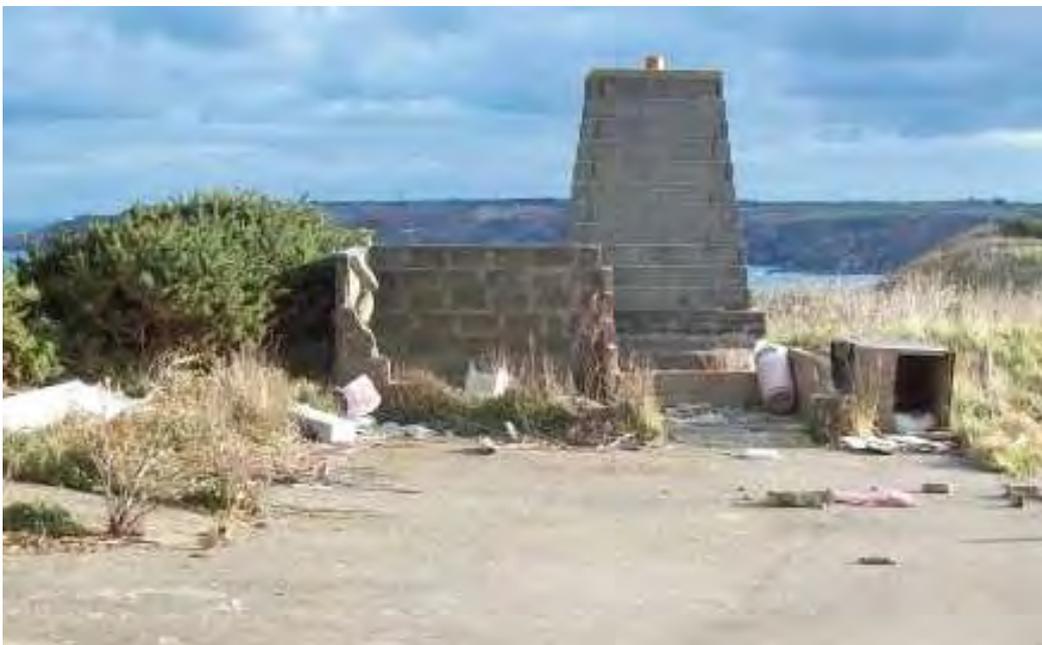
Adjacent to the store building is the remnants of a World War 2 bunker. A breezeblock structure has been built on top.

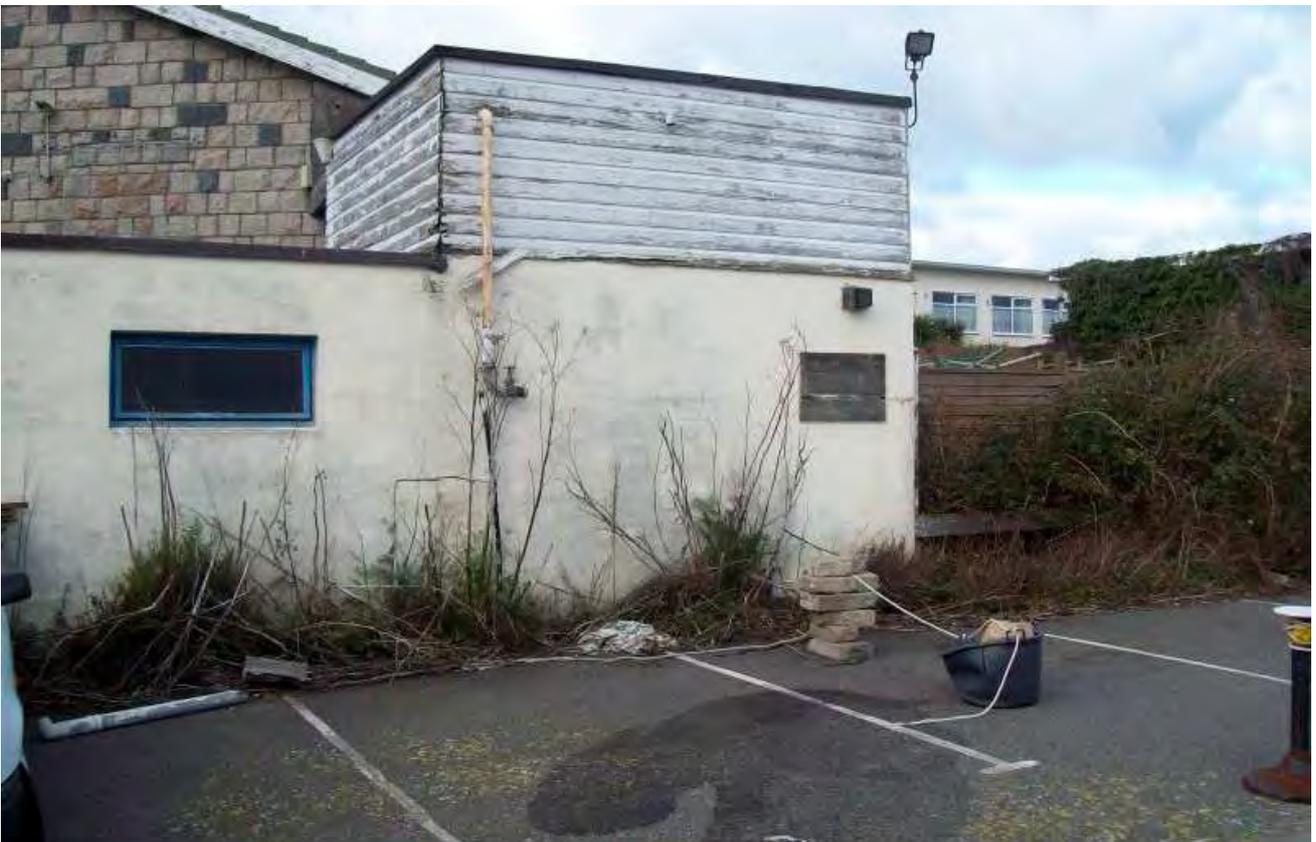
There is a small outhouse to the SW of the house. It appears that header water tank sits on top of one side of the outhouse.
