**Growth, Housing
and Environment**

Minibuses & Large Passenger Carrying Vehicles Inspection Manual

Driver and
Vehicle Standards

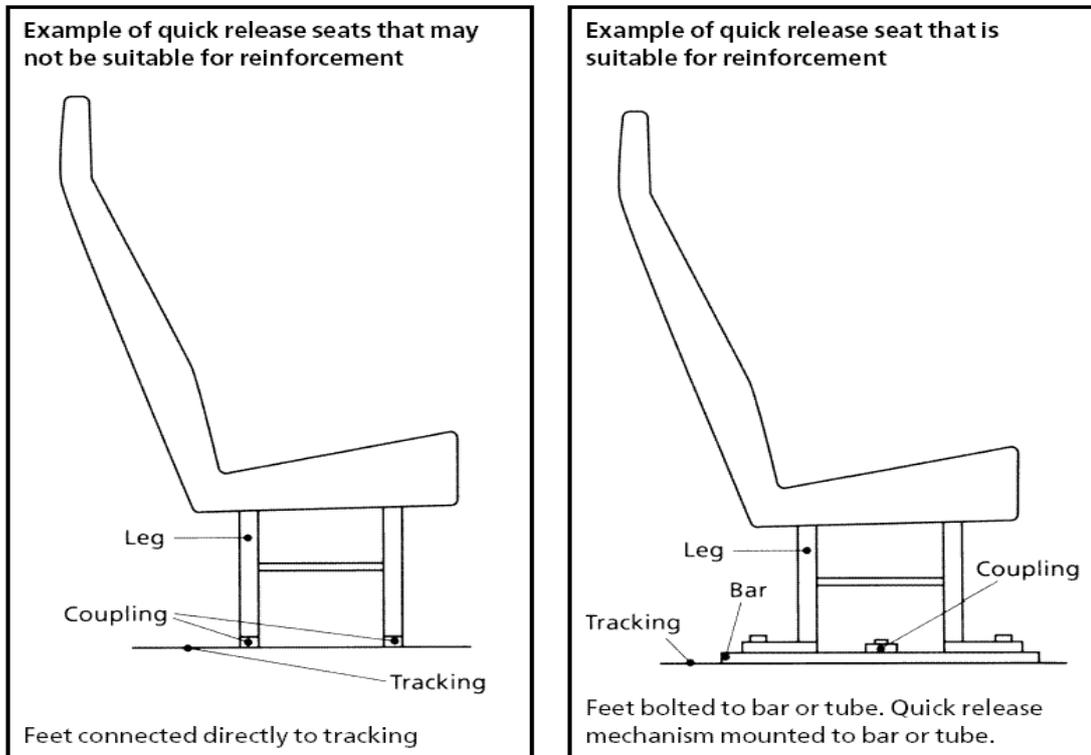
Diagram 7 – Quick release seat examples

The coupling would prevent any reinforcement being placed in an effective position; also the coupling could be damaged if welding occurred close to it. On this type of installation the belts can be attached directly to the tracking with quick release mounts or the legs should be modified to use an alternative method of attachment to the tracking.

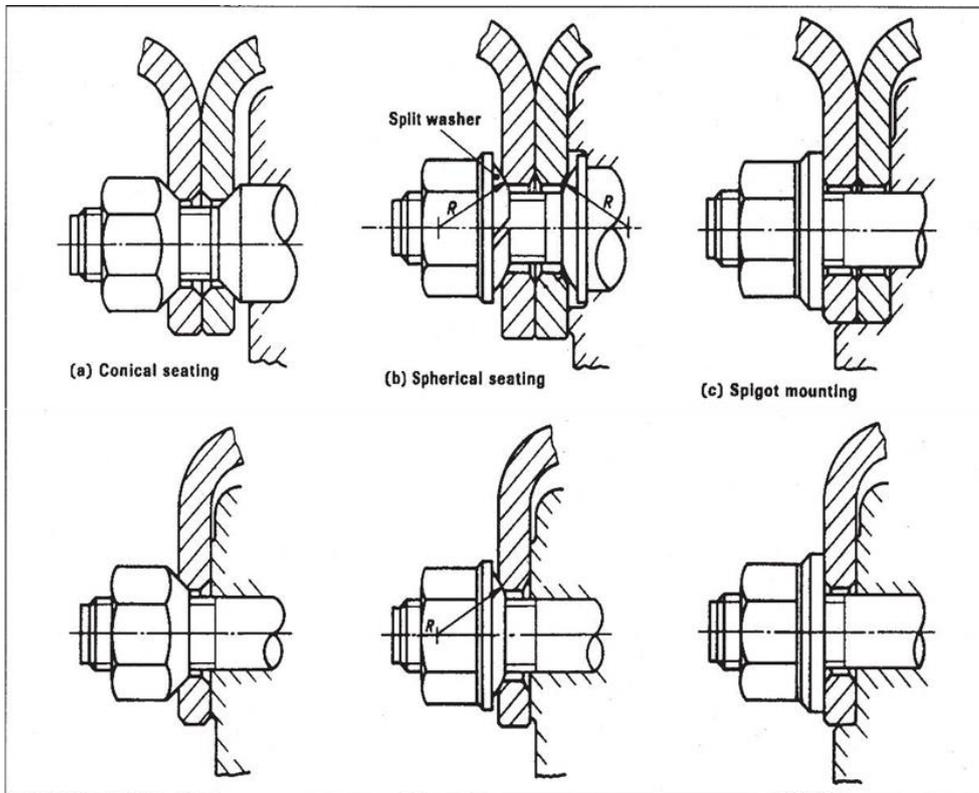
Compatibility of Wheel Fixings

Vehicles with conical wheel fixings **MUST NOT** be fitted with wheels from vehicles designed for use with spherical fixings. (British built vehicles normally have conical wheel fixings).

Vehicles with spherical wheel fixings **MUST NOT** be fitted with wheels from vehicles which are designed for use with conical fixings.

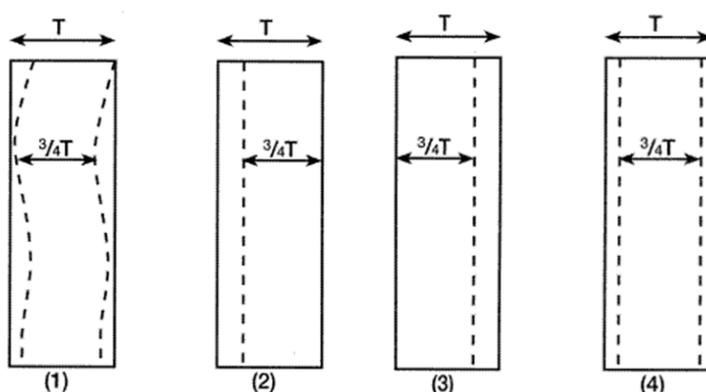
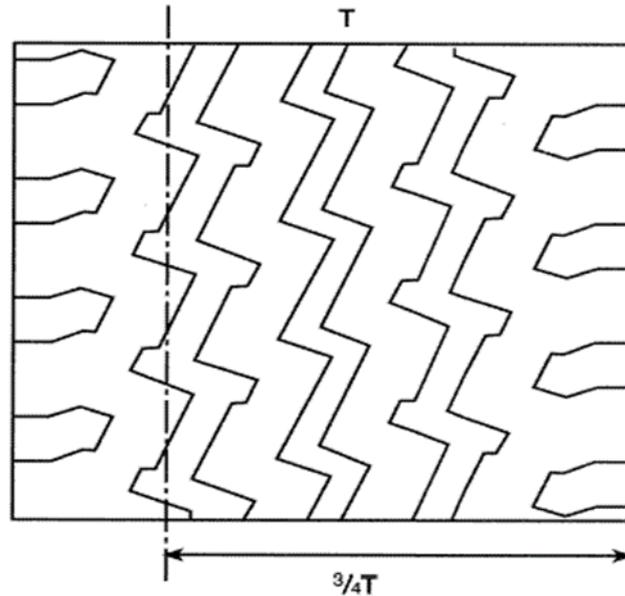
Figures (1), (2), (3) and (4)

T = Breadth of Tread $\frac{3}{4}$ T = Minimum width of continuous band.

In this case the lateral grooves are the same depth as the circumferential groove and are included in the $\frac{3}{4}$ measurement

The breadth of the tread is 'T' The $\frac{3}{4}$ of 'T' measurement can be taken over 'T' as in figure 1 to 4

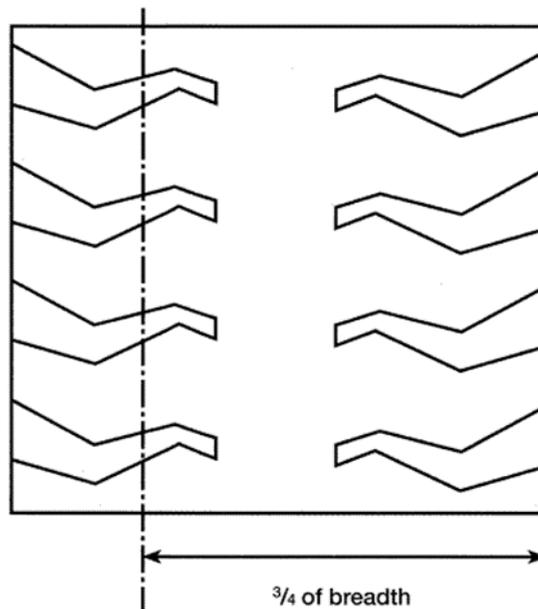
Fig 6

This tyre only has lateral grooving

The band of acceptable tread pattern includes the plain portion which existed when the tyre wall was new. The remaining tread area should contain grooves to the depth of 1 mm.

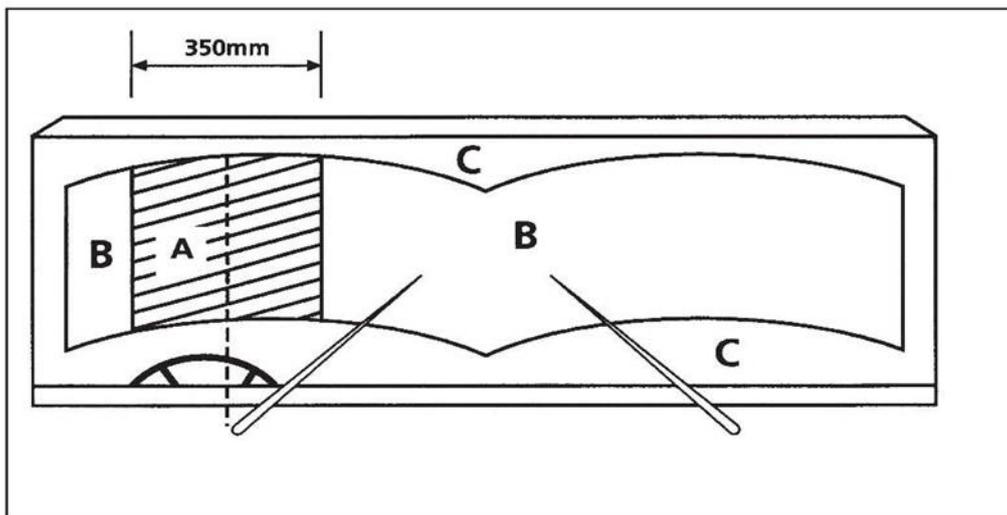
Windscreen

Zone "C" is the remainder of the screen outside the sweep of the wipers.

When checking the windscreen refer to the diagram below.

Examiners should have regard for the three separate "zones" when assessing damage or discolouration. A greater amount of damage or discolouration could be accepted in zone "C" than in zone "B". Likewise a greater amount can be accepted in zone "B" than in zone "A" where relatively minor damage may be a deficiency.

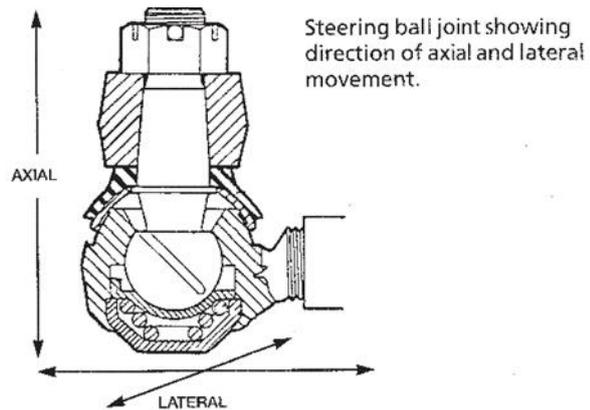
Visually check for axial and lateral movement of all ball joints. Where a ball joint is fitted with a spring to take up such movement, the compression of the spring must not be mistaken for excessive wear. If excessive wear is suspected check by using hand pressure.

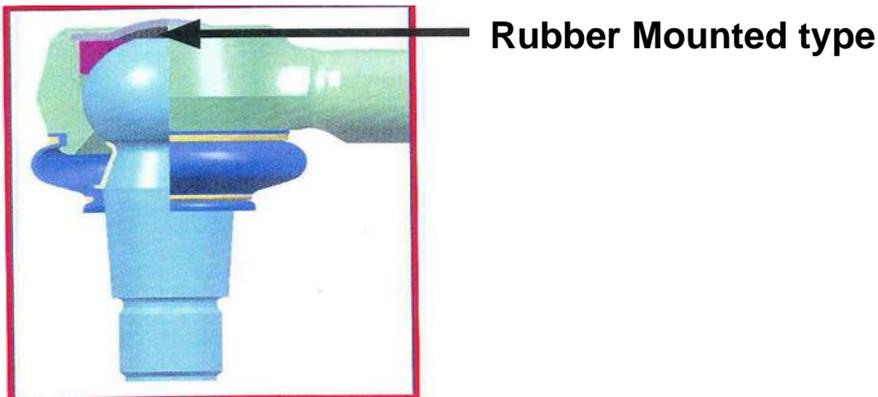
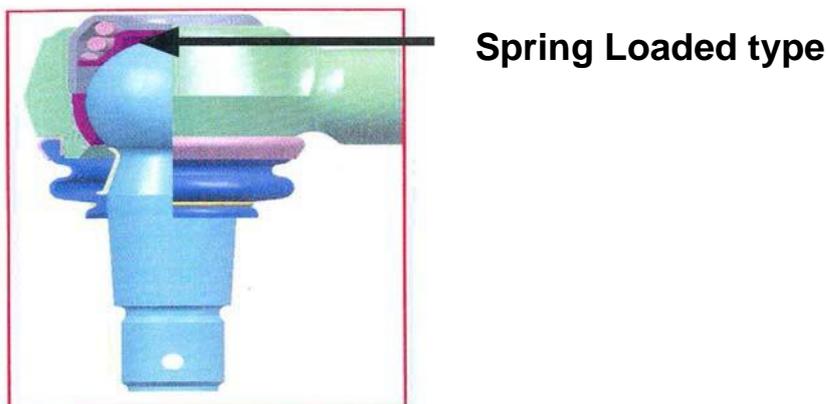
An increasing number of vehicles are now fitted with different types of ball joint, spring loaded or rubber mounted type each having different wear limits (some vehicle may be fitted with both types of joint). The rubber mounted type has a smaller wear limit than the spring loaded type.

Manufacturers with conventional ball joints have stated that axial movement up to 2mm is acceptable

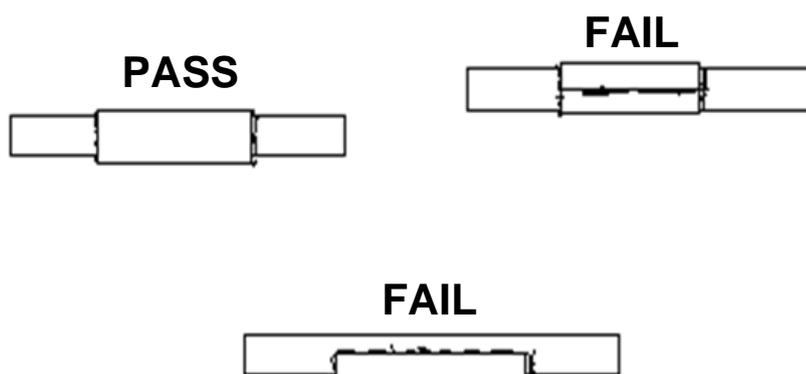
Repairs to metal air brake pipes by sleeving are acceptable, providing the repair appears to be good and sound. A pipe repaired in-situ by brazing is not considered acceptable. Repairs to hydraulic brake pipes are not acceptable. Compression joints of the type using separate ferrules are not considered suitable for joints on hydraulic pressure lines.

Guidance on sleeved repairs of metal brake pipes (sleeving is not acceptable on plastic brake pipes)

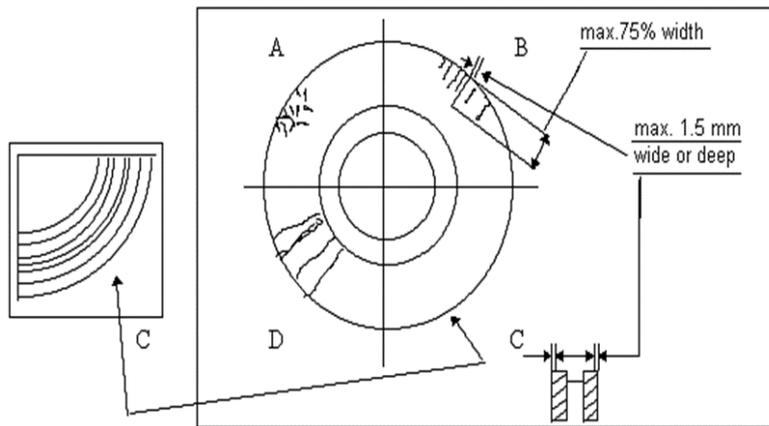
Disc Brakes

The diagram to the left shows the types of damage which are likely to be found on brake discs and gives guidance on how much damage is acceptable before refusing the vehicle. This should be a visual assessment

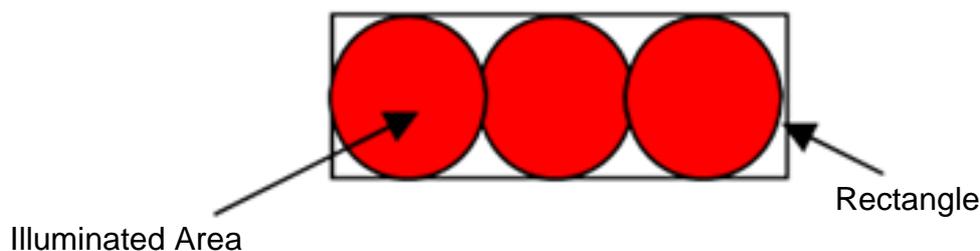
If two or more lamps are fitted and the aggregated illuminated area occupies 60% or more of the area of the smallest rectangle circumscribing the illuminated area this should be treated as one lamp

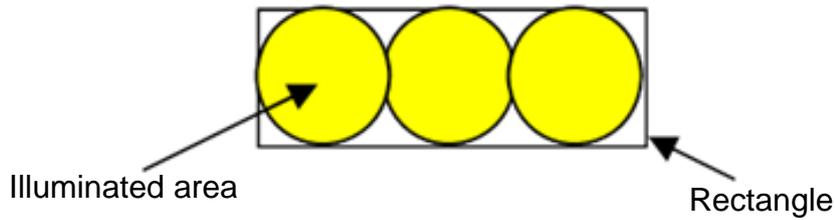
If two or more lamps are fitted and the aggregated illuminated area occupies 60% or more of the area of the smallest rectangle circumscribing the illuminated area this should be treated as one lamp.

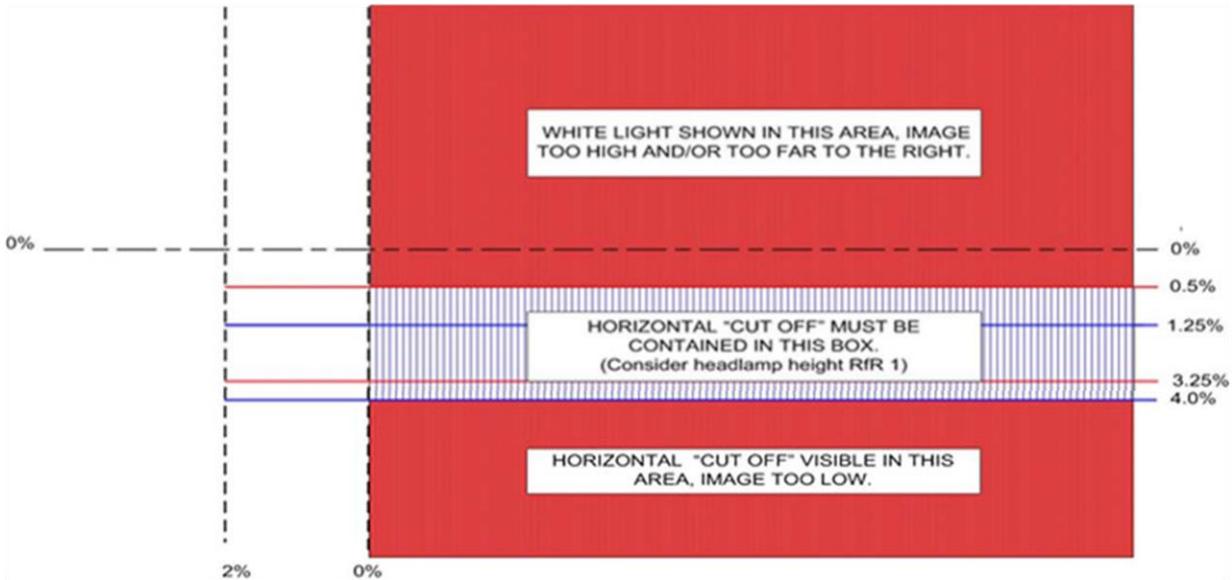
European checked on Dipped Beam

Align the headlamp aim testing equipment to the vehicle in accordance with the manufacturer's instructions.

Deficiency		Deficiency Category
European checked on Dipped Beam:		
1	In relation to the 0% horizontal line, the beam horizontal cut-off Major line is not between the limits listed below.	Major

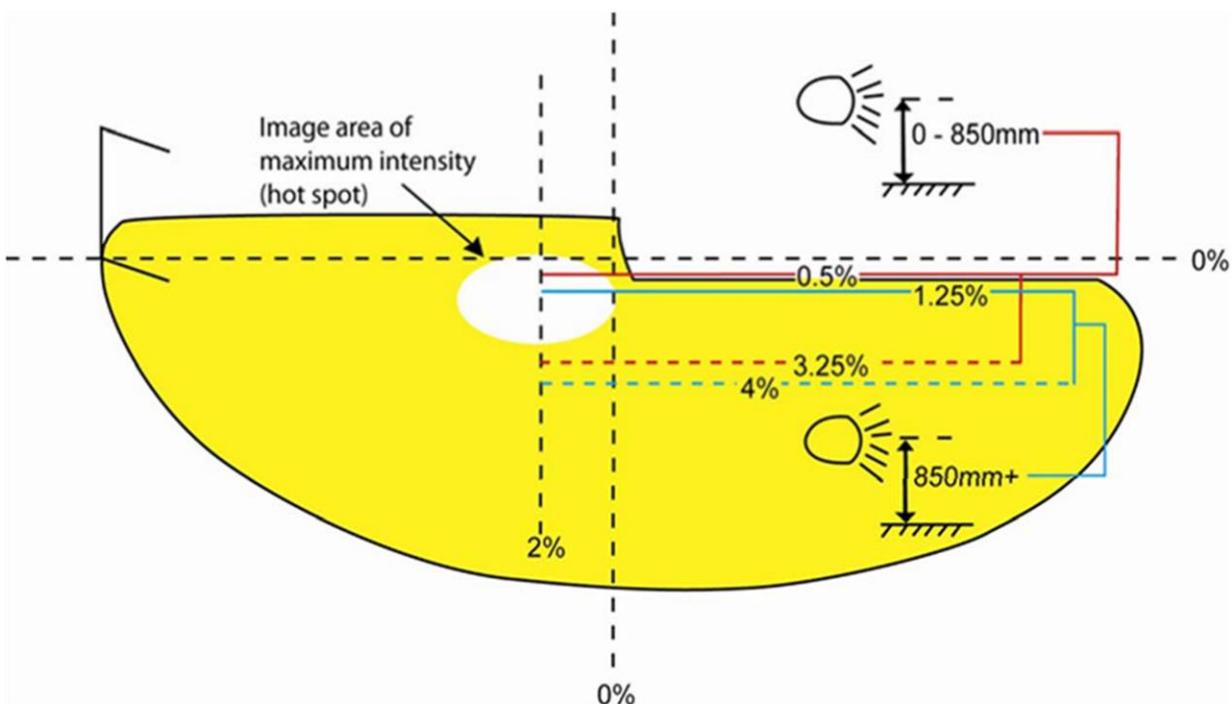
British American Checked on Dipped Beam

Align the headlamp aim testing equipment to the vehicle in accordance with the manufacturer's instructions.

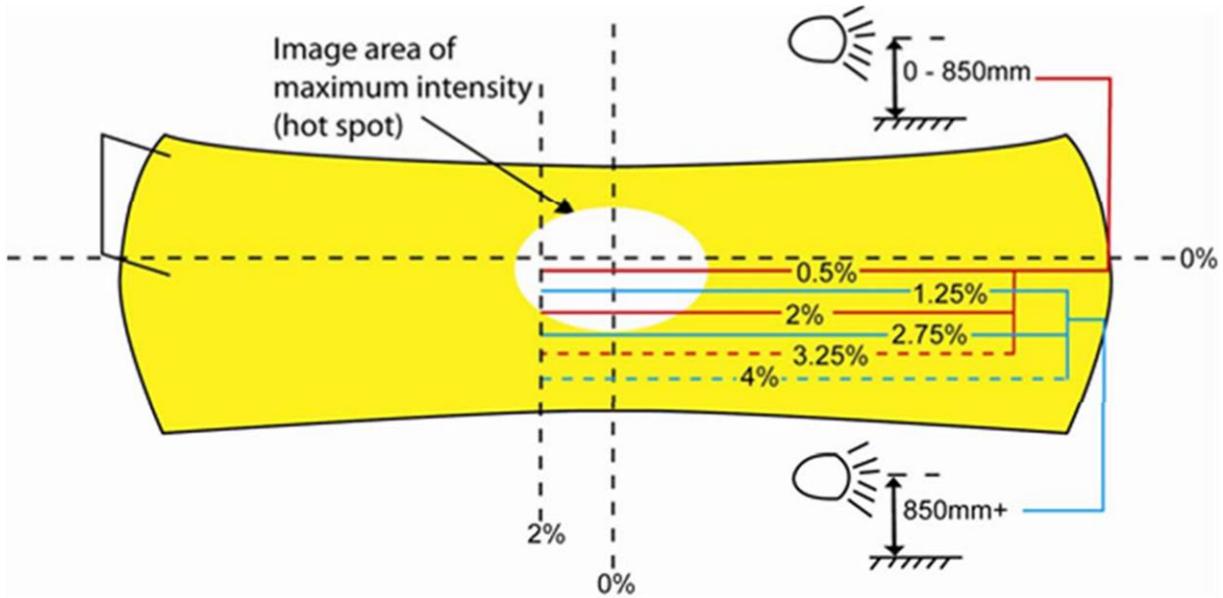
British American Checked on Main Beam

Align the headlamp aim testing equipment to the vehicle in accordance with the manufacturer's instructions
