Listed buildings and places Les bâtisses et endraits historique

8, Dumaresq Street, St. Helier.

File ref: HE0210

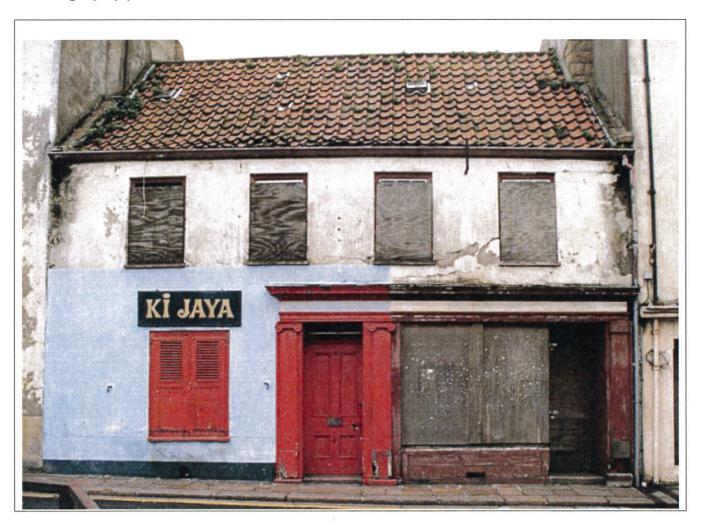
Photograph(s)

This four-bay, two-storeyed house was originally detached; the roof gables have granite copings and kneelers overbuilt by the upper floors of adjoining properties. Both chimney stacks have been heightened; the eastern is rendered, the western built of large squared granite blocks. The walls are granite rubble set in loam, rendered externally. The four symmetrical first floor windows have sixlight sashes with narrow glazing bars in beaded frames. There is another of the same pattern on the ground floor with external shutters. The central fourpanelled front door is flanked by lonic pilasters and incorporated into a shop front under a common dentilled cornice. This has a separate shop door at the west end of the elevation with a terminal pilaster of the same type (now incomplete). Wings have been added at the back of the house; the earlier, on the west side of a flagged central passage is stone-built with a lean-to roof and a pair of six-light sash windows on the upper floor. On the ground floor a large window with a door at either end is set under a common lintel; this is a secondary alteration and the south door appears to be a replacement for the north. The later wing on the east side is brick-built with a gabled roof (originally hipped at the north end). It had a similar ground floor window arrangement under a long lintel, now void and in poor condition. The first floor oversails to form a covered passage at the back of the property.
